COMPREHENSIVE BASIN REVIEW AND WATERCOURSE MONITORING

VOLUME I – MAIN REPORT

City of Mercer Island

December 2006

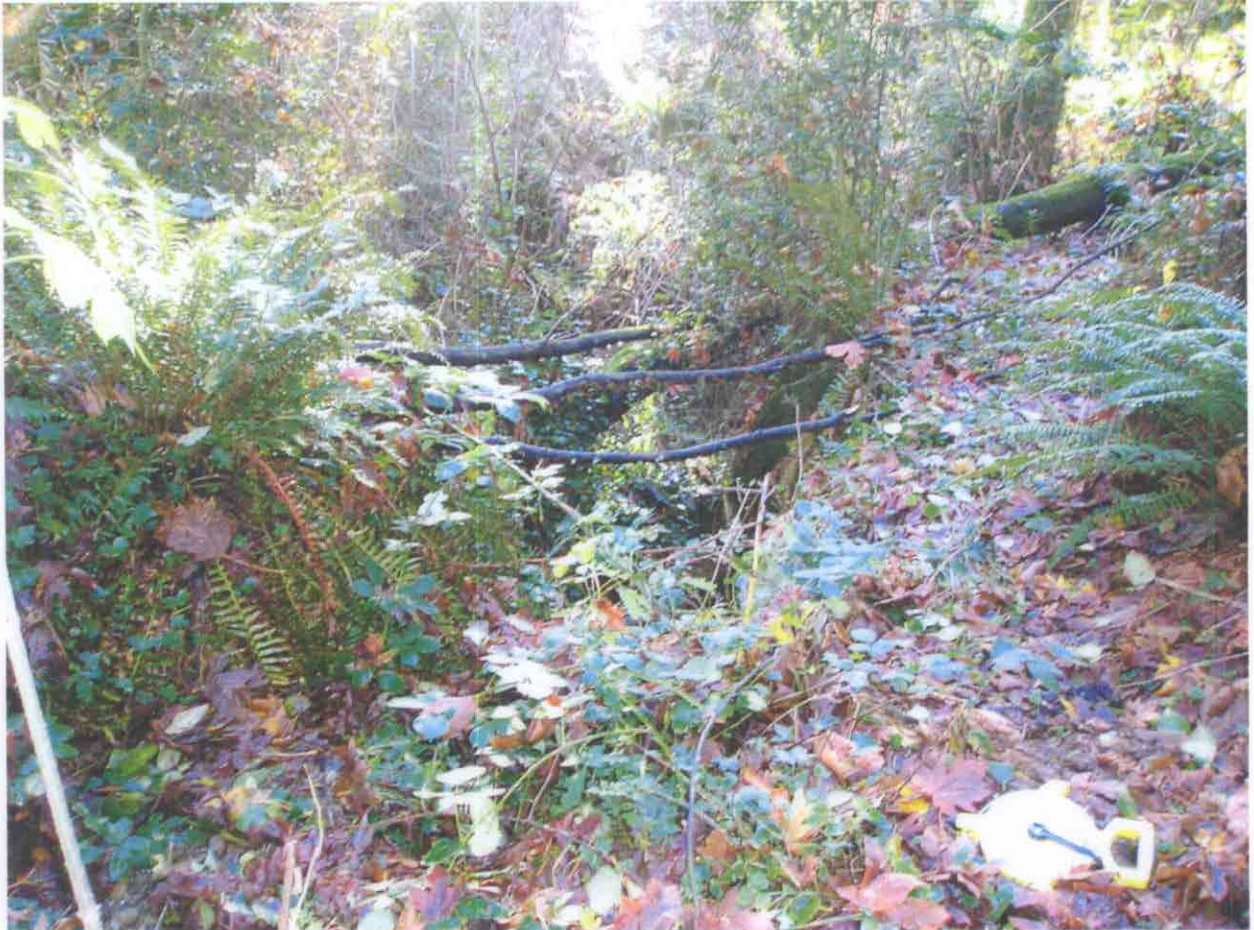
View to the southwest downslope toward the knick point

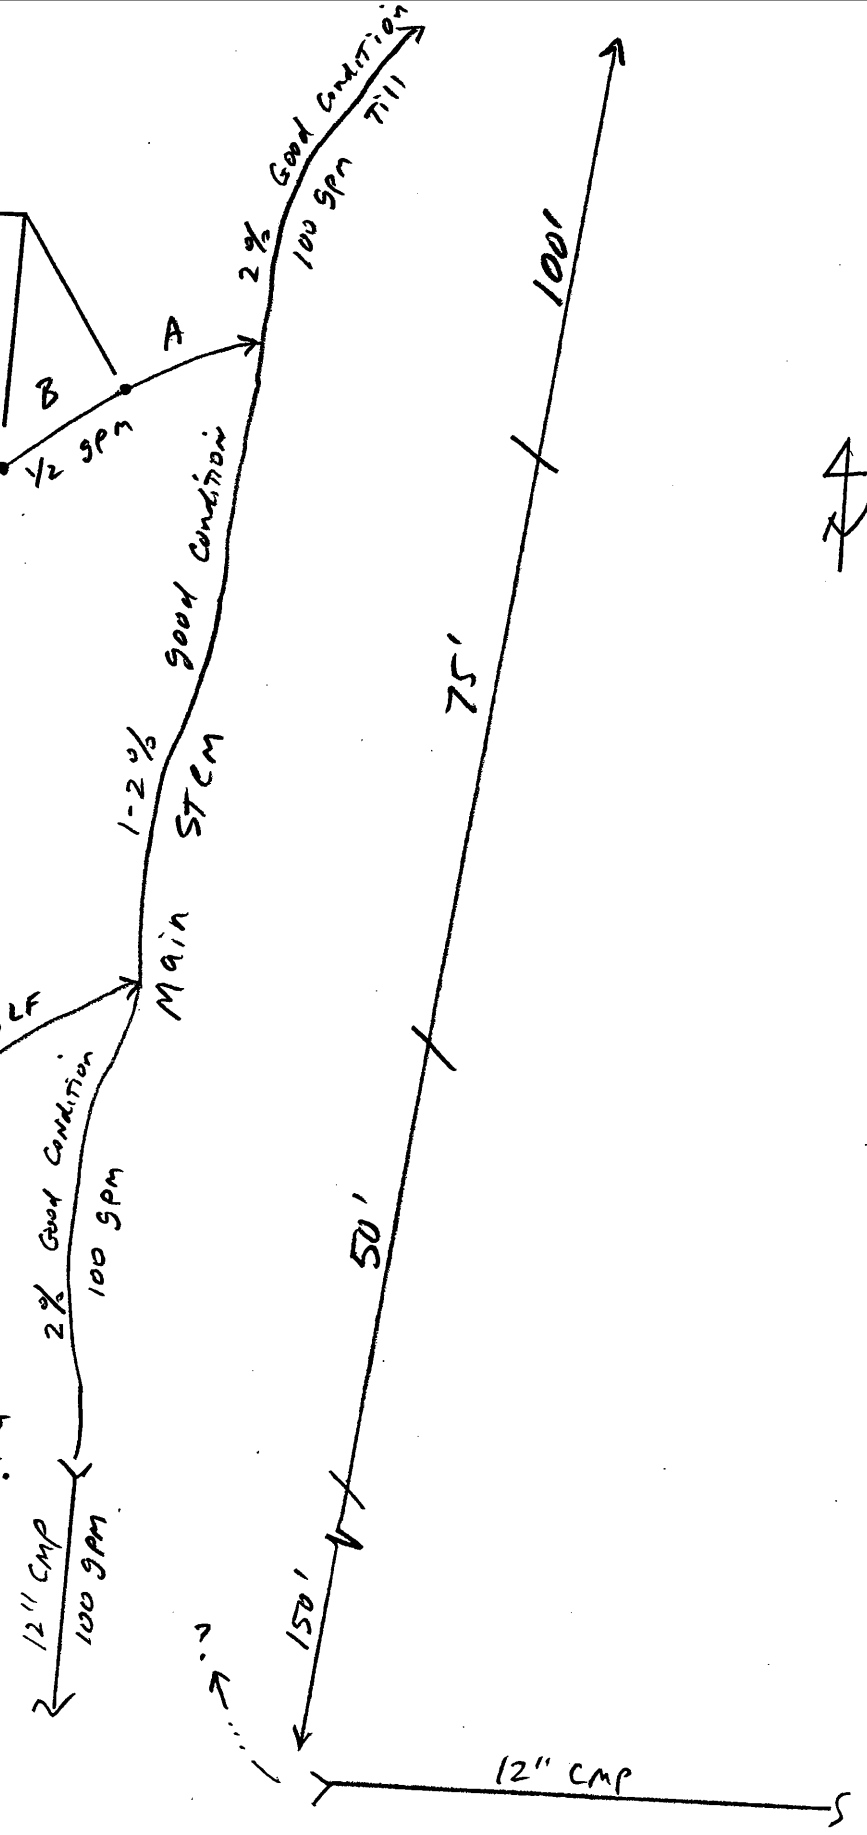
Problem 4.1

18" drop at outlet OK.
ROCK over TILL

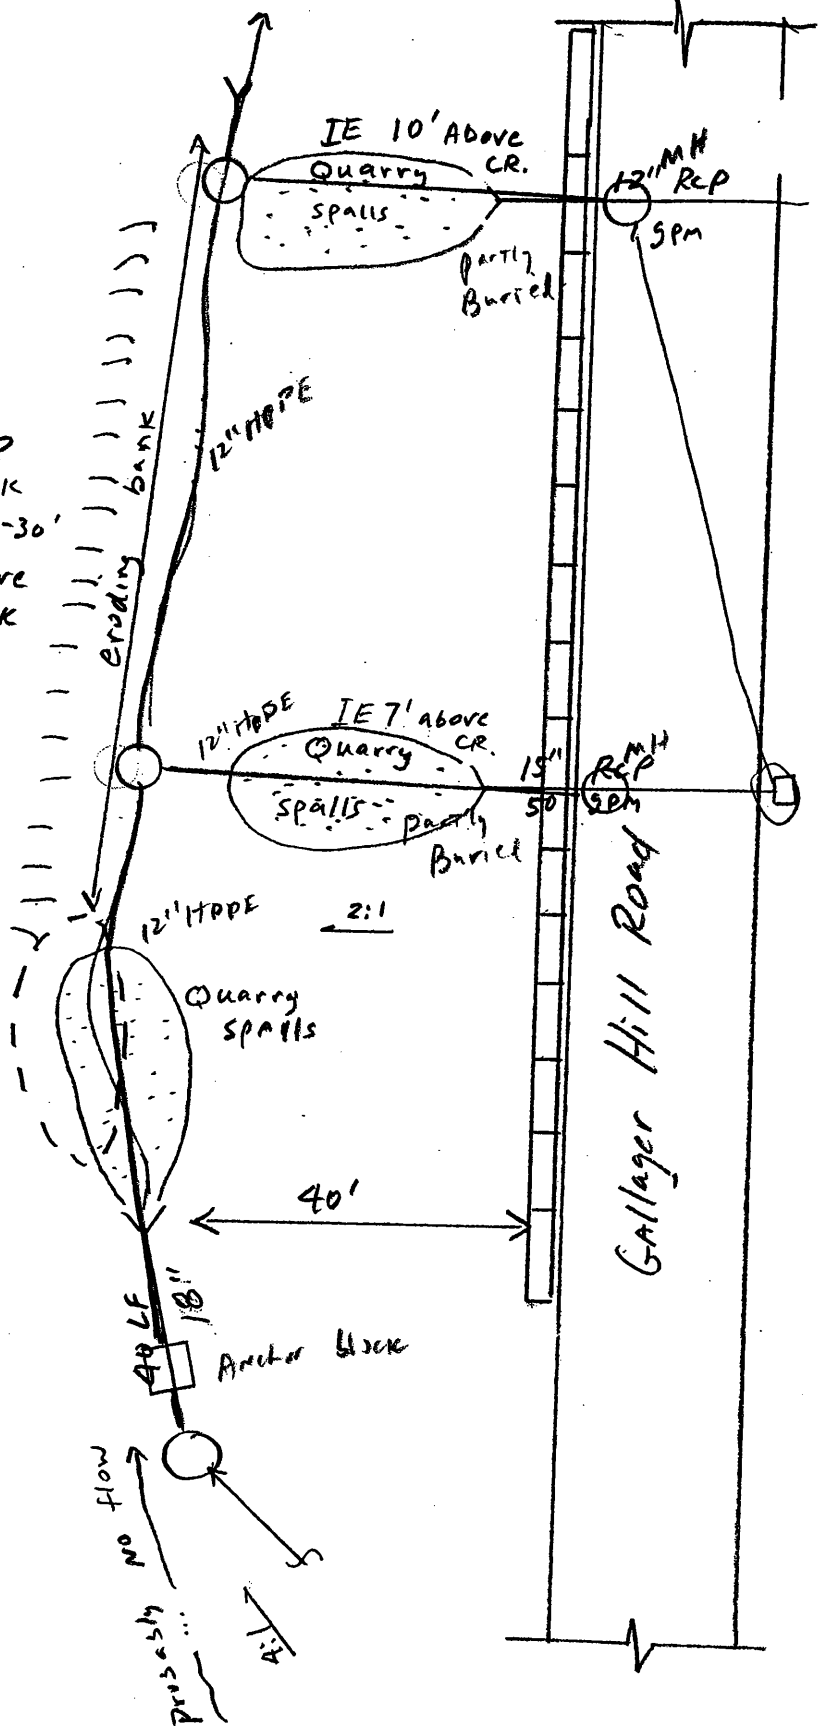
Undercut
and
eroding

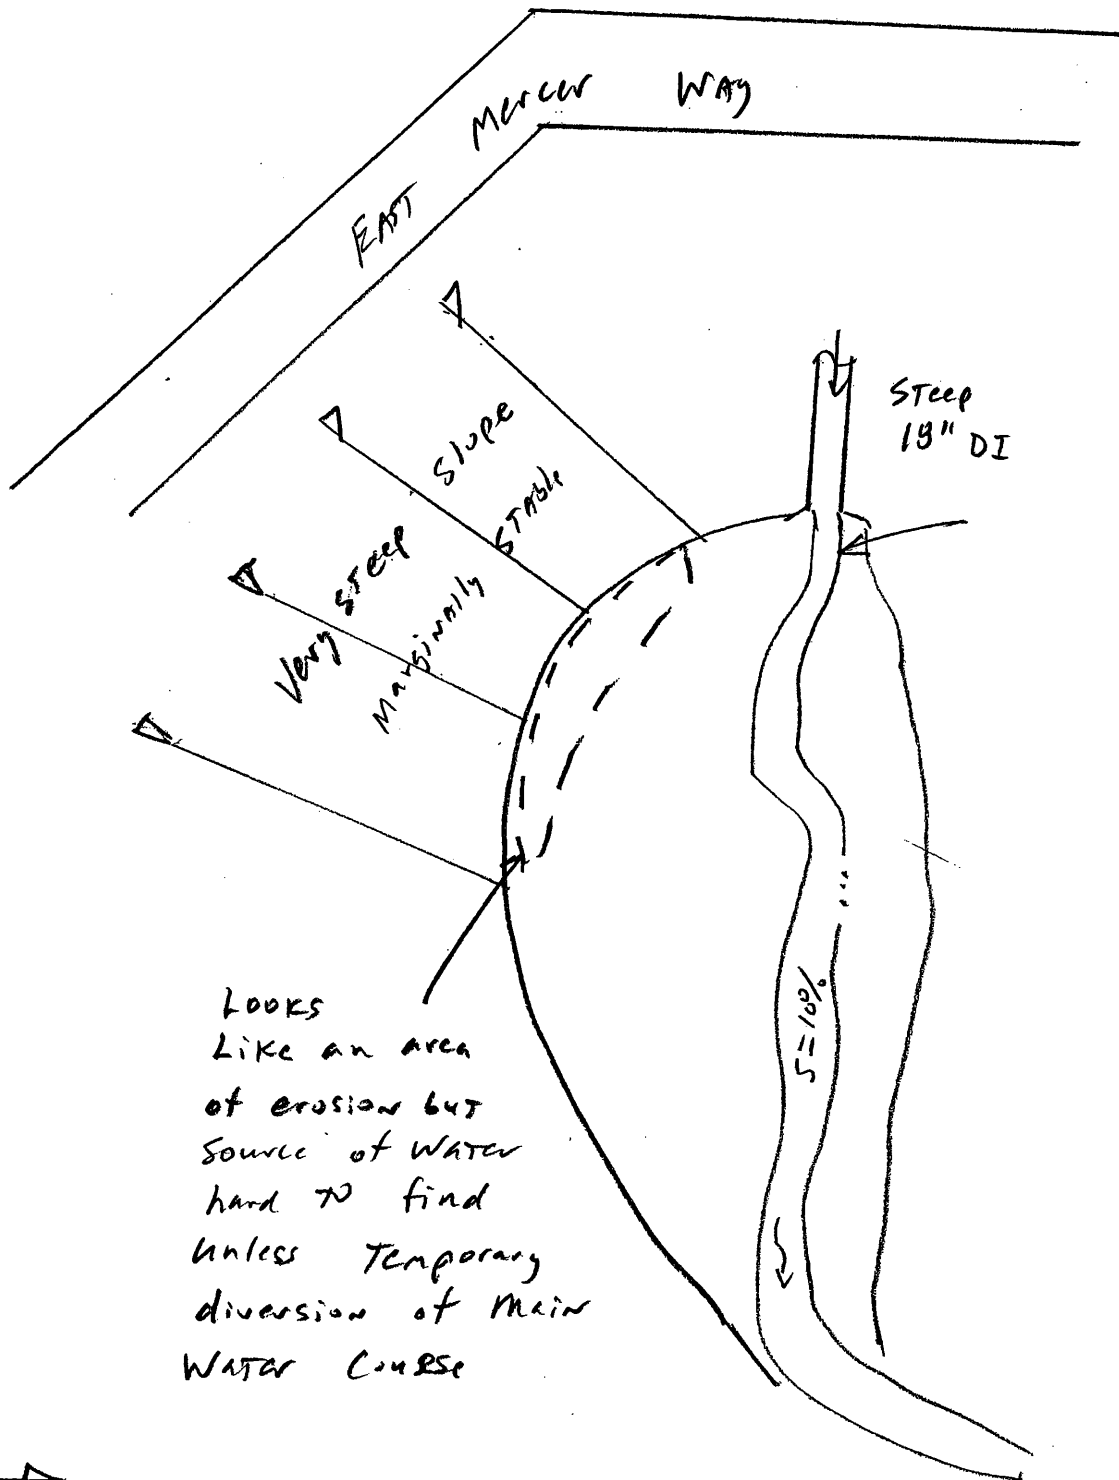
Minor erosion at outfall of 1'-2'. Steep erodible channel with erosion on south bank which is steep and marginally stable. Downstream of site is 150 LF of low intensity erosion. Considerable sand in channel. Upstream slide mapped channel for 100'
 Potential Monitoring Site: Yes No upstream of E.M.W. is okay.

Looks like an area of erosion but source of water hard to find unless temporary diversion of main water course

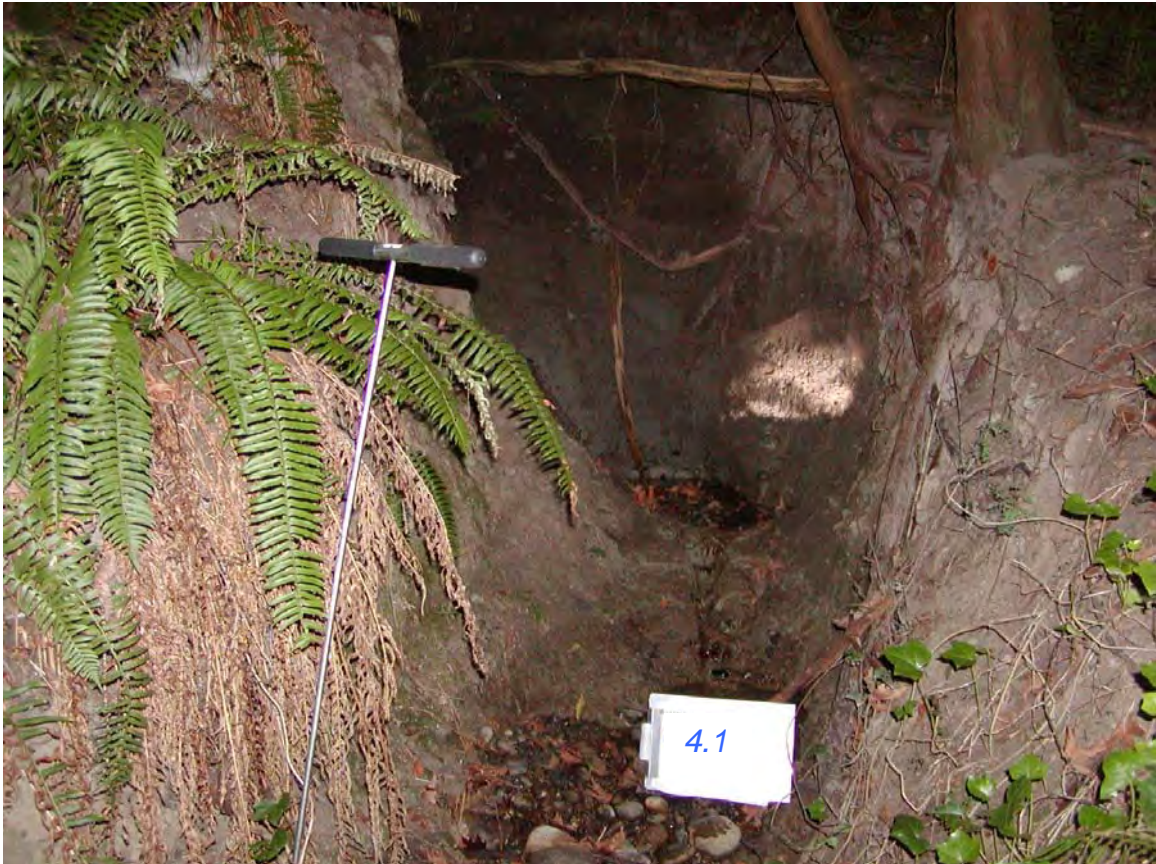
Looking Upstream 9/24/2005

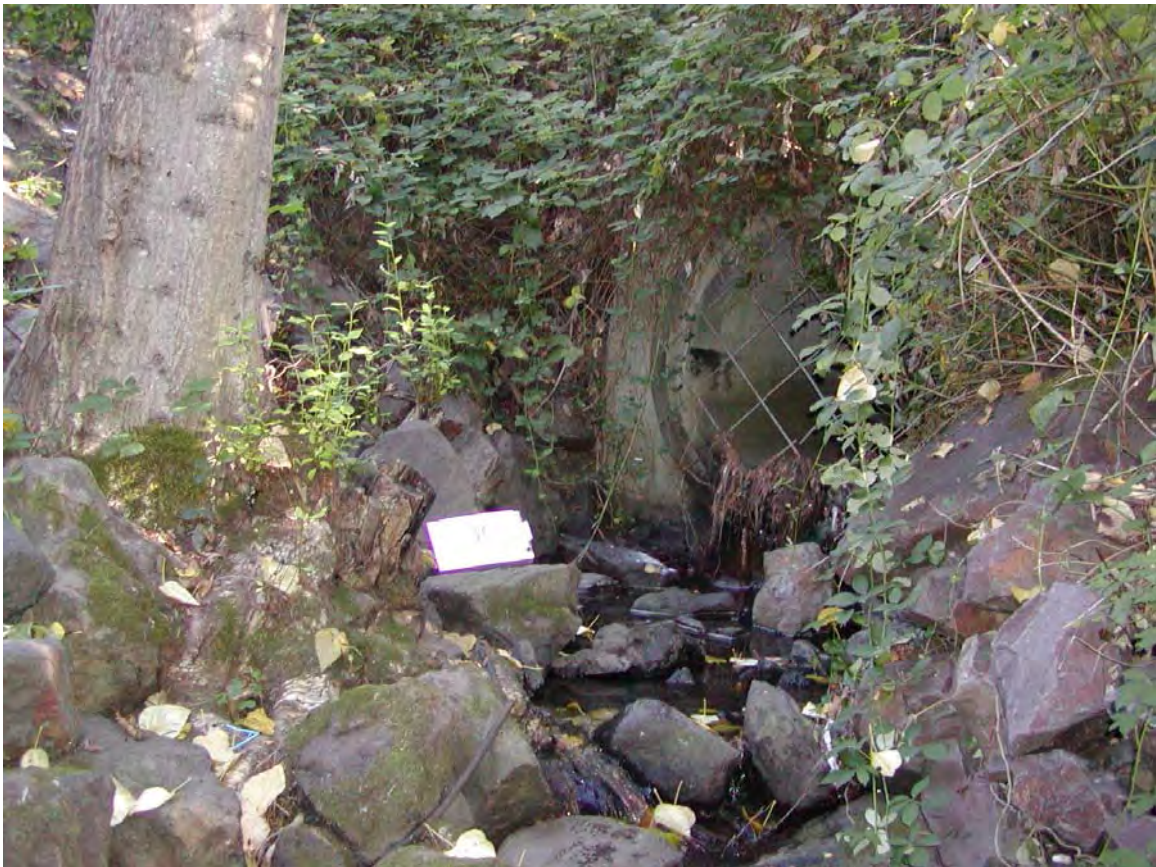
Looking Upstream at 60" Outlet 9/24/2005

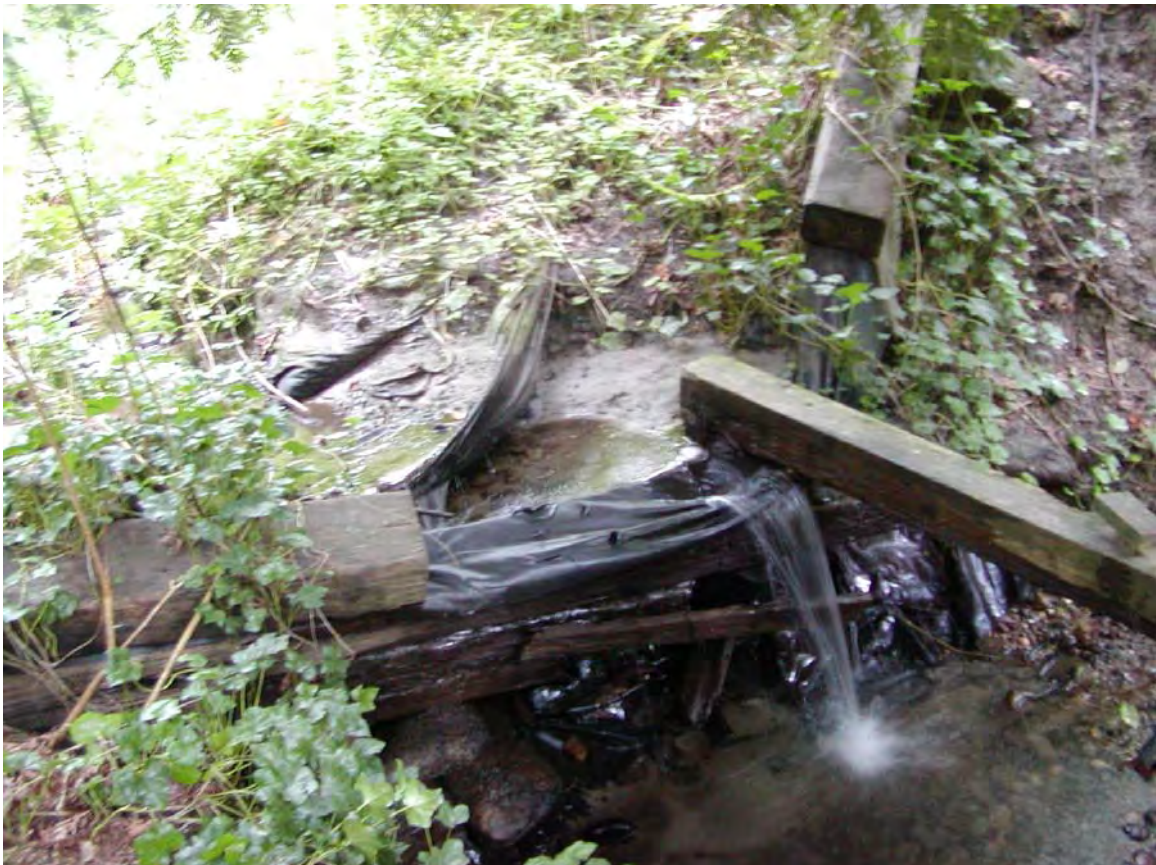
Looking Upstream at Failing Timber Dam 9/28/2006

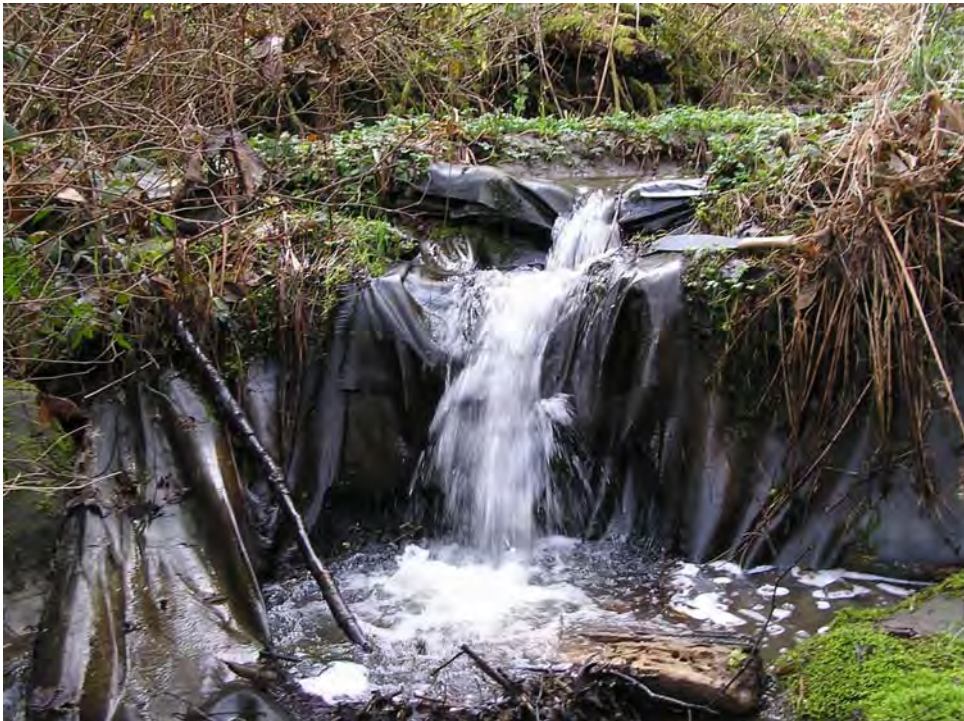
Looking Upstream at 3' High Sandbag and Geotextile Dam 9/28/2005

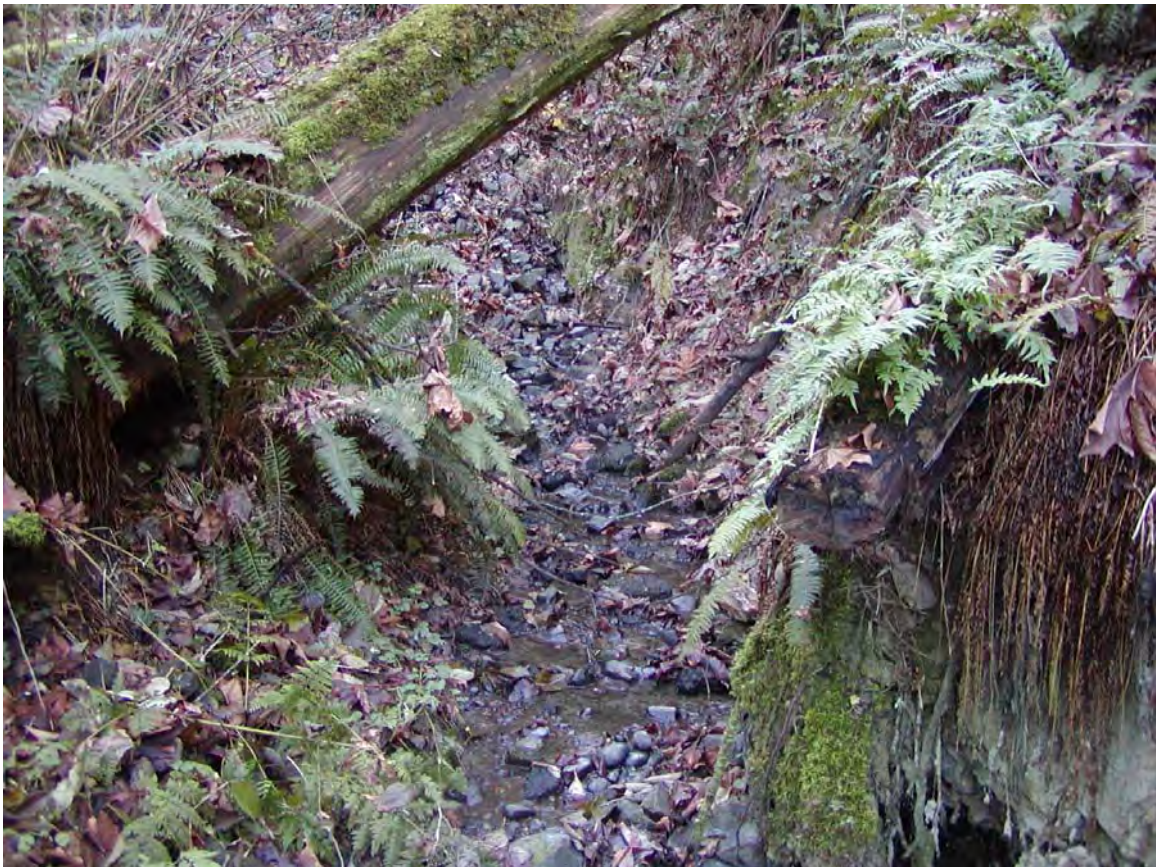
Looking Upstream 12/8/2005

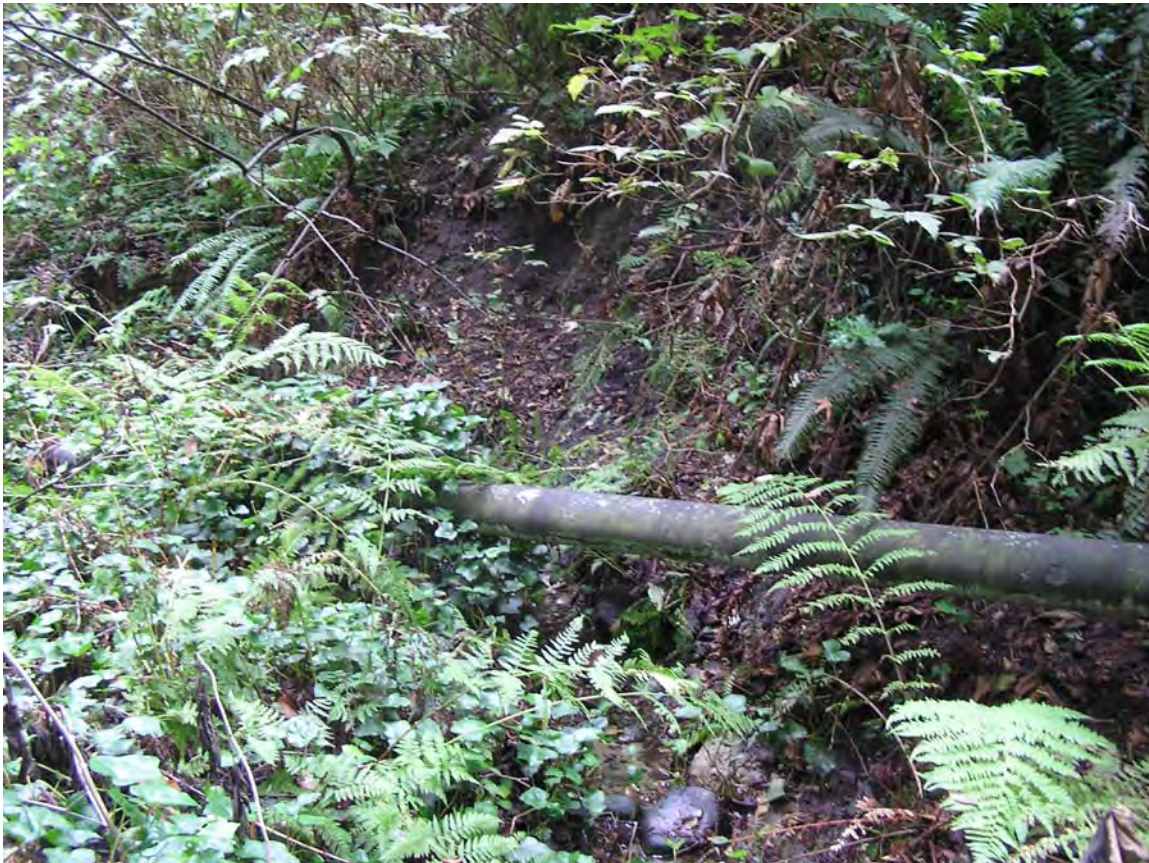
Basin No.:	45b
Project No:	45b.3
Project Title:	450 feet of Stream Restoration and 120 feet of Sewer Replacement at Parkwood
Problem Description:	Stream downcutting has exposed 120 feet of sewer and generated considerable sediment, which is a maintenance problem downstream. Sewer is leaking into water course.
Project Description:	Stream restoration along 450 feet of channel is needed along with reconstruction of 120 feet of sanitary sewer. Erosion problem upstream previously solved by installation of piping in the water course.
Related Projects	Predesign investigation underway for this site.
Estimated Project Cost:	\$444,000

Looking Downstream at Exposed Sewer Pipe 9/12/2005

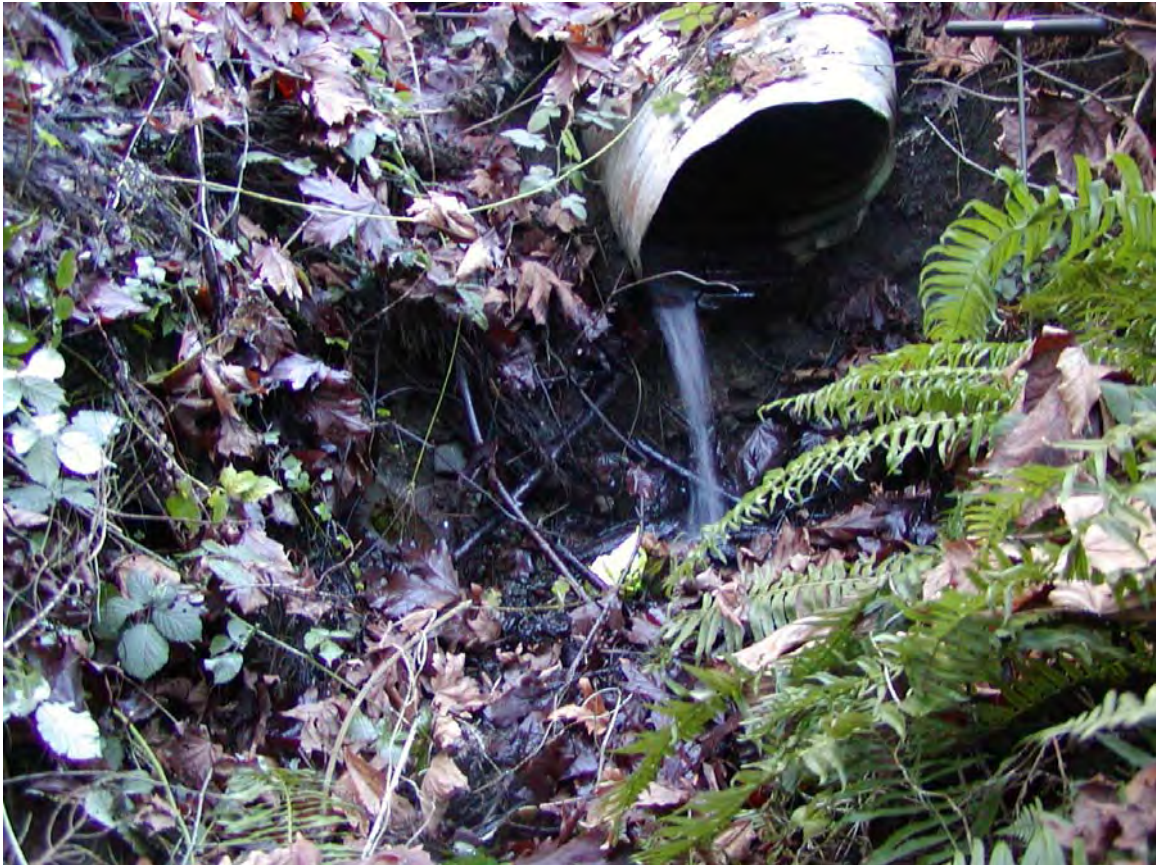
Erosion at Pipe Outlet (pipe crushed) 12/8/2005
