COMPREHENSIVE BASIN REVIEW AND WATERCOURSE MONITORING

VOLUME I – MAIN REPORT

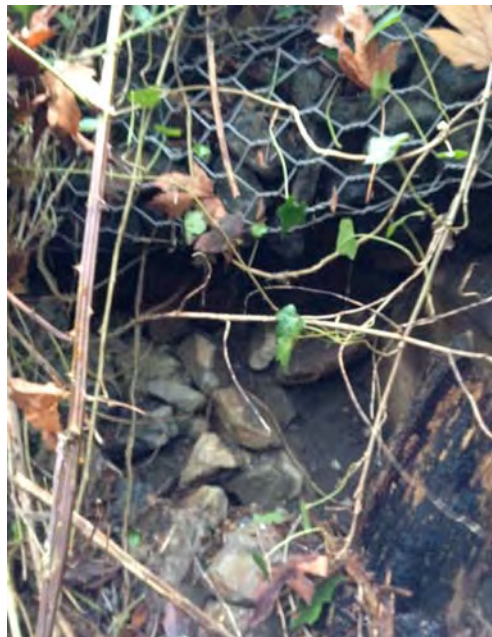
Project 4.2: Failing Gabion Wall 12/22/2011

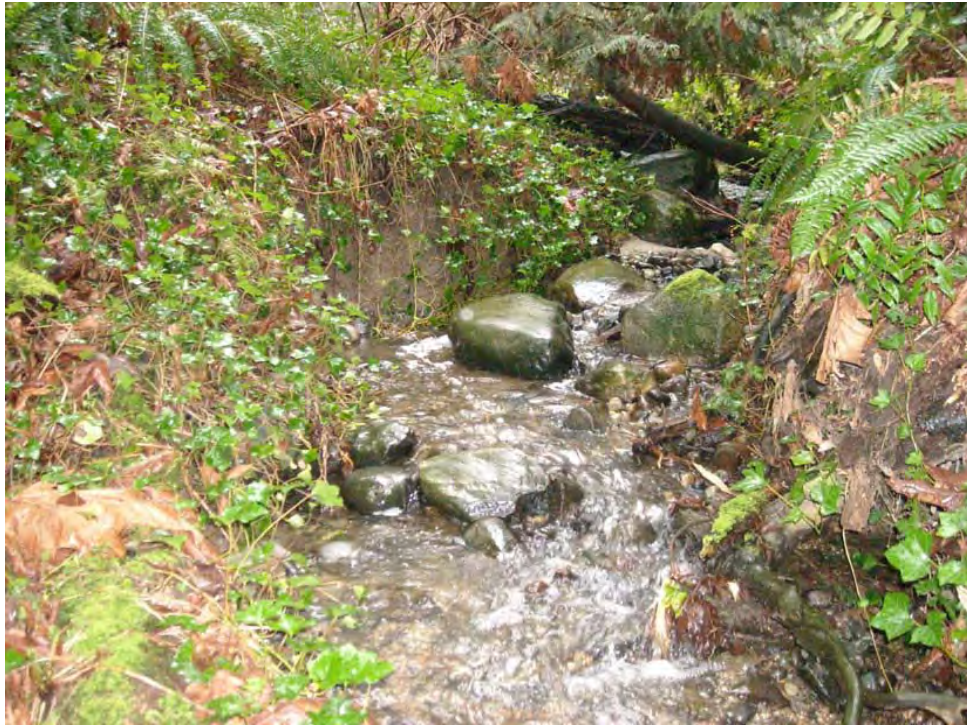
4.3C: Looking Upstream at Bank Erosion at a Stream Bend 3/13/2008

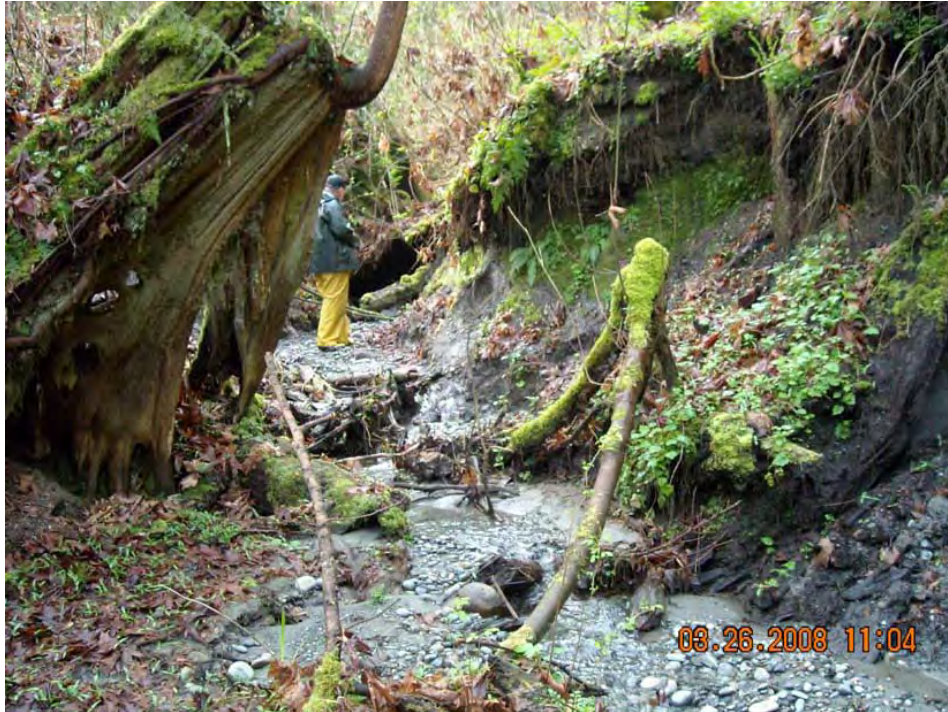
Project 6.4: Looking Upstream 3/26/2008

Project Description:	On main stem (Project 6.5), repair or replace 20 log weirs and stabilize in-channel log jams. Reinforce undercutting banks with boulders/logs at toe or catch/fill structures. Reduce scour in plunge pools with boulders/cobble. On west branch (Project 6.4), 450 feet of 12" pipe to reduce bank erosion and stabilize the hill slopes.
Related Projects	Phase I – constructed in 1990s along Shorewood Apts. Phase II – constructed in 2011 upstream of Shorewood Apts.
Estimated Project Cost:	\$484,000 (2011 estimate)

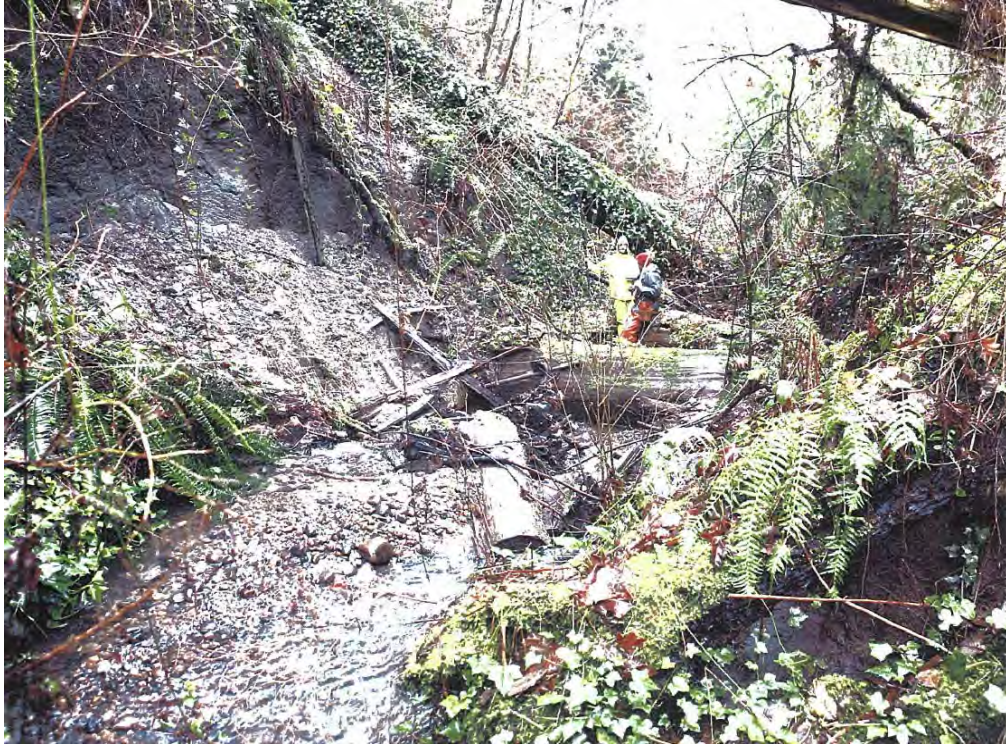
Project 6.5: Failed Log Weir Station 33+20 2/15/2011

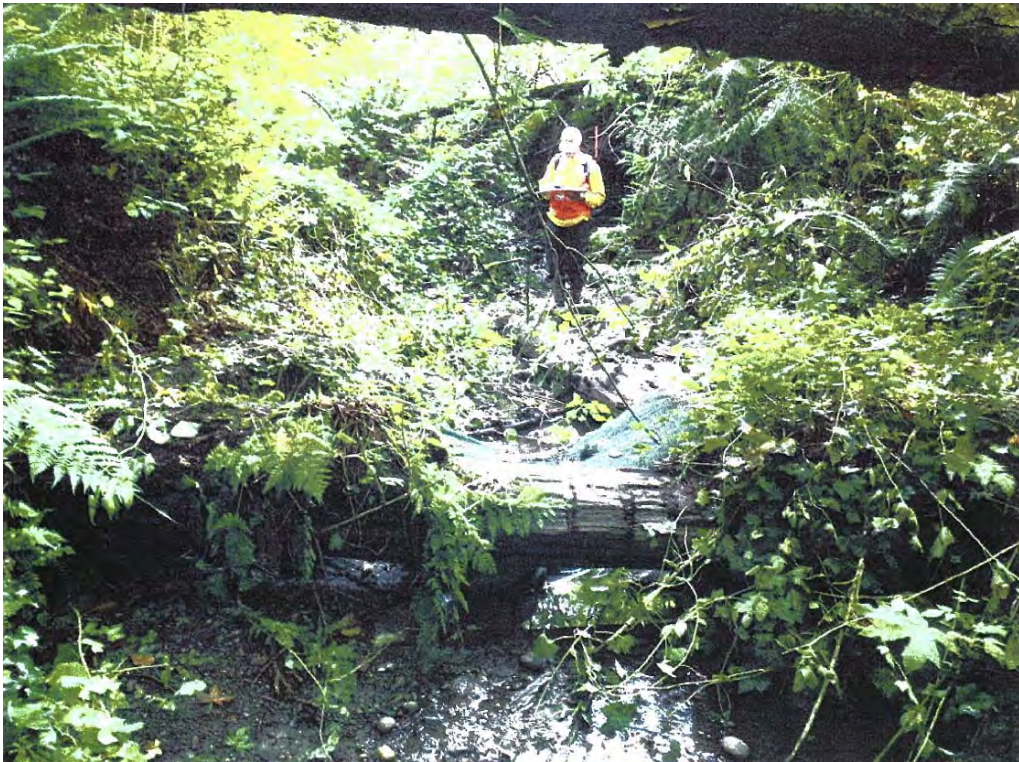
Project 6.5: Station 38+25 2/15/2011

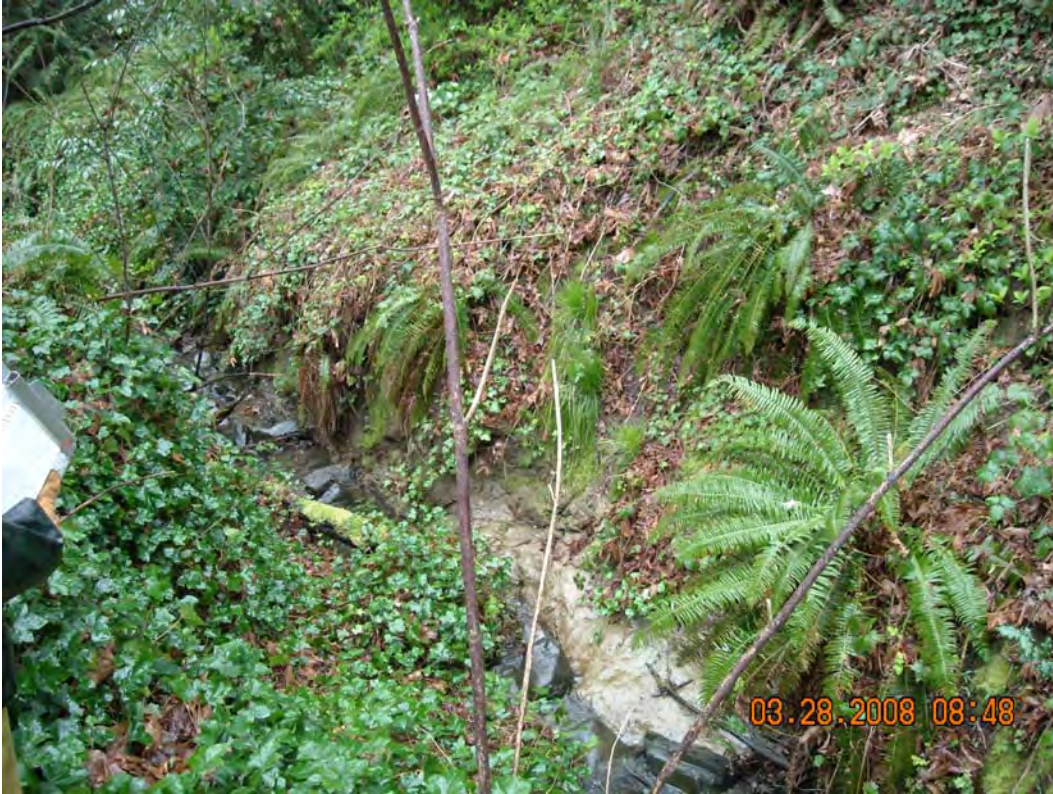
Looking Downstream 3/28/2008

Project Description:	<p>250 LF of channel stabilization consisting of regrading and filling channel to re-create stream. Install boulder cascade at 10 foot headcut at station 2+00 and extend beyond headcut.</p>
Related Projects	<p>About 120 LF of timber retaining wall at 4320 Forest Avenue is failing and will need to be replaced by property owner. Some watercourse stabilization warranted in this subreach as well.</p>
Estimated Project Cost:	\$239,000 (2012 revision)

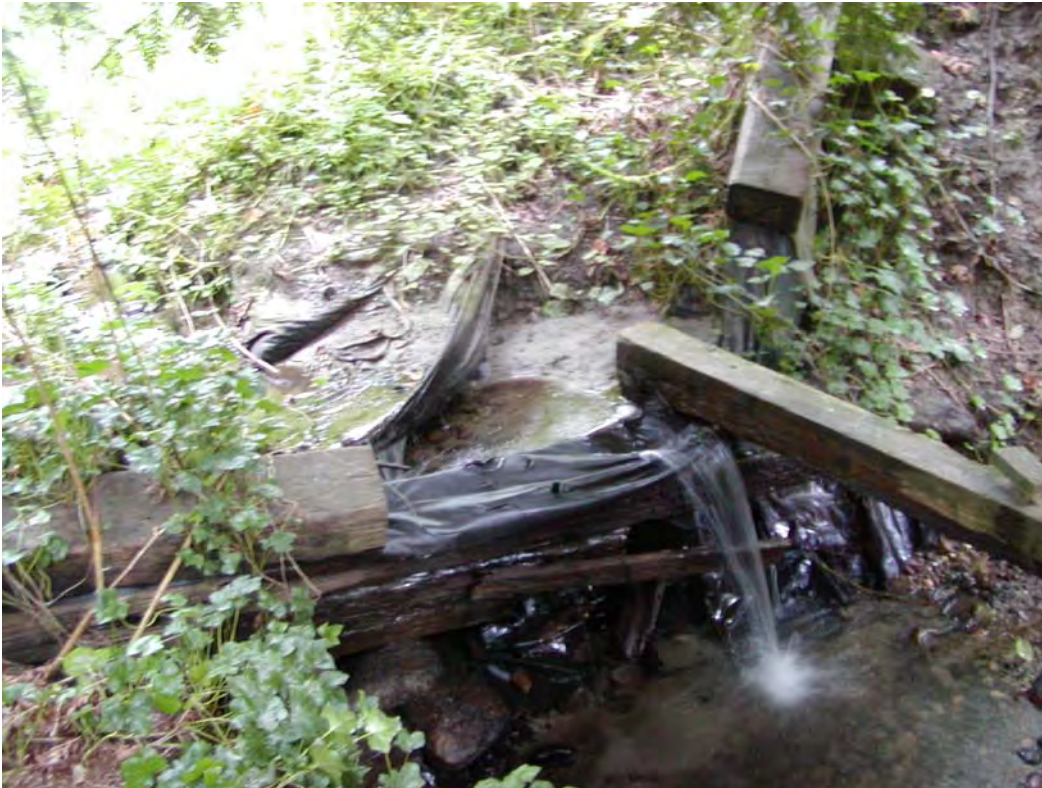
Looking Upstream at Failing Timber Dam 9/28/2006

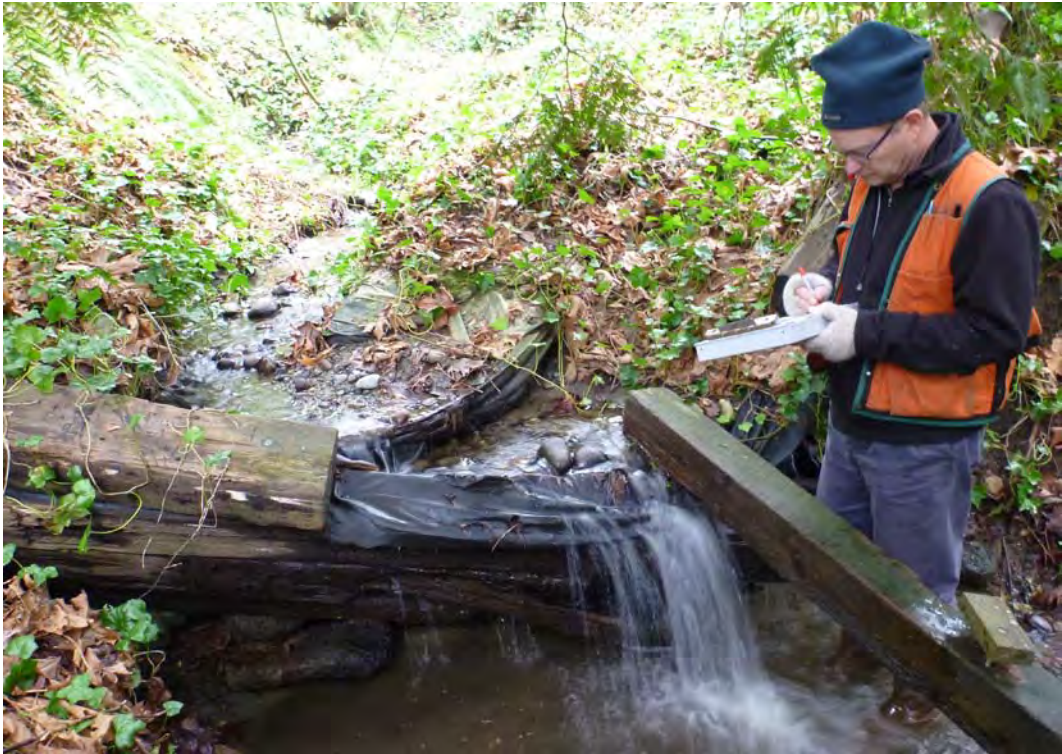
Looking Upstream at Failing Timber Dam 3/9/2012

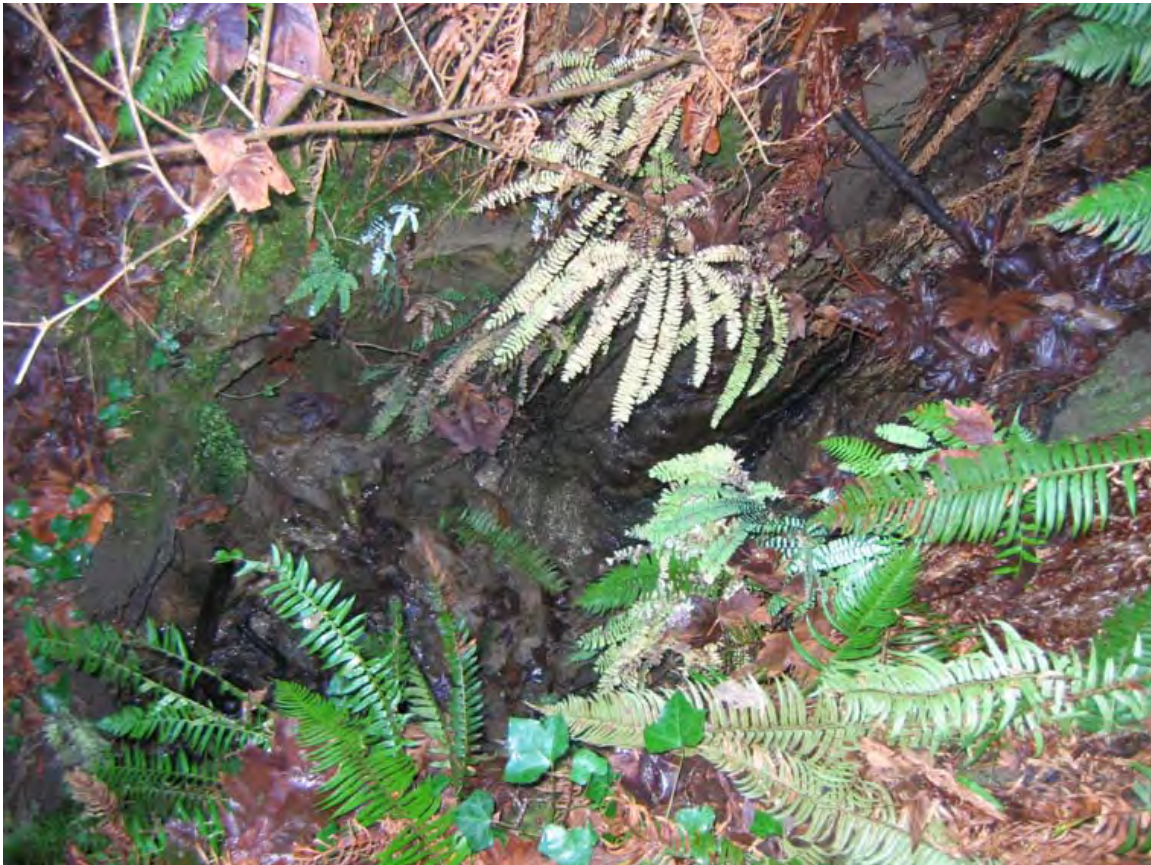
Looking at 10' Incised channel 12/14/2005

Basin No.:	29
Project No:	29.2
Project Title:	140 LF butt-fused HDPE pipe on west side of West Mercer Way in 6100 block
Problem Description:	Very steep channel has created a 15 foot headcut and incised into the east bank of the main stem of the creek. The headcut has retreated about 5 feet since 2005. The small, narrow channel is up to 12 feet deep and rapidly eroding. See Appendix E for a field sketch of the problem area.
Project Description:	Butt-fused HDPE bypass pipe from West Mercer Way down the steep bank to the ravine bottom, a distance of 140 feet. New manhole and anchor near the street. All flow will be conveyed in the pipe.
Related Projects	None
Estimated Project Cost:	\$101,000 (2012 revision)

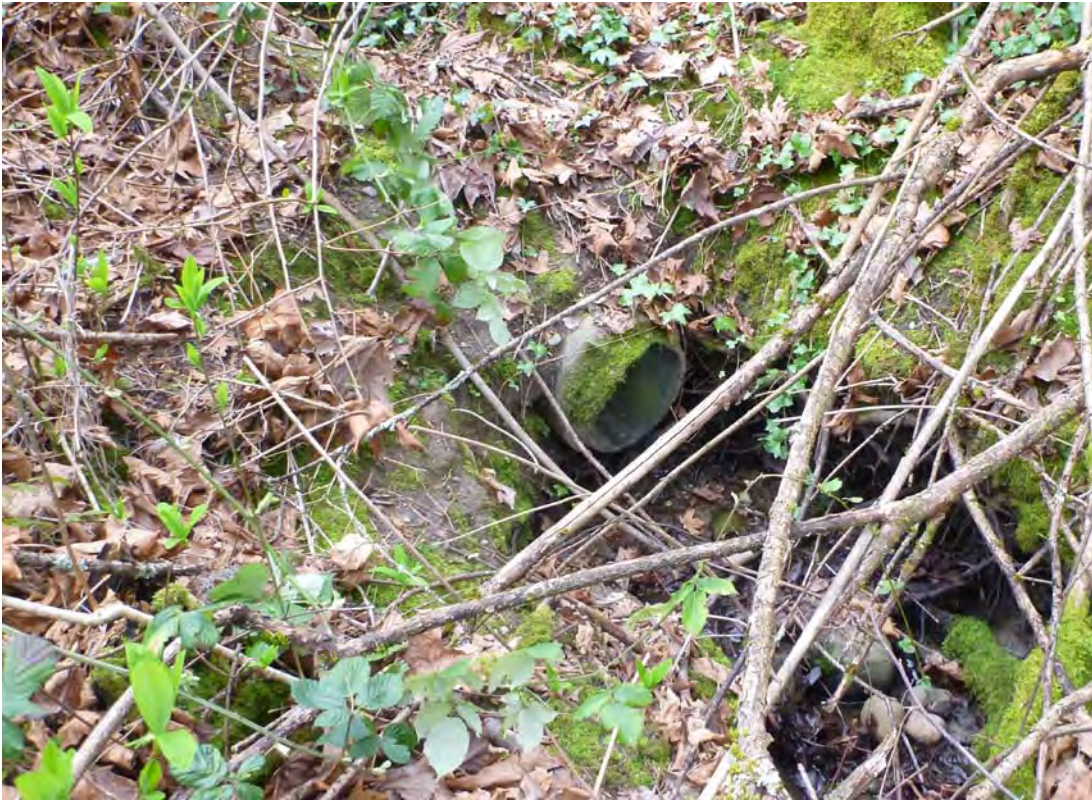
Outfall of 12" reinforced concrete pipe under West Mercer Way 03/09/2012

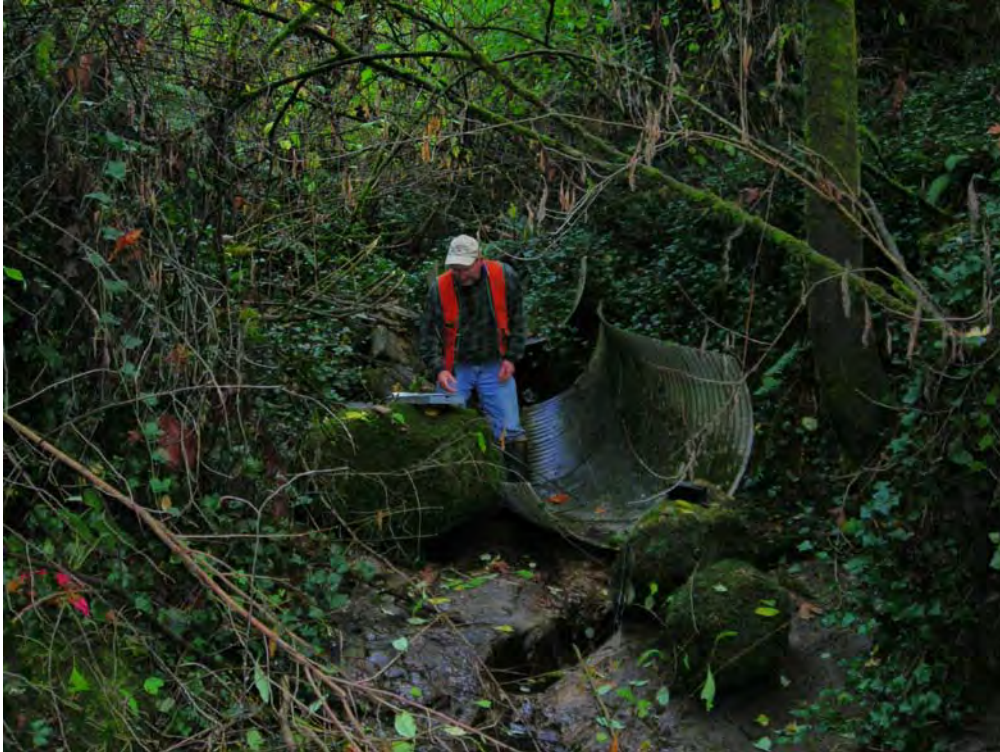
Looking upstream (32b.1) 10/20/2006

Project Description:	<p>In Project 32b.1 construct approximately 30 linear feet of boulder cascade for outfall protection below half round pipe outlet and in Project 32b.2 install 50 linear feet of boulder cascade at headcut downstream. Regrade upper banks and replace invasive plants with native vegetation.</p>
Related Projects	None
Estimated Project Cost:	\$82,000 (2012 revision)

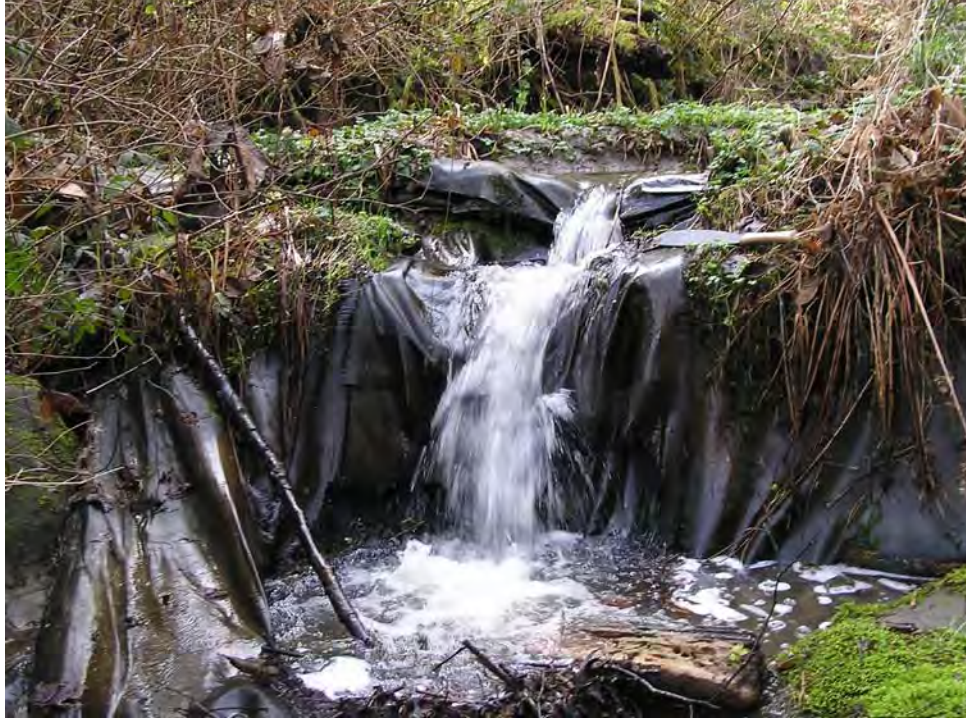
Looking Upstream at 3' High Sandbag and Geotextile Dam 9/28/2005

Project Description:	Replace failing sandbag check dams that pose a risk to increase erosion with rock check dams or rock vortex weirs. Check dams are less expensive but rock vortex weirs may be needed to provide fish passage. Also provide bank protection and stream restoration along about 95 feet of bank. Stream restoration would include logs/large woody debris, boulders, bank regrading and planting.
Related Projects	None
Estimated Project Cost:	\$284,000 (2012 revision)

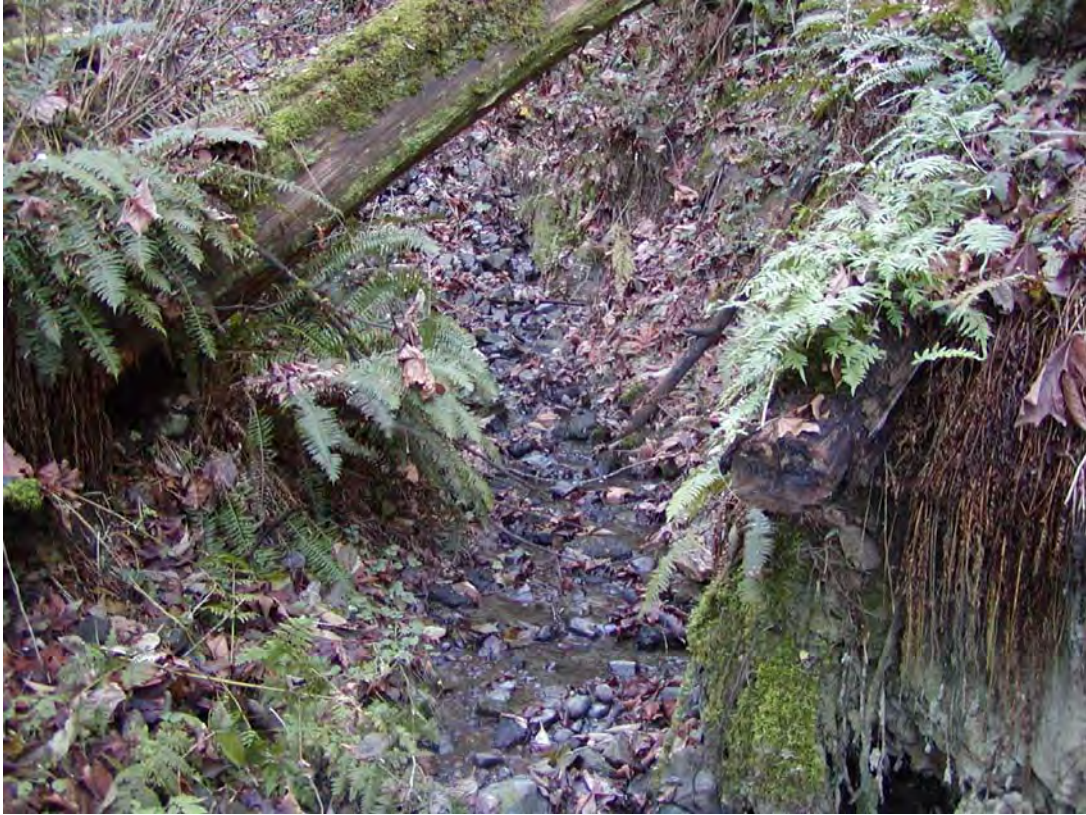
Looking Upstream 12/8/2005

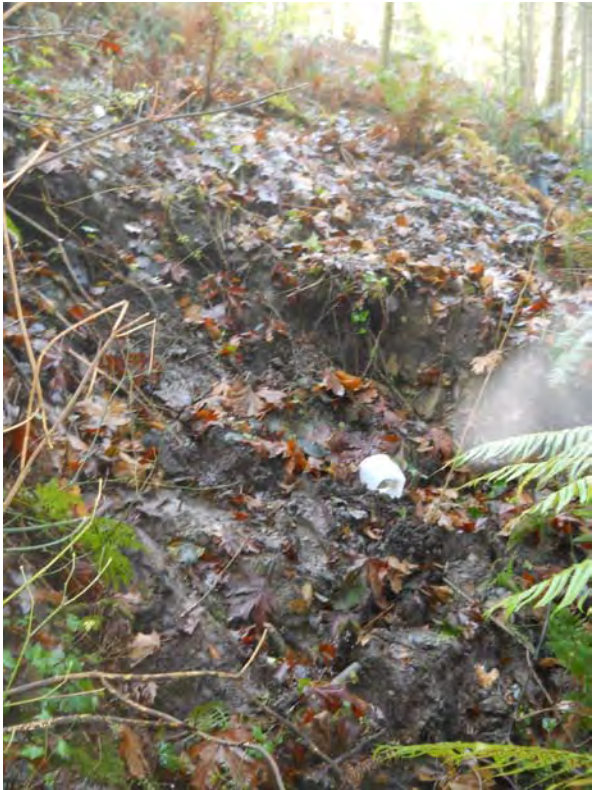
Recent Slope Toe Failure from Bank Erosion 12/22/2011

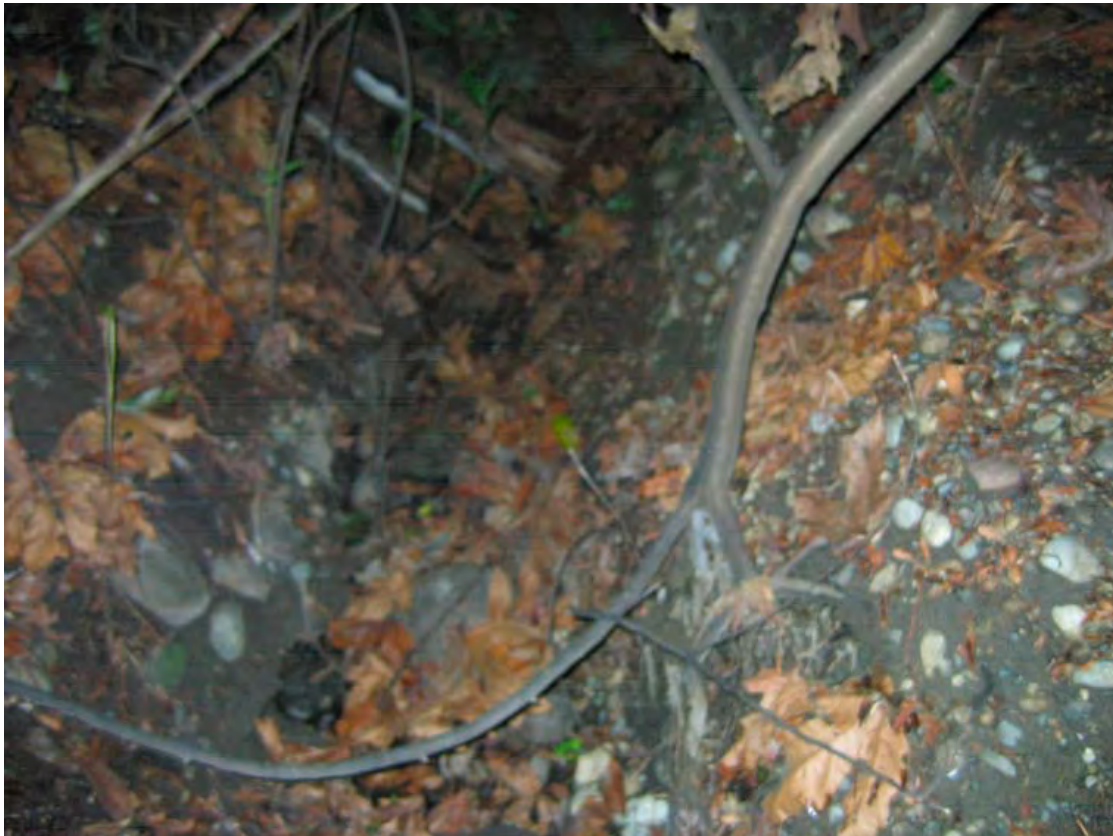
Looking Upstream 12/14/2005

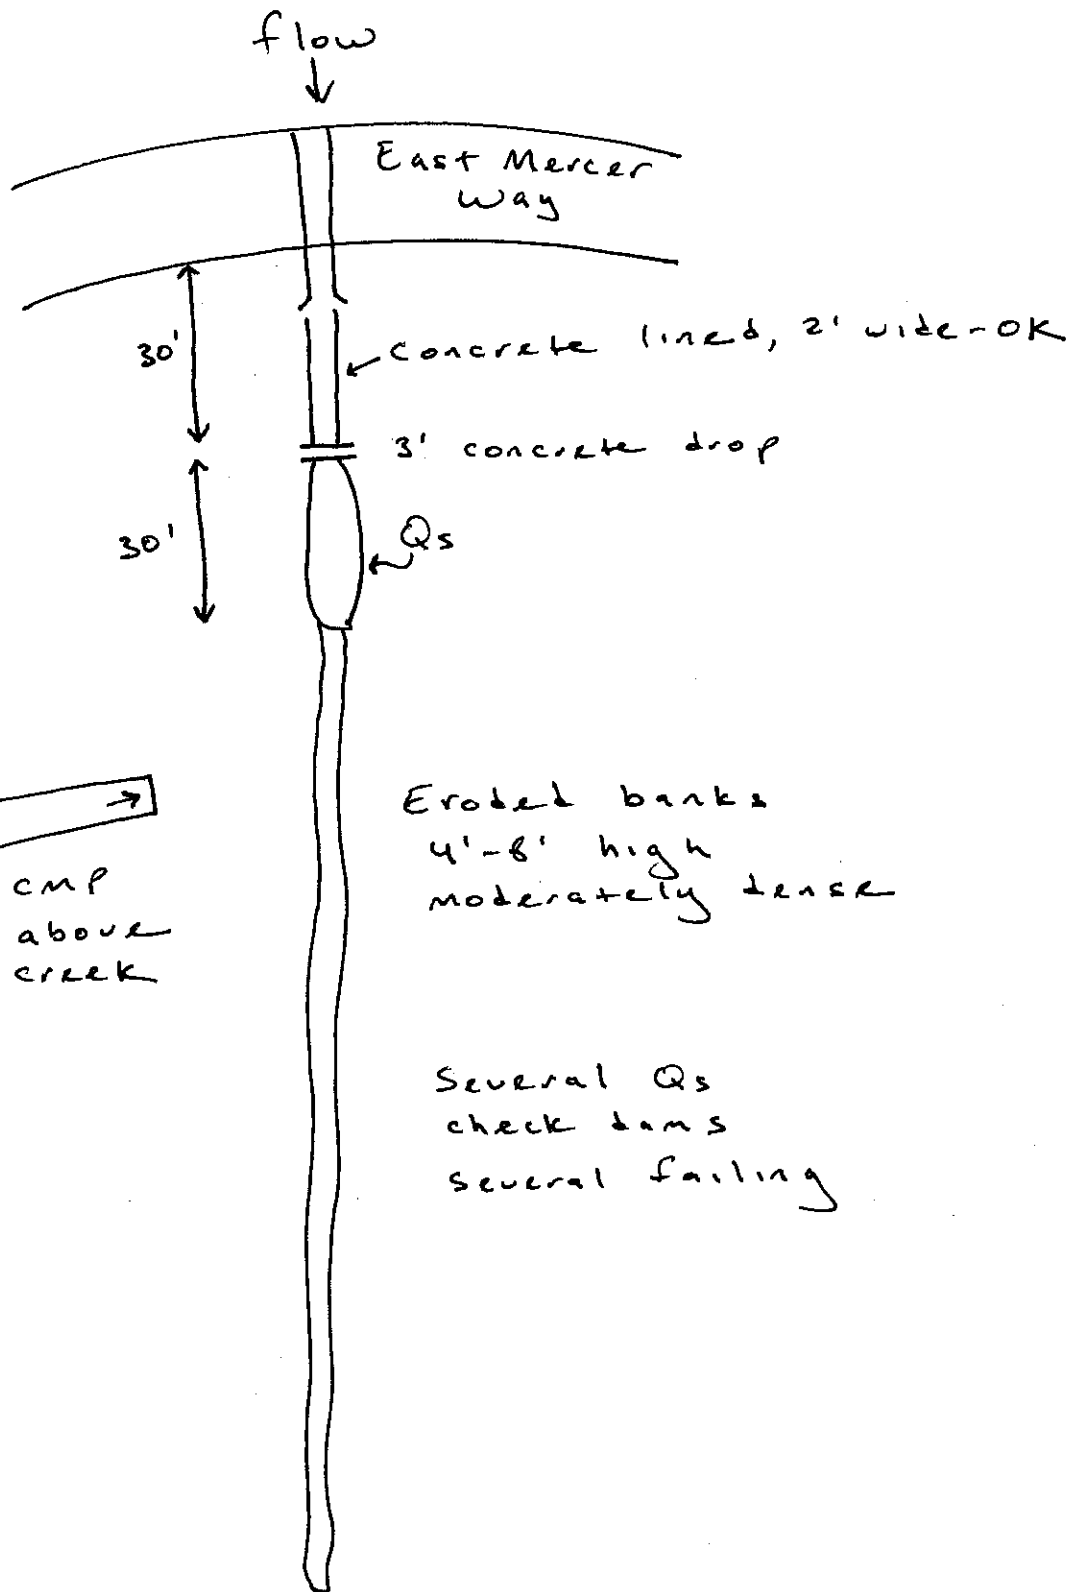
A little worse
by events since
2008?

→
12" CMP
15' above
creek

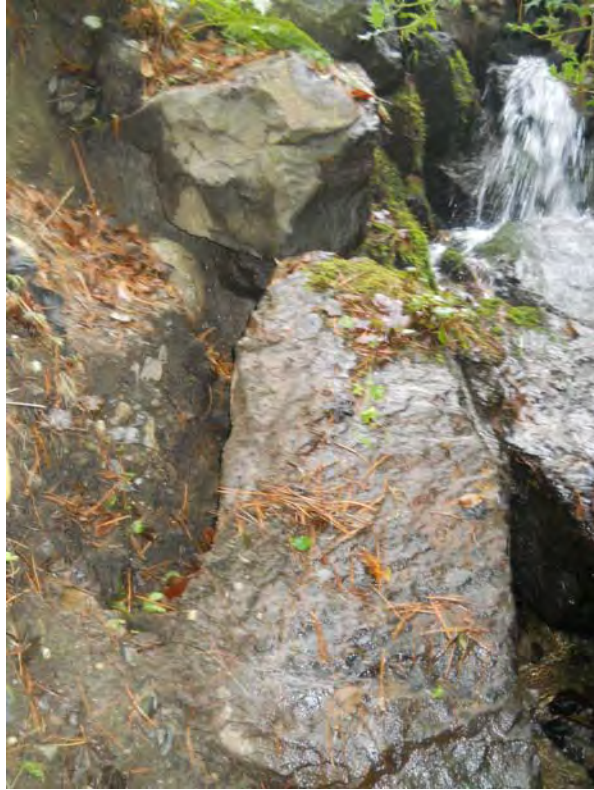
**Project 50b.4E: Looking Upstream at Failing Bank Protection at Outlet
12/22/2011**

Basin No.:	50b
Project No:	50b.4E (upstream) and 50b.4F (downstream)
Project Title:	Install Drop Manhole and CPE Pipe along 40 LF of Channel and Install rock and/or log step structures or Repair Concrete Weir In Place
Problem Description:	Downstream of Ferncroft Road at culvert outlet bank protection is failing. At the culvert outlet the channel drops approximately 8 feet along 20 LF of channel. Boulders placed along both banks are dislodged and falling into channel. In 50b.4F, approximately 2 foot high concrete weir has failed and is inclined downstream. See Appendix E for field sketches of problem areas.
Project Description:	<p>In 50b.4E, the preferred approach includes installation of a drop manhole and CPE pipe along 40 LF of channel to stop erosion of banks at culvert outlet. Significant environmental and permitting concerns are likely with this approach. Alternate solutions include repair rock bank protection in-place and anchor into slope, or replace with gabion or other retaining wall.</p> <p>In 50b.4F, the preferred approach includes replacement of the weir using a short series of rock or log step structures. An alternate approach would be to repair the existing weir in place.</p>

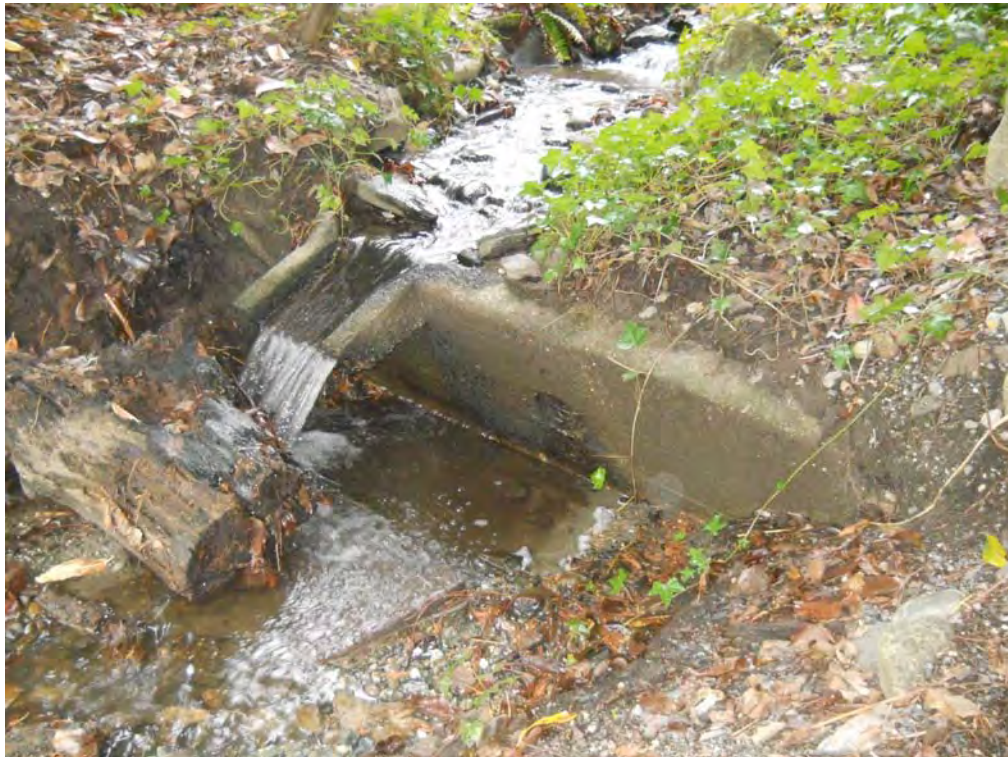
Project 50b.4F: Looking Upstream at Failed Concrete Weir 12/22/2011
