**City of Mercer Island  
Request for Qualifications  
Subbasin 29 Watercourse Stabilization Design**

# Subbasin 29 and 34 Watercourse Project

## Subbasin 29 Watercourse Assessment Summary

May 31, 2024  
Draft Report, Rev. 1

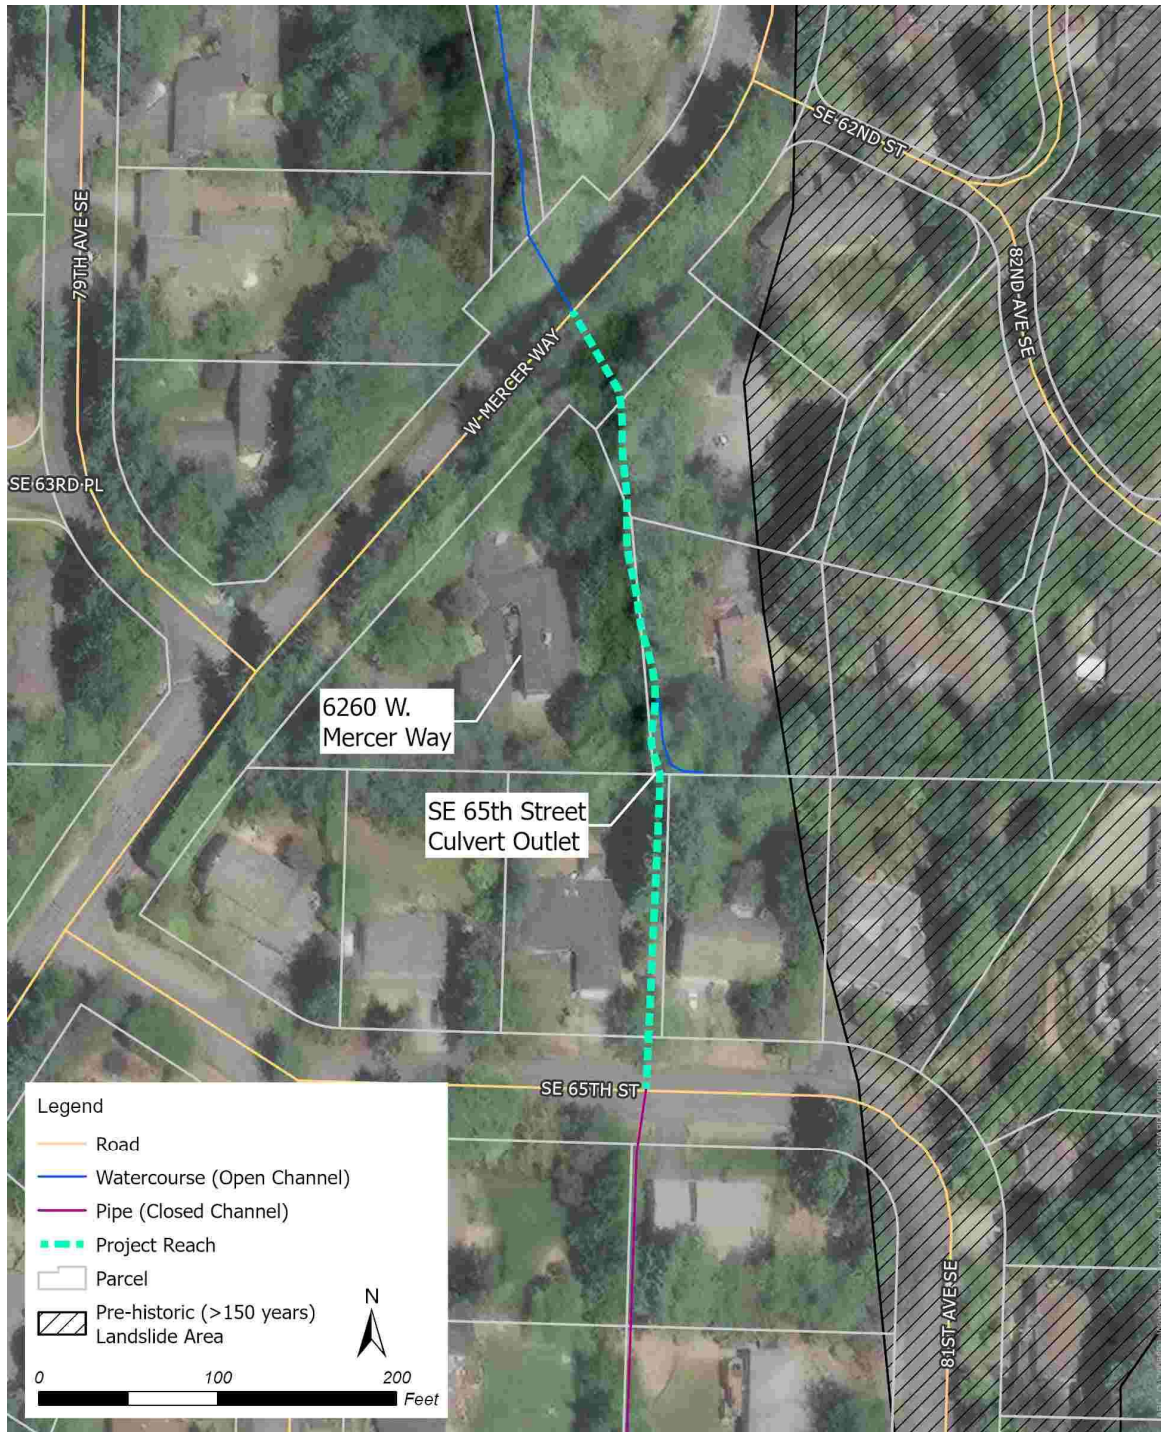
Figure 2.2 Project reach map with stream station and landslide areas.

Residential structures along the project reach are generally within 35 and 45 feet of the channel on the left and right banks, respectively (Figure 2.2).

<sup>2</sup> Stream stationing shown on Figure 2.2 begins at the roadway centerline of SE 65<sup>th</sup> Street and progresses in the downstream direction along the watercourse.

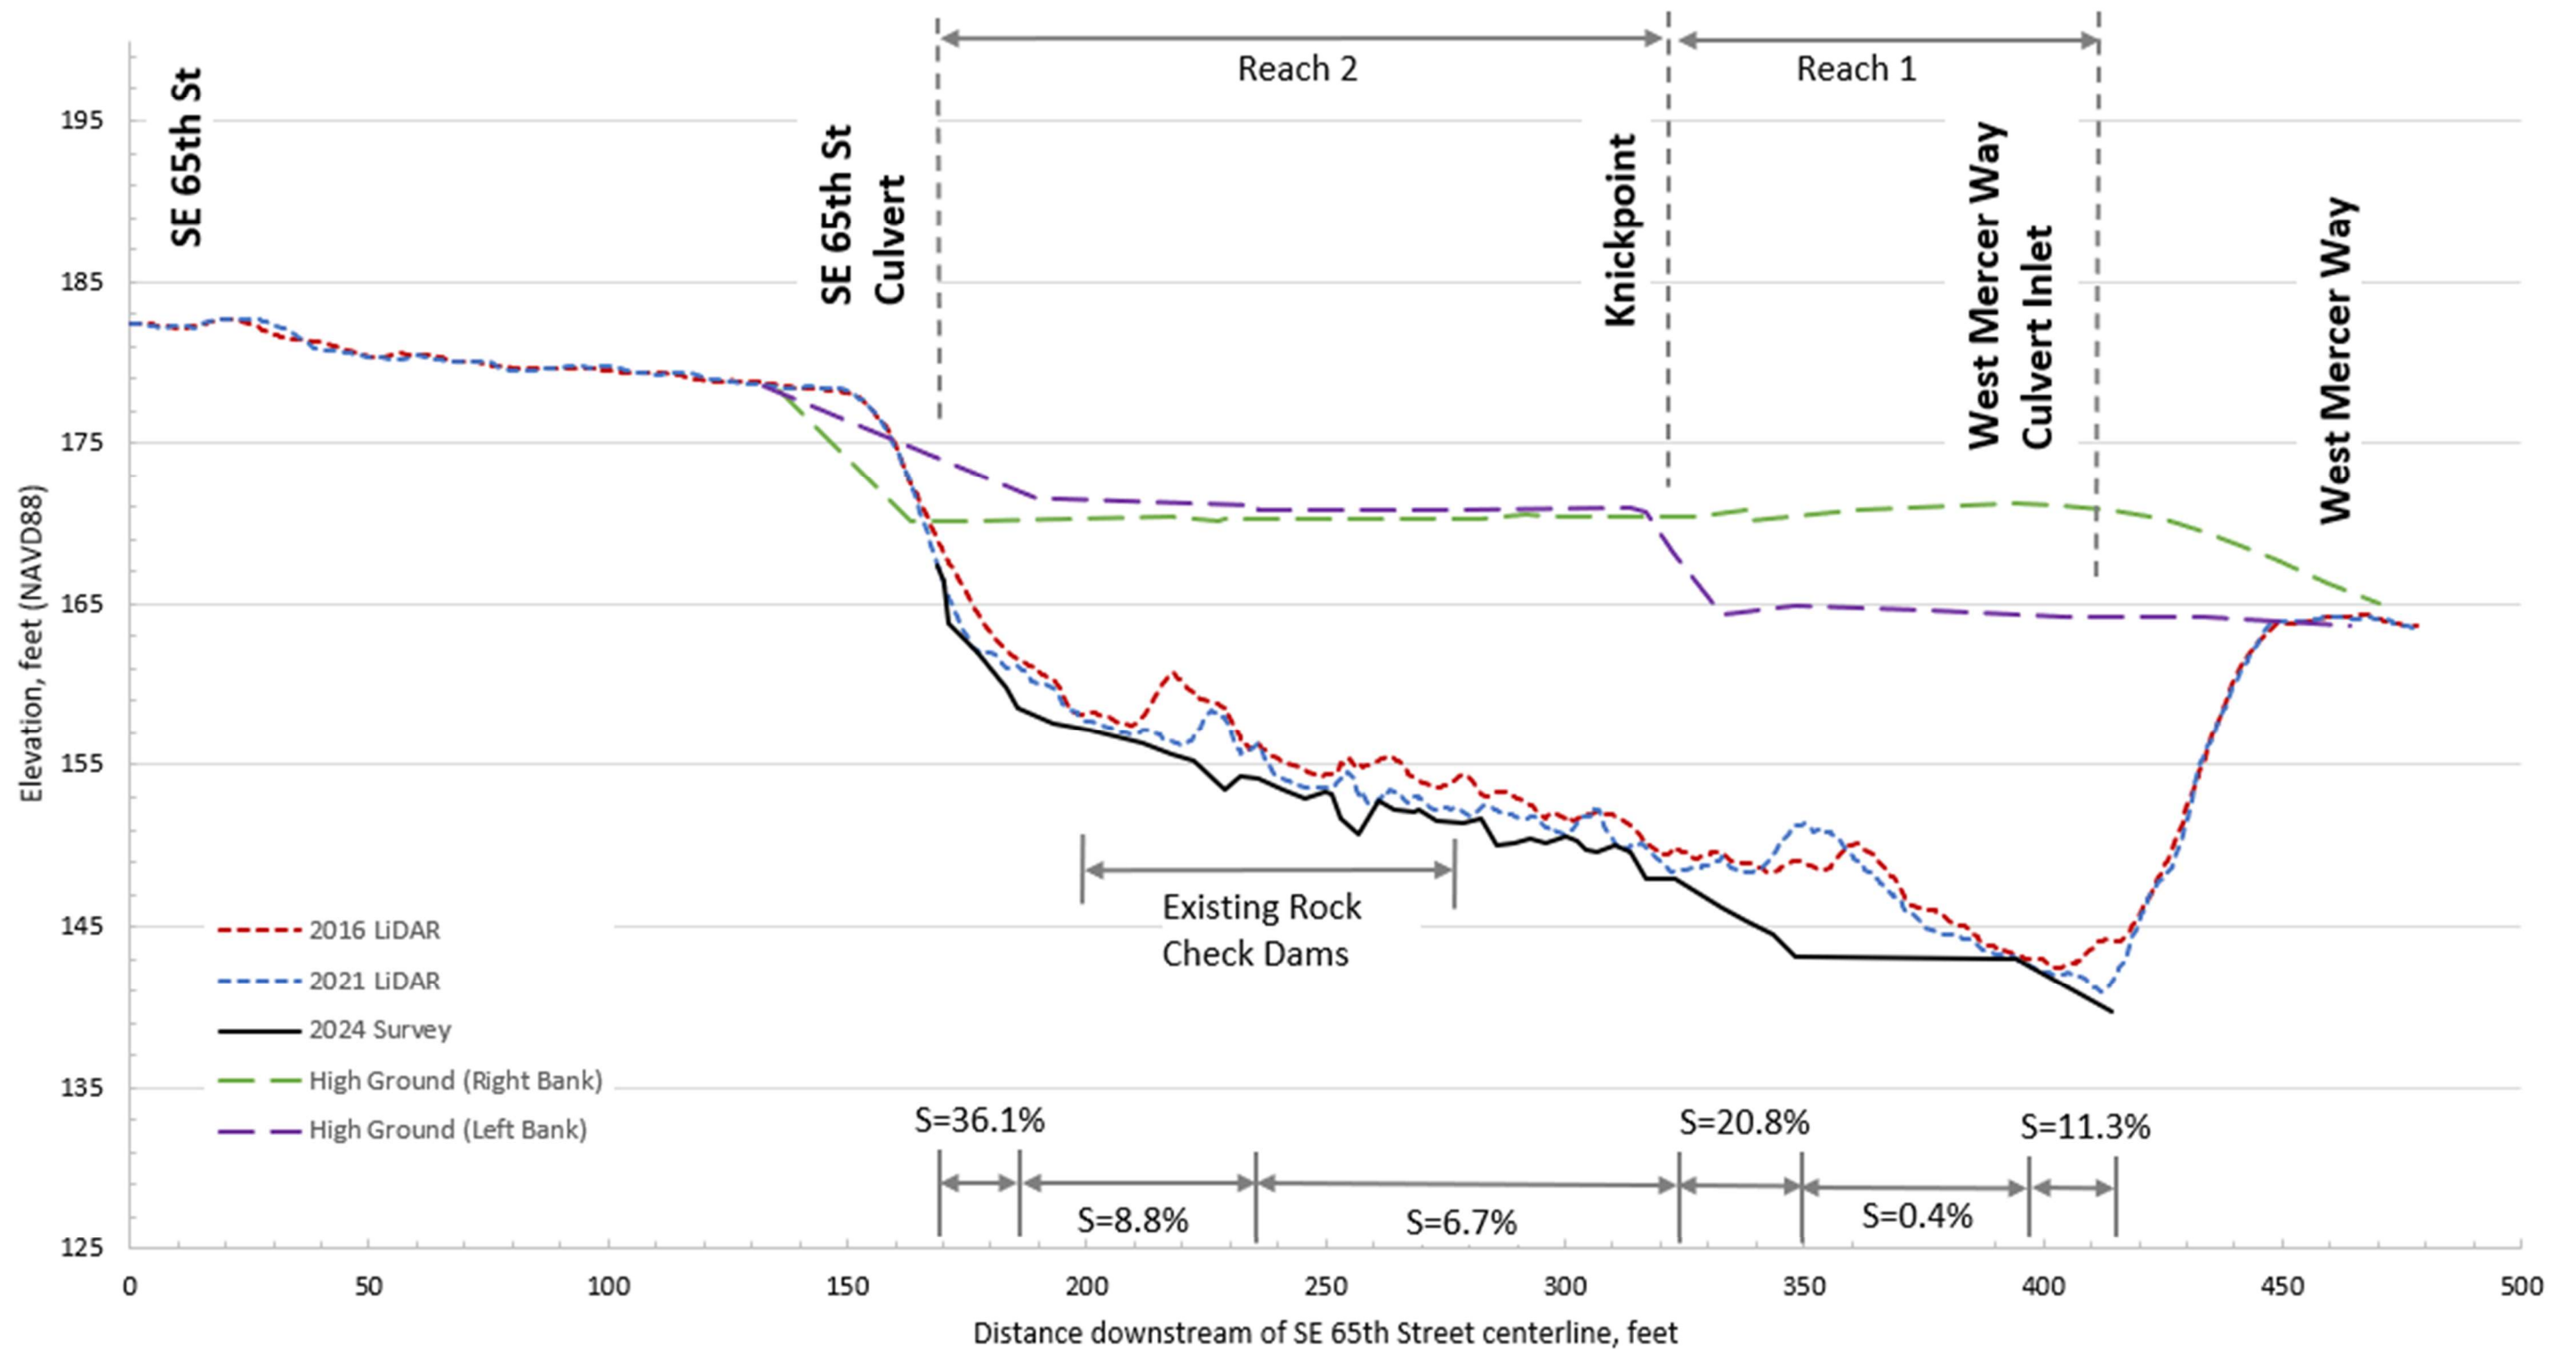
The watercourse within the project reach can be classified into two separate sub-reaches based on slope and channel controls. Figure 2.3 illustrates these sub-reaches as well as culvert and structure locations, adjacent bank elevations, and computed sub-reach slopes. Longitudinal profiles provided on Figure 2.3 were derived from 2016 and 2021 LiDAR and 2024 ground survey data collected by NHC.

Figure 2.3 Subbasin 29 Watercourse Profile (Project Reach)

The channel appears to be incising, with various knickpoints observed along the project reach (See Figure 2.3). Upper portions of the bank were generally held in place by vegetation with erosion at the channel toe, resulting in channel widening and classification of the project reach as stage 4 in Figure 2.4. It appears that hillslope instabilities are initiated more by toe erosion than upslope geotechnical processes. Downstream of a pronounced knickpoint at Fig 2.3 STA 3+22, the channel is relatively stable due to large woody material (LWM) accumulations that are storing gravels and holding bed elevations.

low-flow channel width is moderately wide, ranging from 8.1 to 14.3 feet. Approximate top of bank elevations are provided in Figure 2.3 and show bank heights ranging from 16 to 28 feet, indicating relatively high levels of channel entrenchment within the reach. Bank erosion was observed throughout Reach 1 and was found to be more pronounced on the left (south) bank, indicating less resistant bank materials and with the left bank, compared to the right bank. In general, relatively high bank heights limit floodplain connection. Side slopes on both banks are generally 1.5H:1V or steeper.

Existing rock check dams are not functioning as intended. As a result, the channel appears to be actively incising, with average lowering of the channel bed estimated between 2 to 3 feet since 2016 (Figure 2.3), based on comparison of LiDAR data and survey data. Observations indicate the channel also appears to be widening, resulting in impacts to in-channel and riparian habitat and potential threats to adjacent residential structures. Bank erosion was observed to be more pronounced on the left (south) bank. Capital improvements are recommended within all reaches, totaling 244 lineal feet of proposed improvements with the project reach. The extents of improvements are shown on Figure 3.1 and summarized below within Table 3-1. Concepts and cost information should be considered conceptual, requiring further engineering analyses and preparation of detailed design drawings.

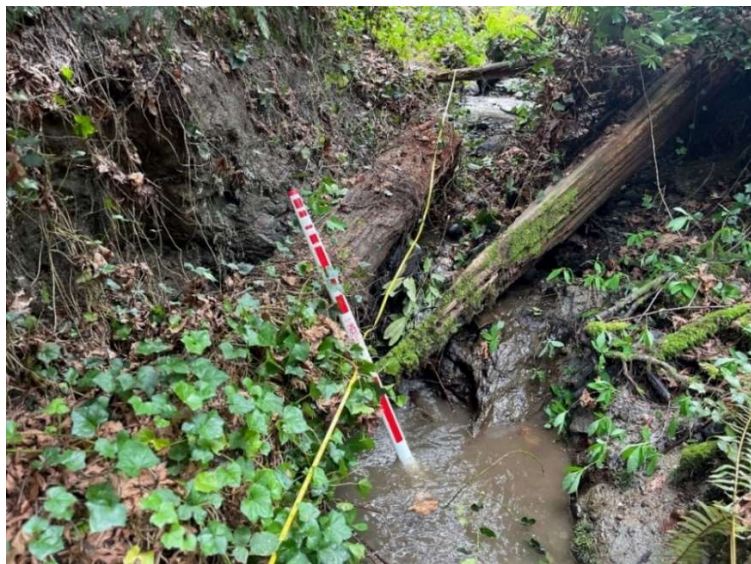
**Photo 2.1** View of watercourse looking upstream from the base on the knickpoint (STA 3+50). Note, level rod indicating relative drop in bed elevation.

Reach 1 extends from the West Mercer Way culvert upstream 90 feet to a knickpoint formed by a localized lens of what appears to be relatively non-erodible material (STA 3+50) (Photo 2.1). This reach appears to have experienced significant degradation over recent history, with an estimated average 3-foot drop in bed elevation since 2016 (Figure 2.3). This reach exhibits a wood-forced step-pool morphology. LWM accumulations, approximately 60 feet upstream of West Mercer Way (STA 3+90) currently control bed elevations (Photo 2.2), with overall channel slopes of 0.4% upstream of this location, and 11.3% downstream of it. This sub-reach is generally straight with a sinuosity of 1.0. The

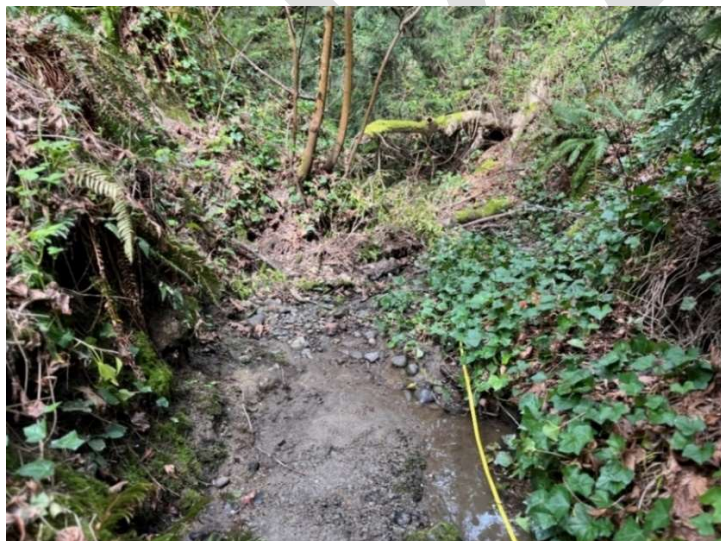
**Photo 2.2** View of watercourse looking downstream from the base of the knickpoint. Note LWM accumulation (background) (STA 3+90) retaining gravels and holding channel bed elevation (foreground).

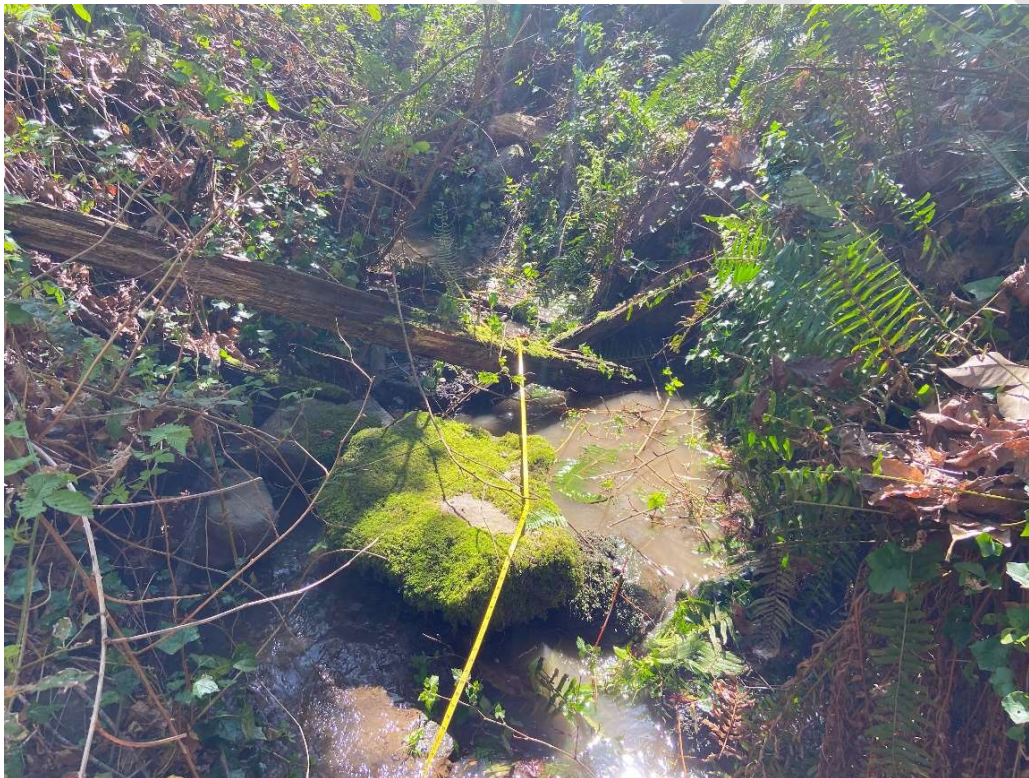
**Photo 2.3** View of watercourse looking upstream about 50 feet downstream of the SE 65<sup>th</sup> Street culvert outlet (STA 2+20). Note, flanking of rock check dam and displacement of rock.

The 154-foot reach downstream of the SE 65<sup>th</sup> Street culvert outlet exhibits a step-pool morphology. Channel slopes were 8.8% within the upper portion of the reach (upstream of STA 2+36) and about 6.7% within the downstream section. Figure 2.3 indicates that bed elevations have likely been steadily lowering over recent history, with an estimated average drop in bed elevation of about 2 feet since 2016. This consistent change in bed level indicates that constructed rock check dams (Section 2.1.1) are ineffective in providing stability of the channel bed. This is not surprising as these features were generally all observed to be flanked, with rock displaced in the downstream direction (Photo 2.3). This sub-reach is also generally straight with a sinuosity of 1.0. The low-flow channel width is highly variable, ranging from 2.9 to 17.2 feet. Approximate top of bank elevations provided in Figure 2.3 show bank heights ranging from 13 to 20 feet, indicating relatively high levels of channel entrenchment throughout reach. Side slopes on both banks are generally 1.5H:1V or steeper. Bank slopes are steepest on the left bank, from the SE 65<sup>th</sup> Street culvert to approximately 40 feet downstream (STA 2+20), consistent with the location of observed bank erosion and some displacement of outfall rock protection (Photo 2.4). Erosion of the channel banks was observed throughout the reach, and like Reach 1, was consistently more pronounced on the left bank, especially near the location of existing rock check dams. This is likely a result of flow concentration where the dams had been flanked.

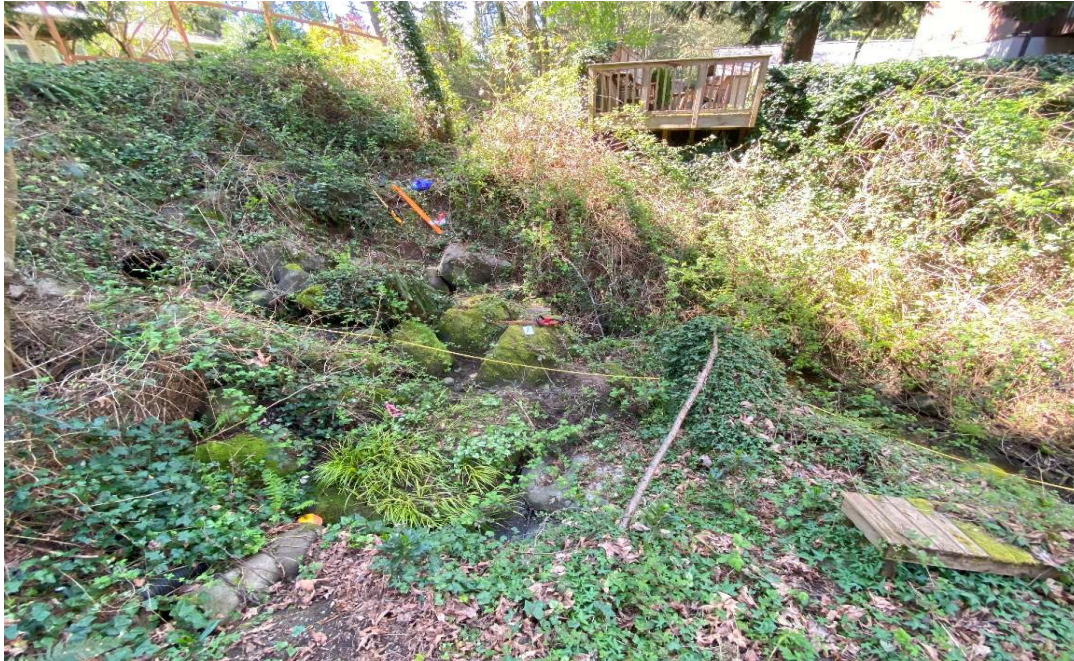
**Photo 2.4** View of watercourse standing on right bank facing west about 30 feet downstream of SE 65<sup>th</sup> Street culvert outlet (STA 2+00). Note, observed left bank erosion and displacement of outlet protection rock.

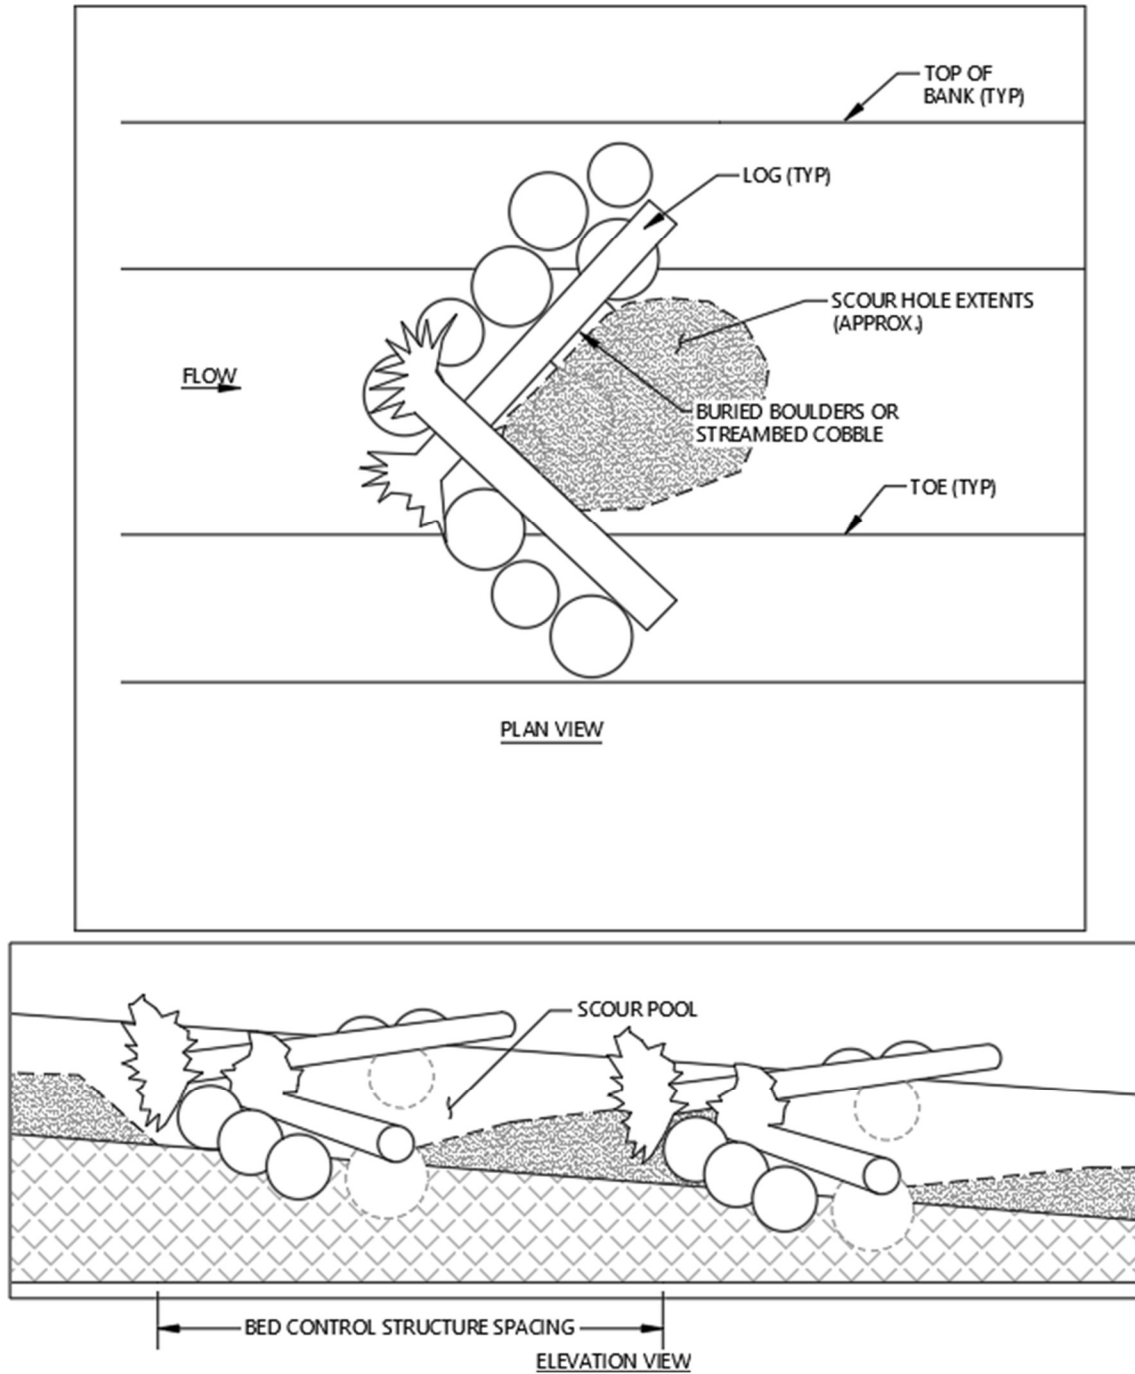
Figure 3.2 Example bed control structure detail.

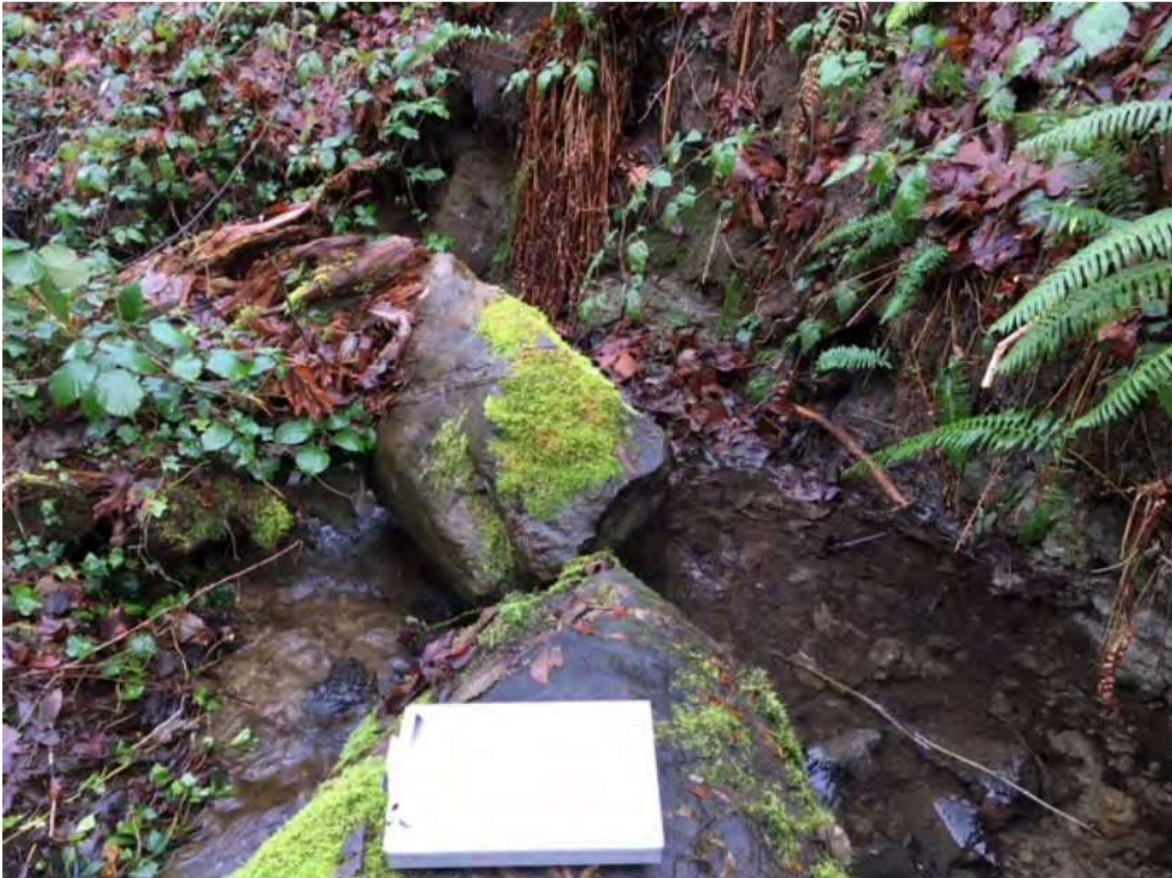
**Bank erosion below pipe outfall from 8010/8020 SE 65<sup>th</sup> Street. 01/19/2018**

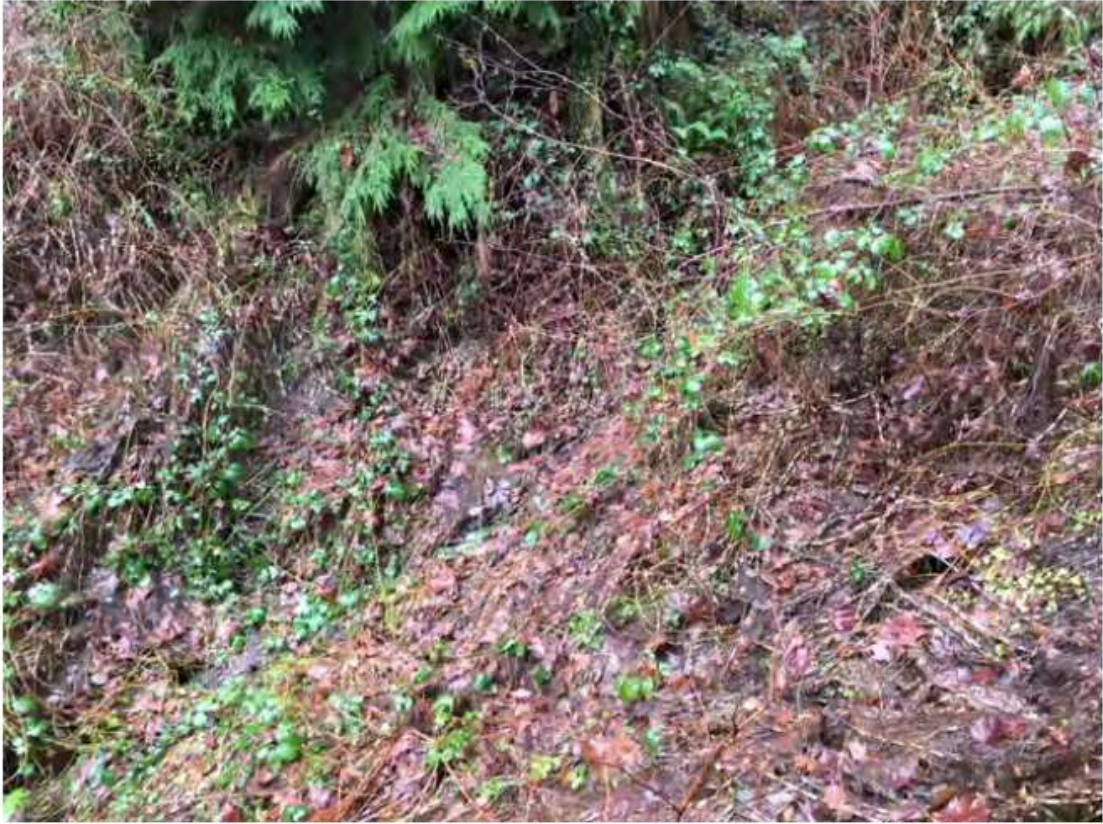
**Observed west bank instability. Activity unknown. 01/19/2018**
