COMPREHENSIVE BASIN REVIEW AND WATERCOURSE MONITORING

VOLUME I – MAIN REPORT

City of Mercer Island

December 2006

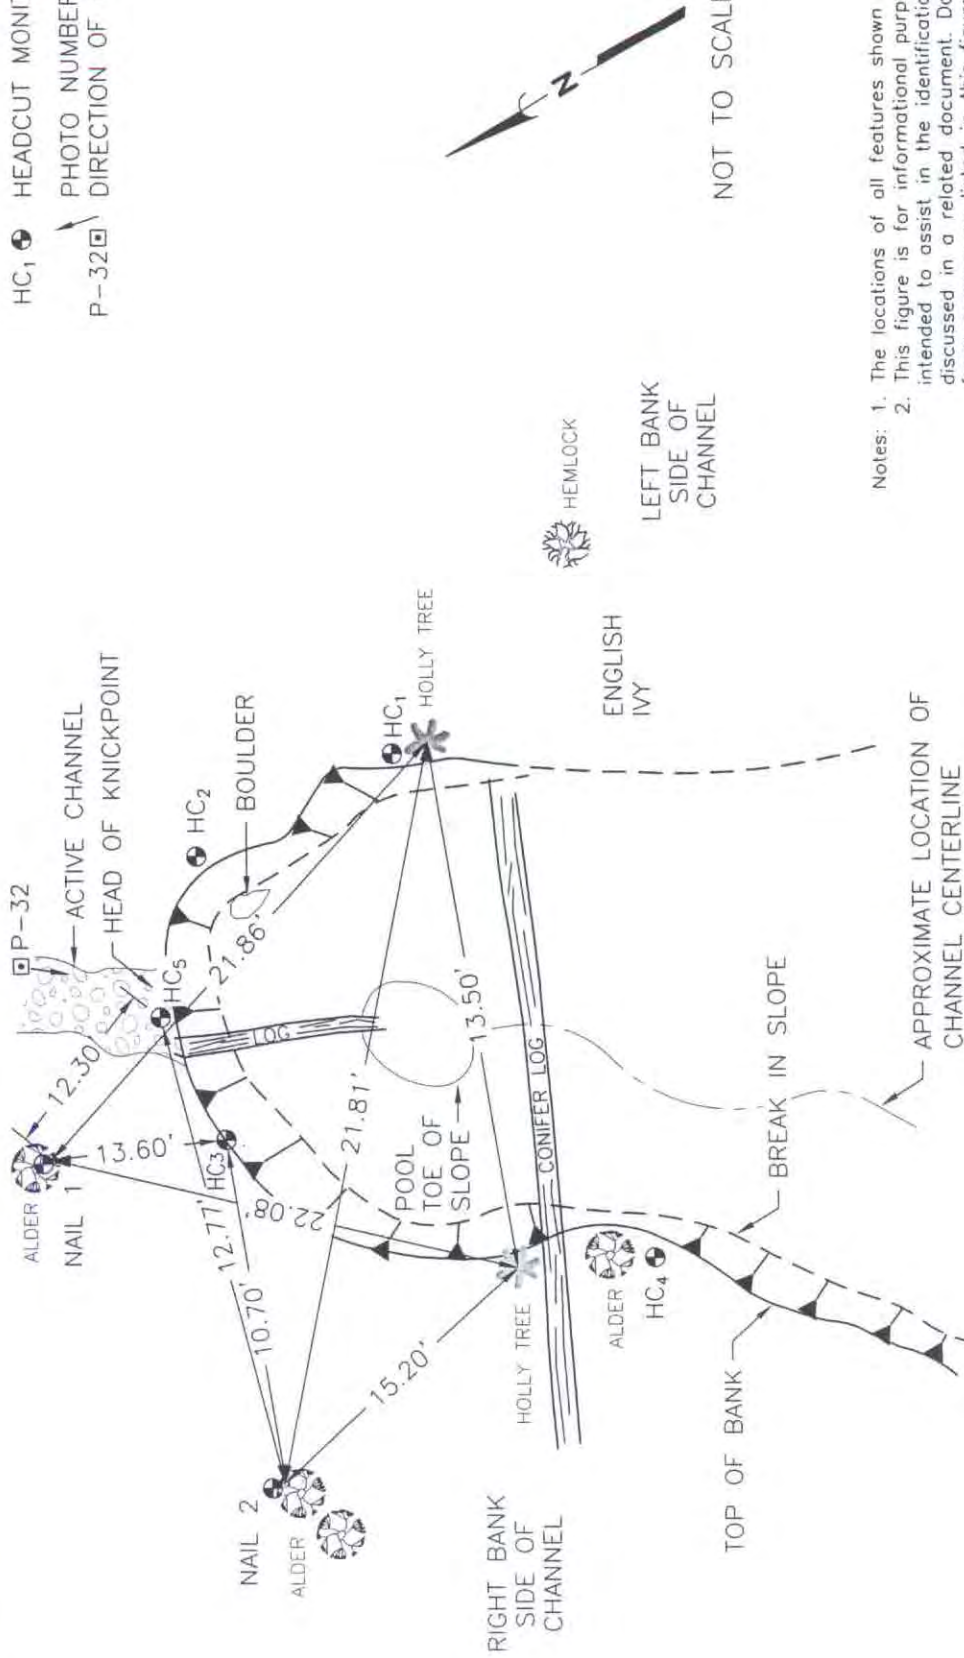
FIGURE 1

SKETCH MAP
BASIN 26, PLAN VIEW

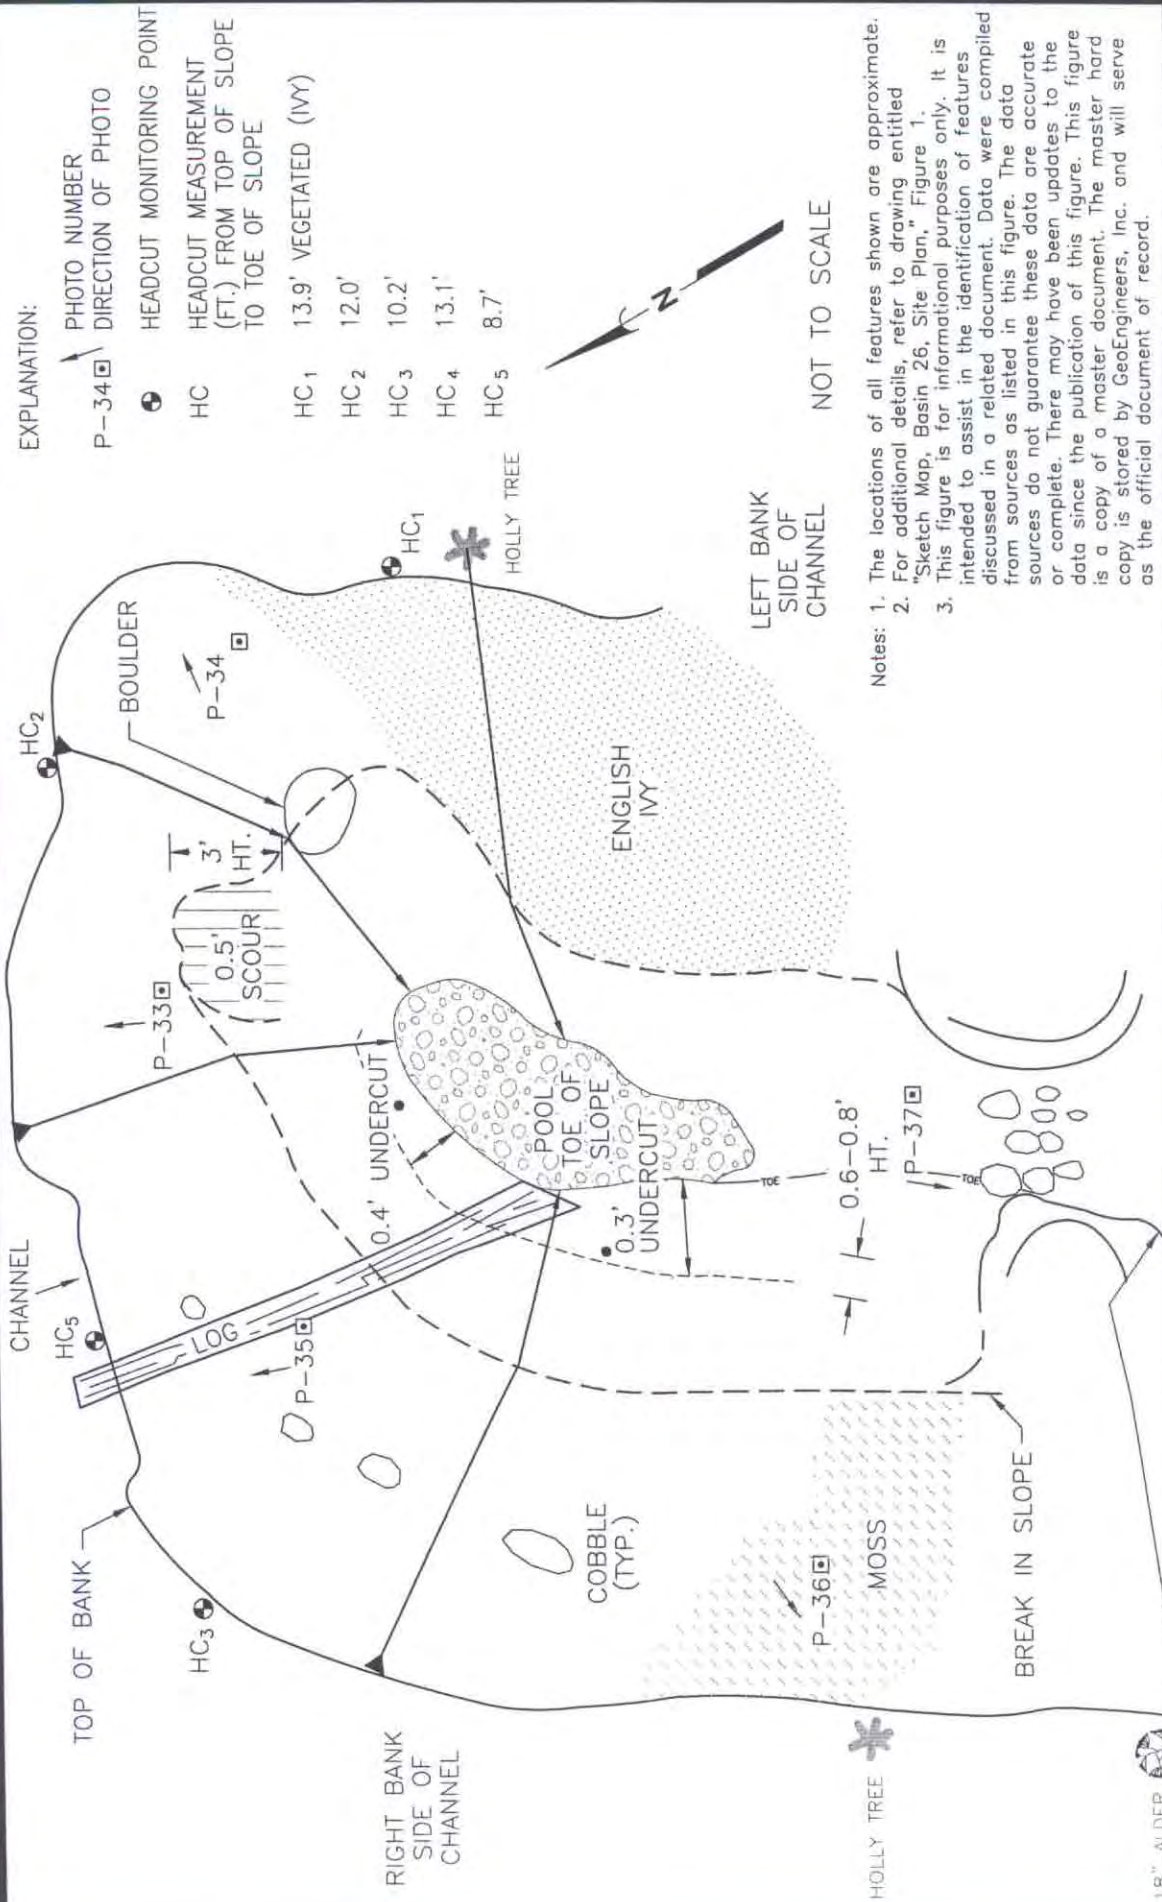
- P-34 □ PHOTO NUMBER
↑ DIRECTION OF PHOTO
- HEADCUT MONITORING POINT
- HC HEADCUT MEASUREMENT
(FT.) FROM TOP OF SLOPE
TO TOE OF SLOPE
- HC₁ 13.9' VEGETATED (IVY)
- HC₂ 12.0'
- HC₃ 10.2'
- HC₄ 13.1'
- HC₅ 8.7'

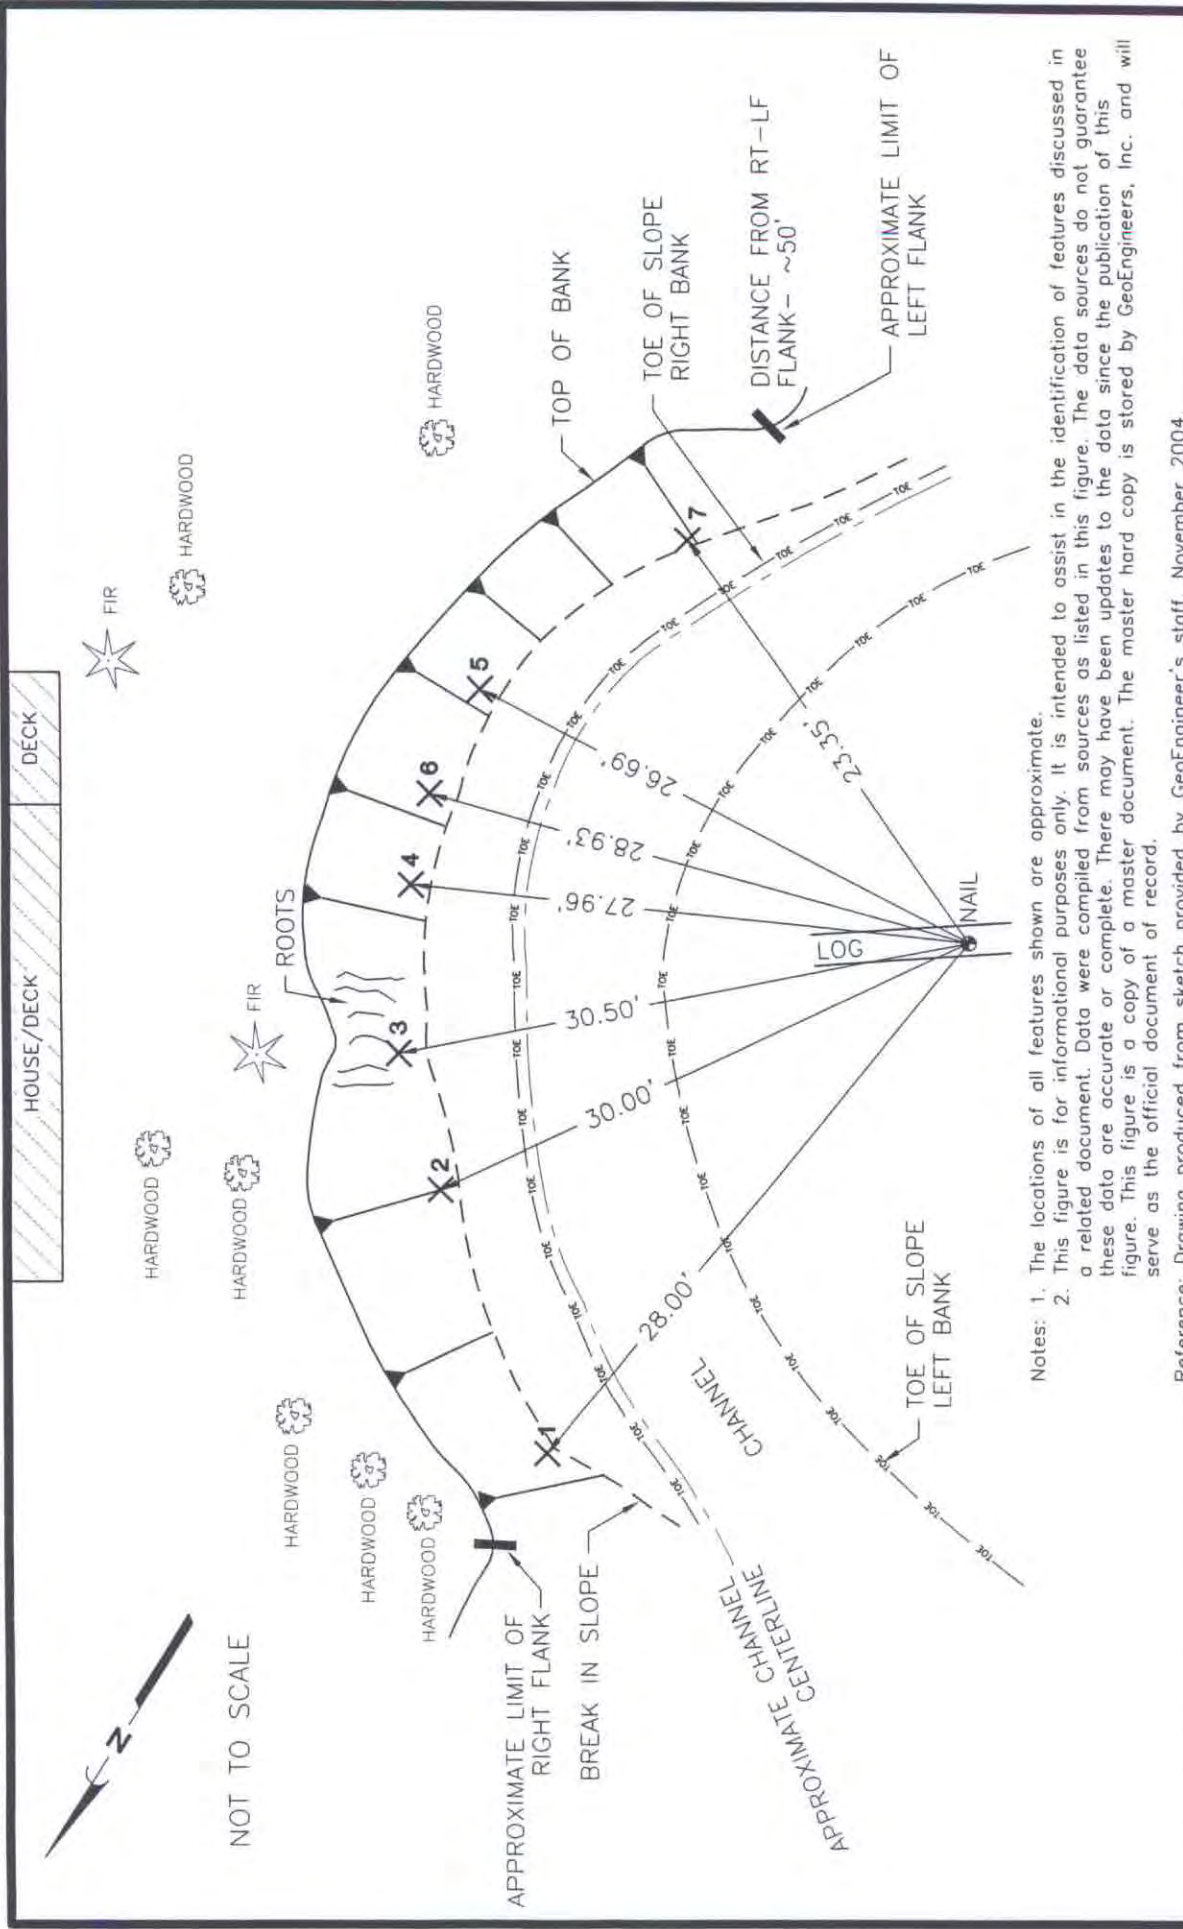
FIGURE 1

- The measurements from Nail to points 1 through 7 compared to the baseline data will reflect the change in geometry of the bank failure. For example, an increase in the distance from the Nail to points 1 through 7 would indicate that the bank is receding (eroding).
- If the sand bags undergo further deformation compared to the baseline, then erosion is occurring.
- An increase in the depth of undercutting compared to the baseline data would indicate an increased potential for additional failure.

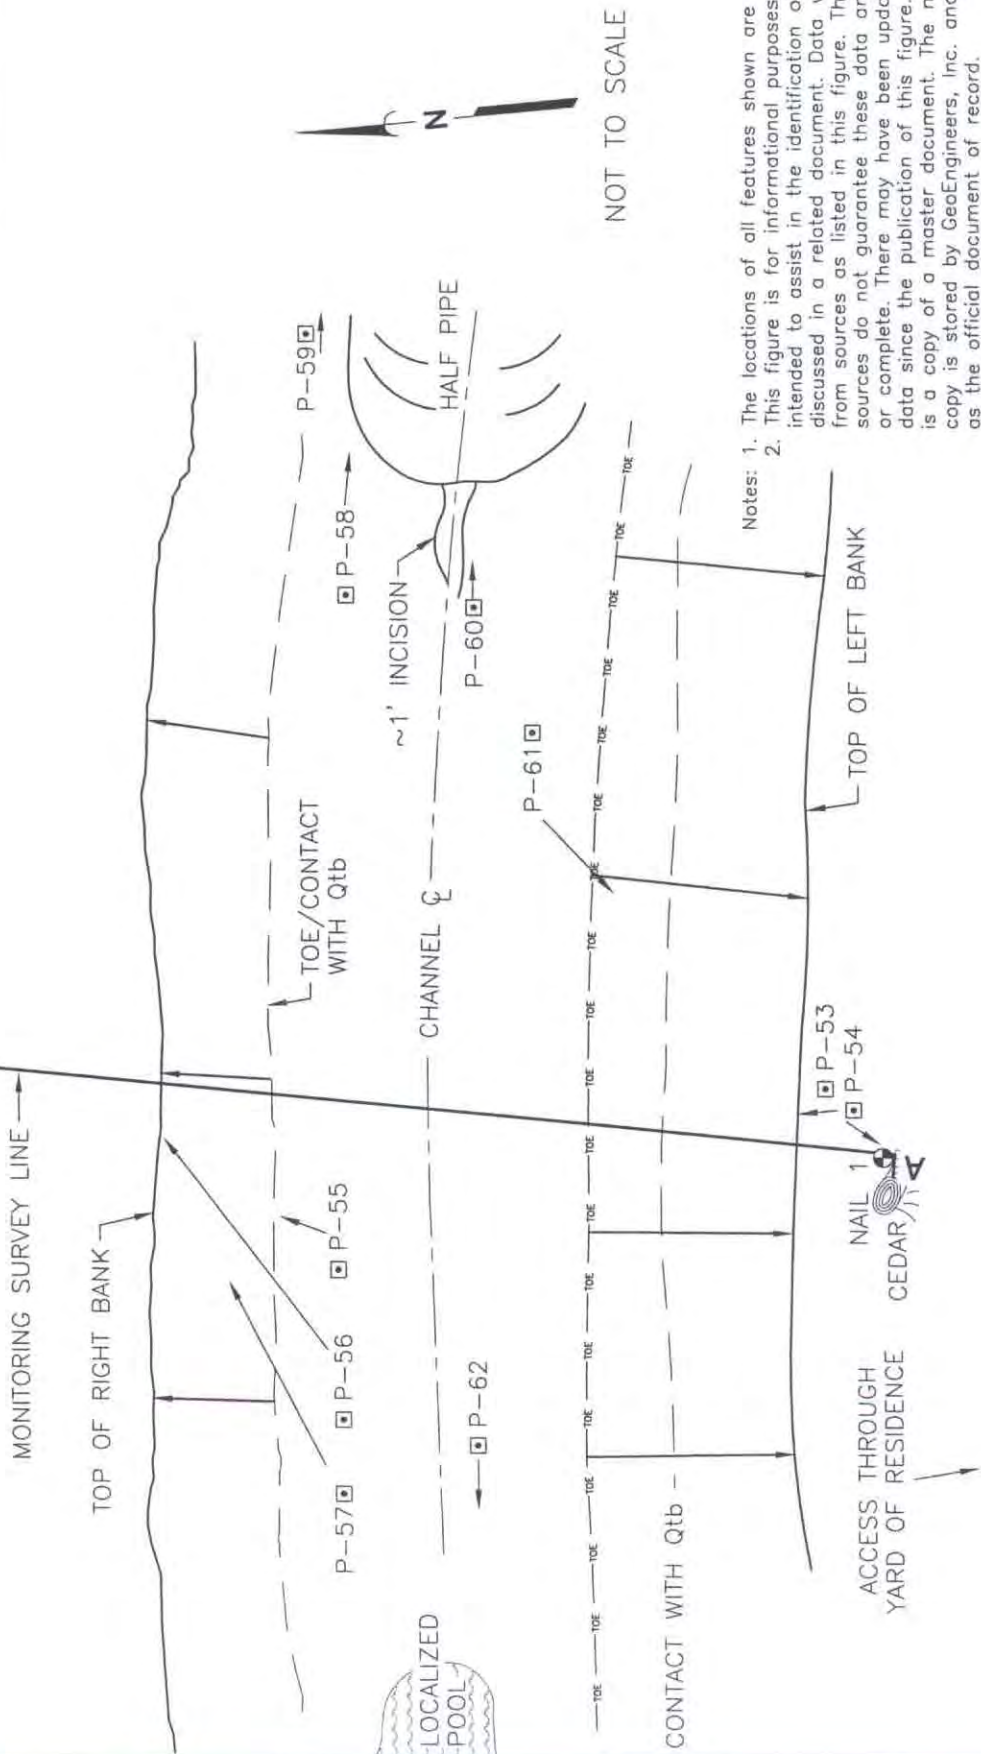
This memorandum provides a summary of information related to the Basin 32a monitoring site. The location of the site is approximately 200 feet downslope from the Henkle residence located along the north side of Holly Hill Drive in Mercer Island, Washington. Holly Hill Drive is a side street off the west side of West Mercer Island Drive. The site is accessed by parking along Holly Hill Drive near the second residence on the right (north) side of the road and traversing the embankment to the channel. The site includes an area of channel incision, as shown in the Sketch Map site plan, Figure 1.

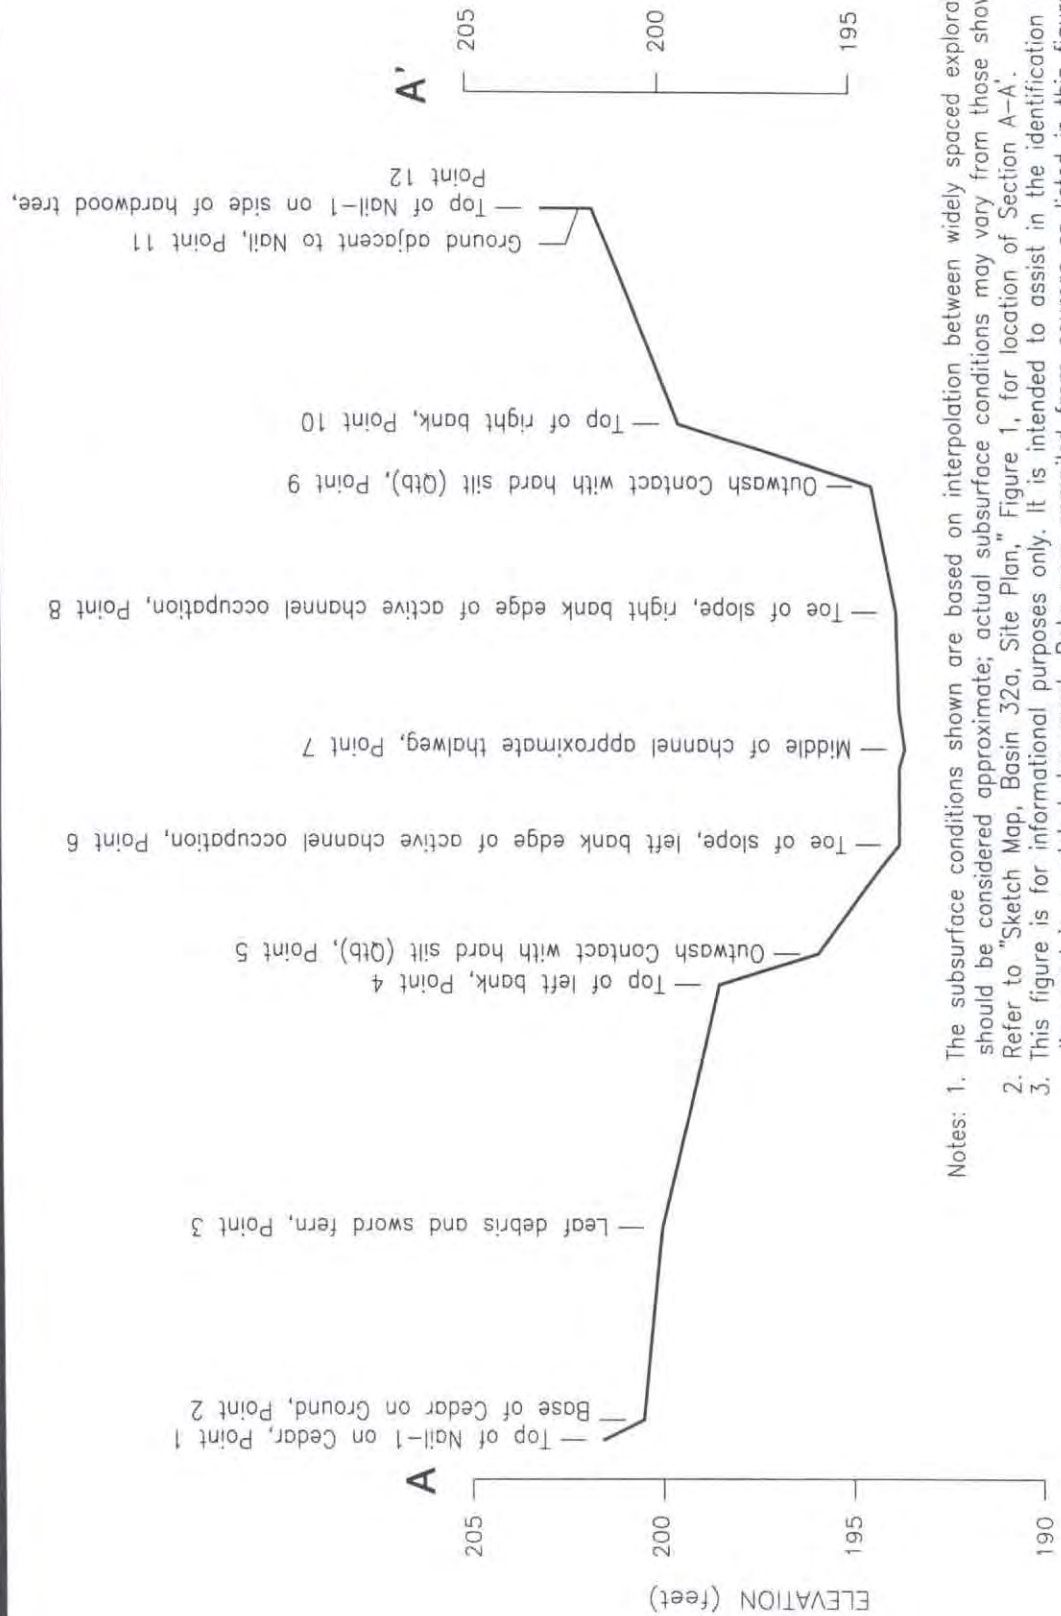
FIGURE 2

- A change in channel gradient would likely provide supporting information regarding erosion or incision. For example, a decrease in gradient would indicate an increased potential for bank erosion or that bank erosion is occurring. By contrast, an increase in gradient would indicate an increased potential for incision or that incision is occurring.

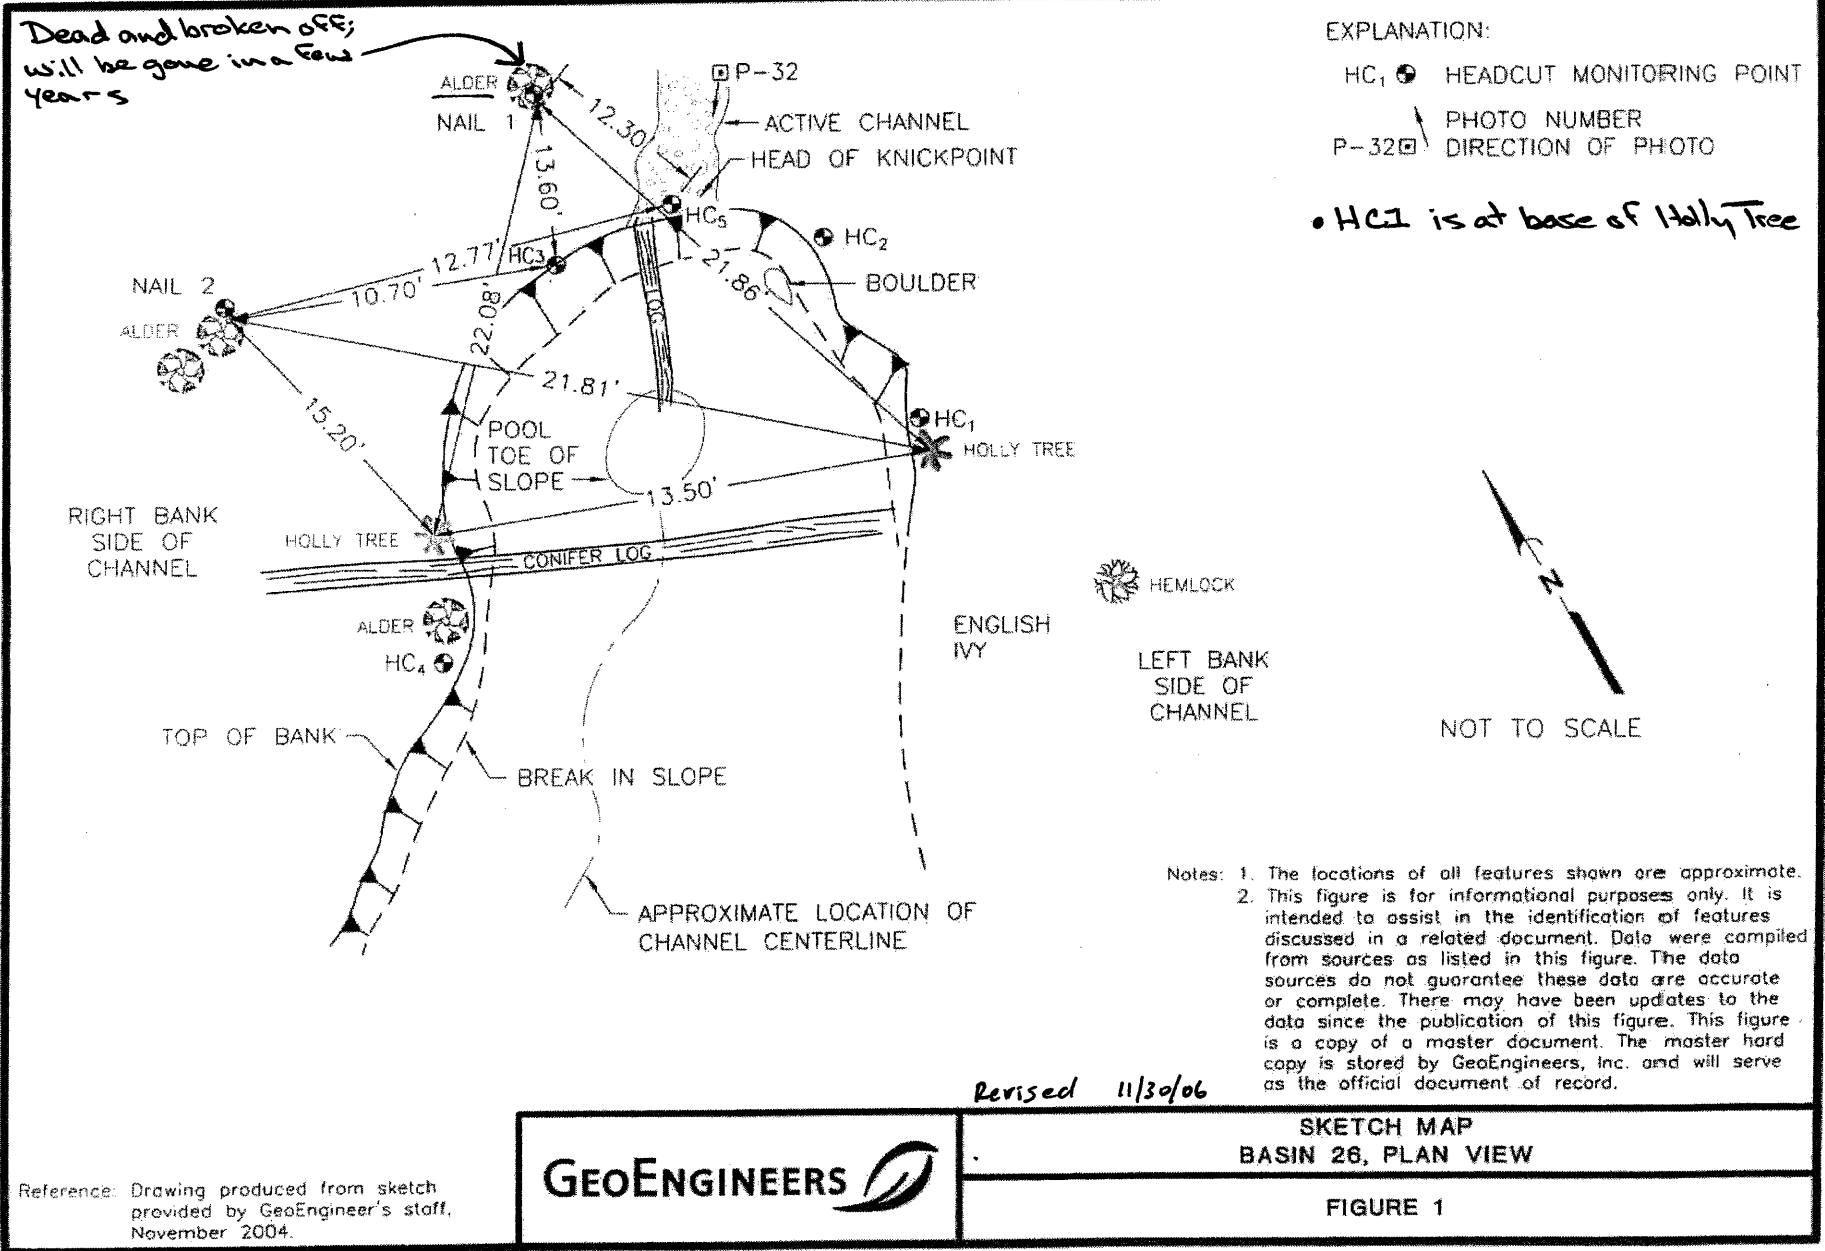
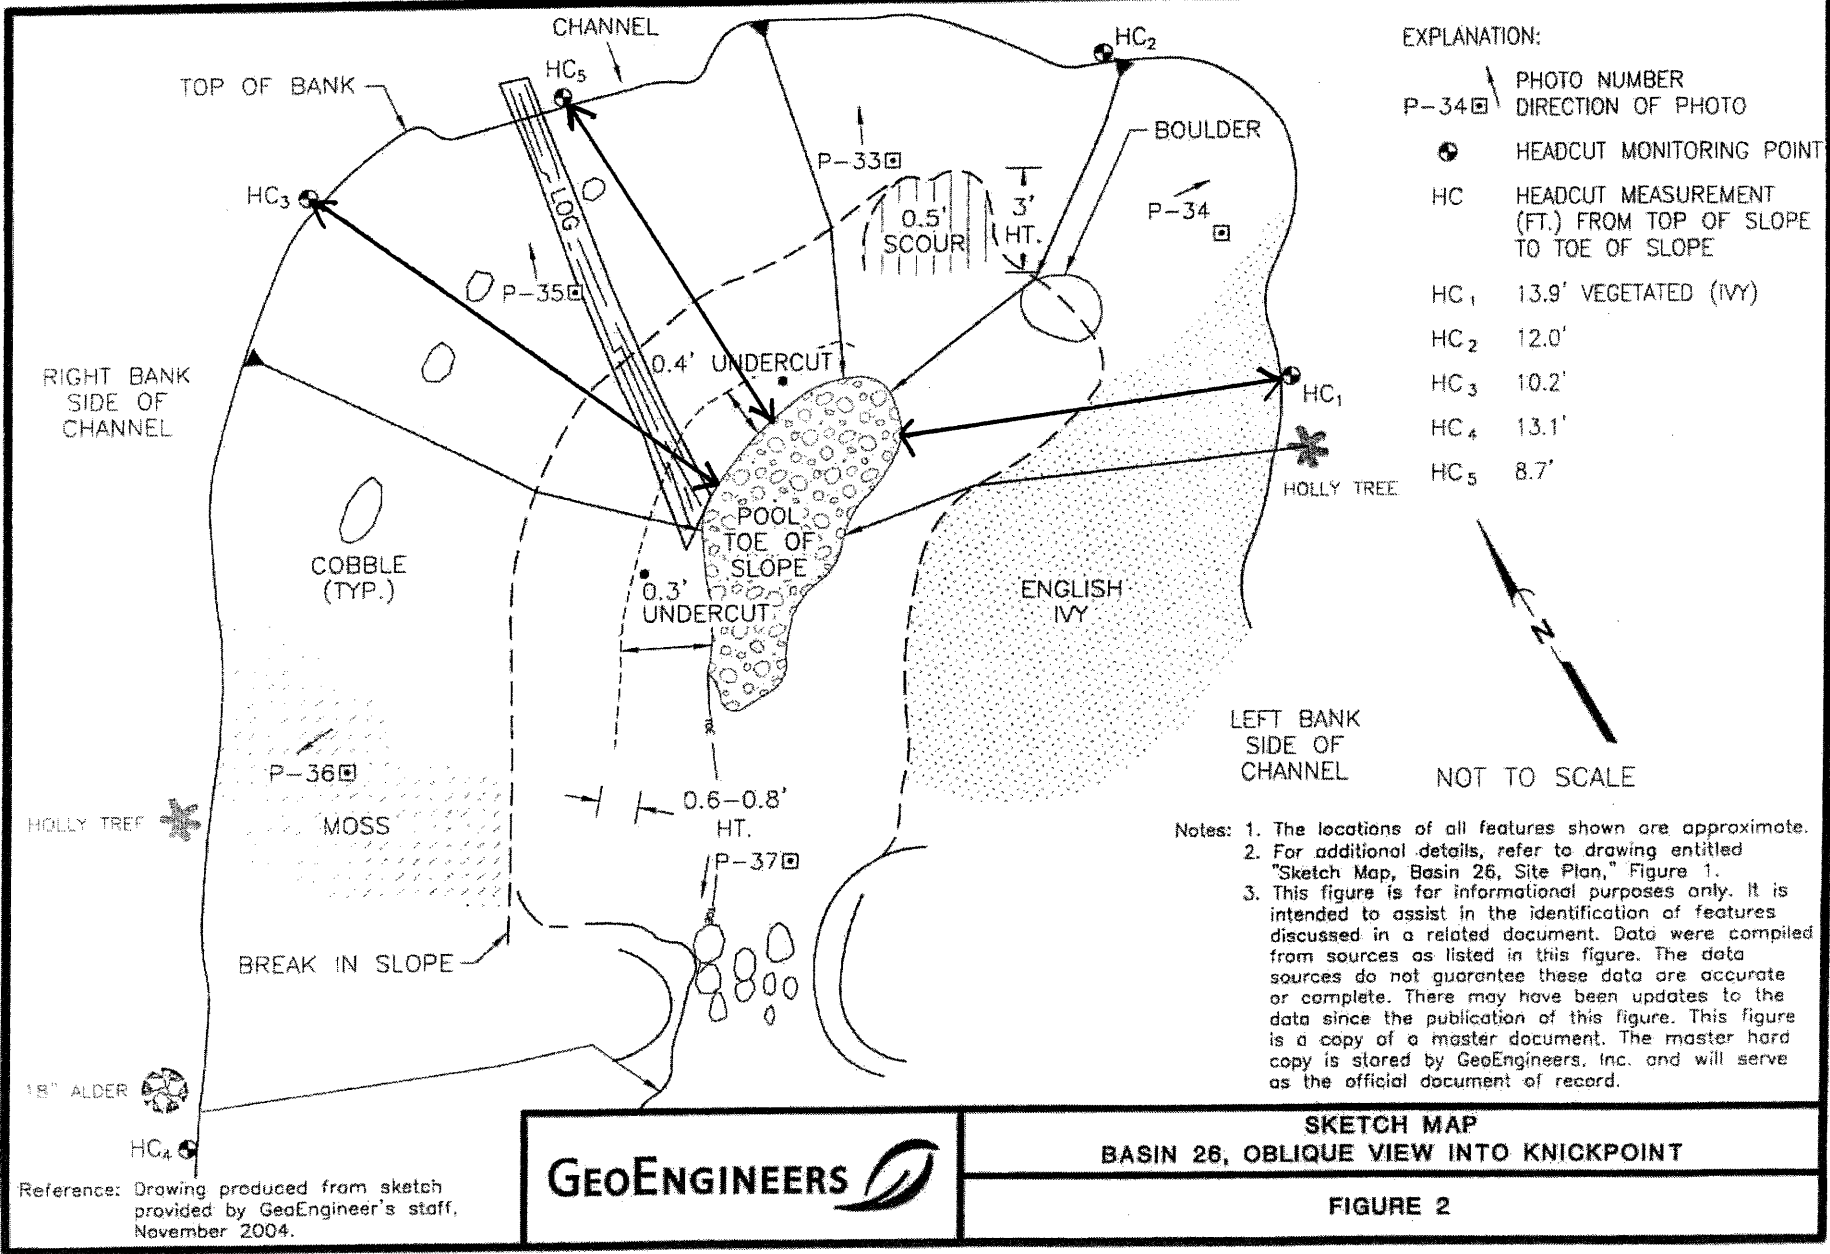
from point	to point	taped distance (ft)	taped distance (ft)	taped distance (ft)																																												
nail 1	HC5	12.3	11.6	10.4																																												
nail 2	HC5	12.8	13.7	13.3																																												
nail 1	HC3	13.6	not measured	13.5																																												
nail 2	HC3	10.70	9.1?	10.7																																												
from point	to	distance (ft)	distance (ft)	distance (ft)																																												
HC1	toe slope	13.9	14	12.8																																												
HC3	toe slope	10.2	not measured	8																																												
HC5	toe slope	8.7	8.5	8.6																																												
Conclusion		Headcut has retreated about 1' since Nov 2004 but stream invert about the same.	Headcut has retreated nearly another foot since Jan 2006. Pool has filled in with sand and gravel. Side banks unchanged since 2004

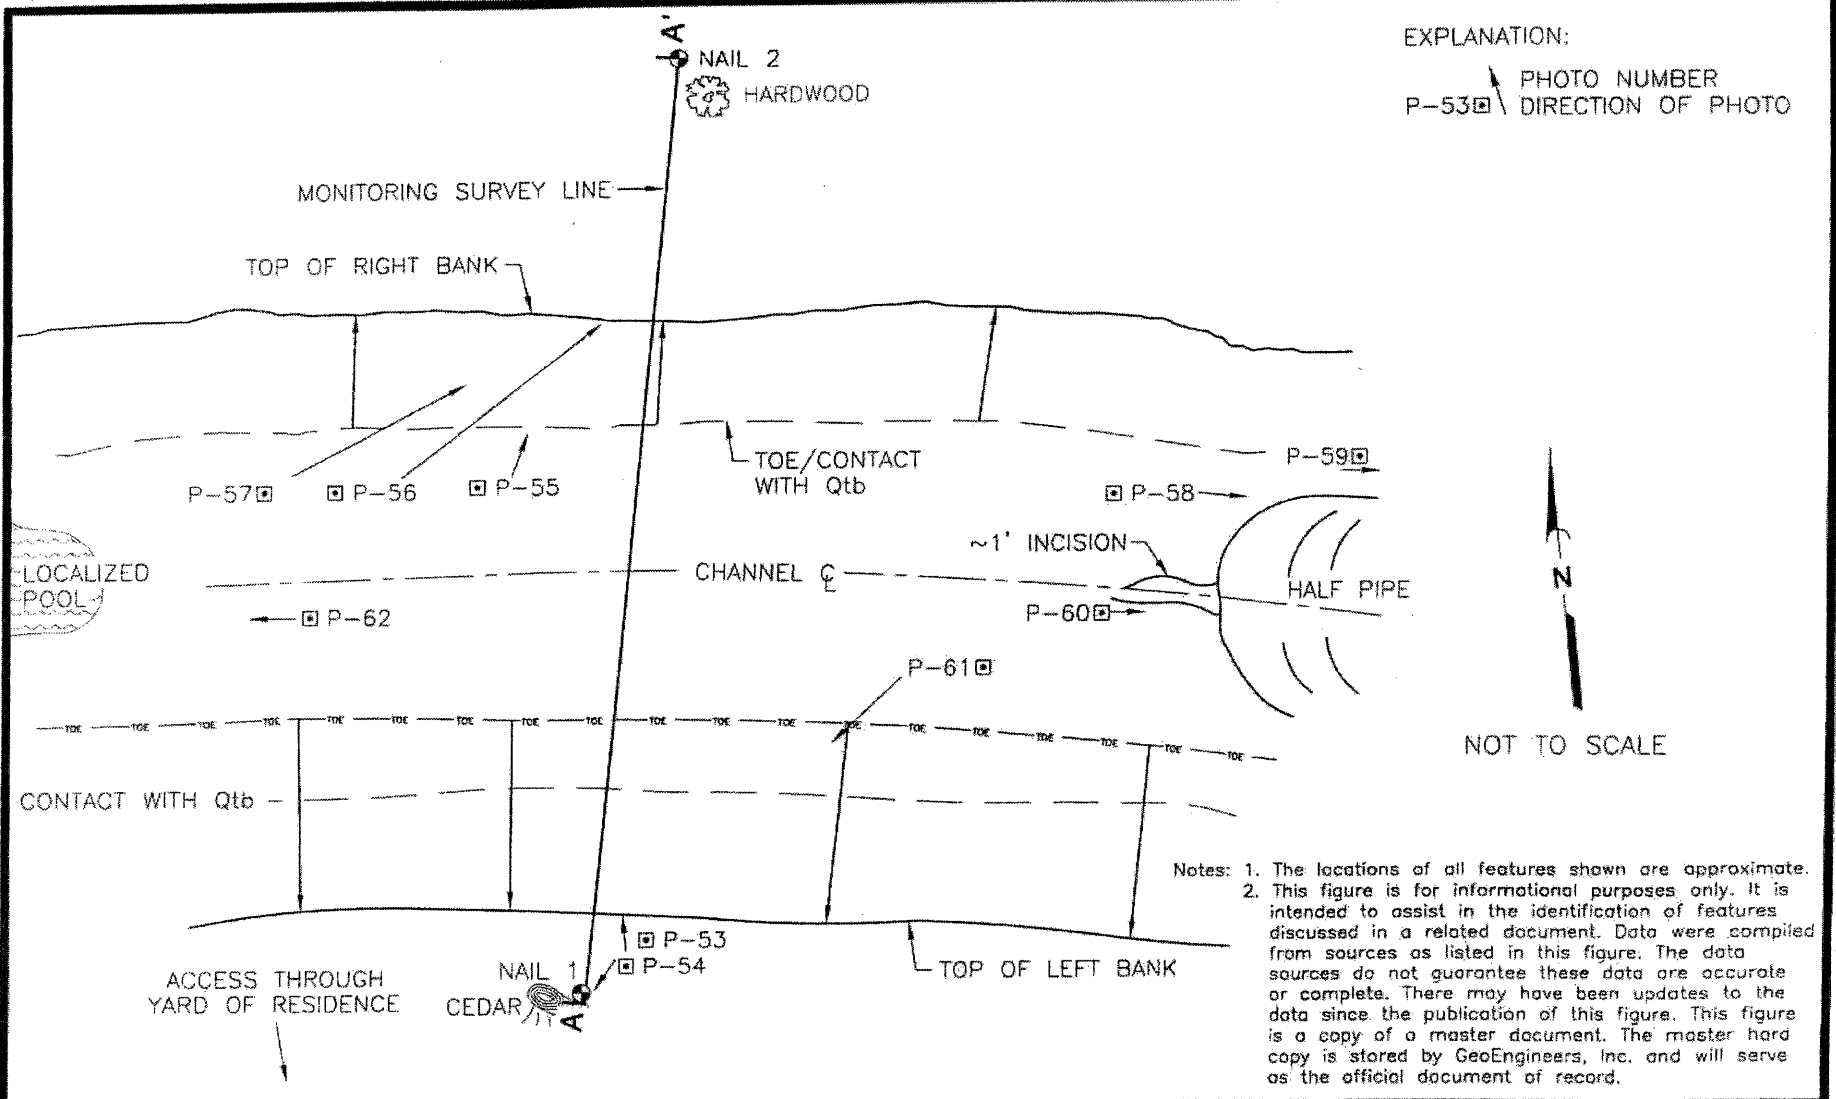
Water Course Monitoring Data
Cross section in subbasin 32b

measurement:	1	2	3
by:	GeoEngineers	Beck/City	Beck
date:	11/24/2004	1/5/2006	10/20/2006
Conditions:		very fast water and rainy.	Dry
Streambed Material	Smooth dense silt	Smooth dense silt	Smooth dense silt
Instrument:	optical level	laser level	transit
quality of measurement	very good	poor	fair
	station Elevation	station Elevation	station Elevation
	0 201.55 Nail #1	0 201.55 Nail #1	0 201.55 Nail #1
	0.5 200.51	7 199.8	7 199.9
	5.4 200.00	11.5 198.6	11 198.6
	11.8 198.49	15 194.2	14.2 194.29
	12.6 195.88	18 193.90	15.5 193.74
	14.9 194.2	24 194.8	18 193.76
	15.5 193.71	27 200.15	21 193.87
	17.5 193.7	31.9 202.9 Nail #2	24.8 194.87
	18 193.55		26.7 199.84
	19 193.7		32 203.09 Nail #2
	21.5 193.77		
	24.8 194.42		
	26.4 199.49		
	32 201.72		
	32 203.02 Nail #2		
Conclusion		No change since November 2004	No change since November 2004

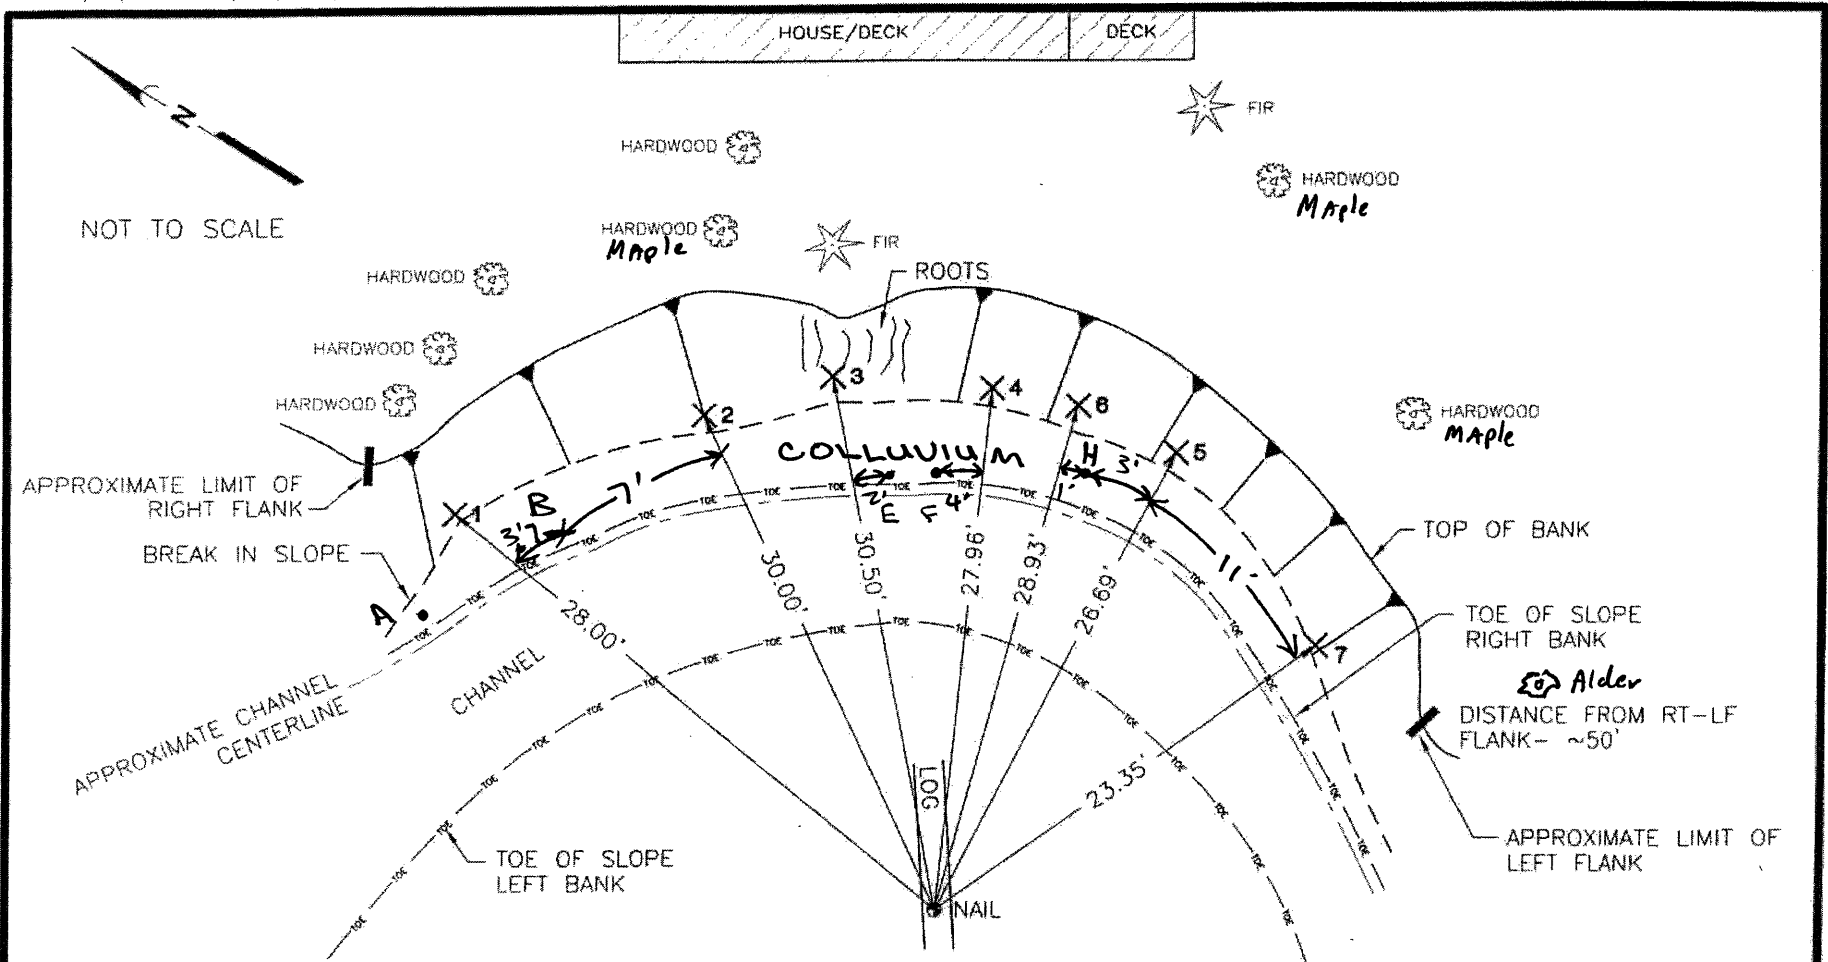
Water Course Monitoring Data subbasin 29

measurement:	1	2	3
by:	GeoEngineers	Beck/City	Beck
date:	11/18/2004	1/5/2006	10/20/2006
Conditions:		very fast water and rainy.	Dry
Radial distance			
(see Figure 1 in 12/15/04 Monitoring report)			
point	distance (ft)	distance (ft)	distance (ft)
1	28	28	28
2	30	30	30.4
3	30.50	30	30
4	27.96	26.6	27
5	28.93	not measured	26.60
6	26.69	26.9	27.1
7	23.35	not measured	23.00
Undercutting			
(see Figure 2 in 12/15/04 Monitoring report but letters not shown. Post F also added to drawing)			
steel fence post No. (downstream to upstream)	distance (ft)	distance (ft)	distance (ft)
A	0	0	0.1
B	0.5	0.4	0.7
C	0.8	0.75	0.5
D	0.5	0.5	post is gone
E	0.4	0	0.4
F	0	0	0.2
G	0	0.5	0.25
H	0	0	0.1
Conclusion		No significant change since Nov 2004	No significant change since Jan 2004. No significant sand bag losses. For posts A-G: creek thalweg below sand bags. For posts G-H: creek thalweg at sand bags

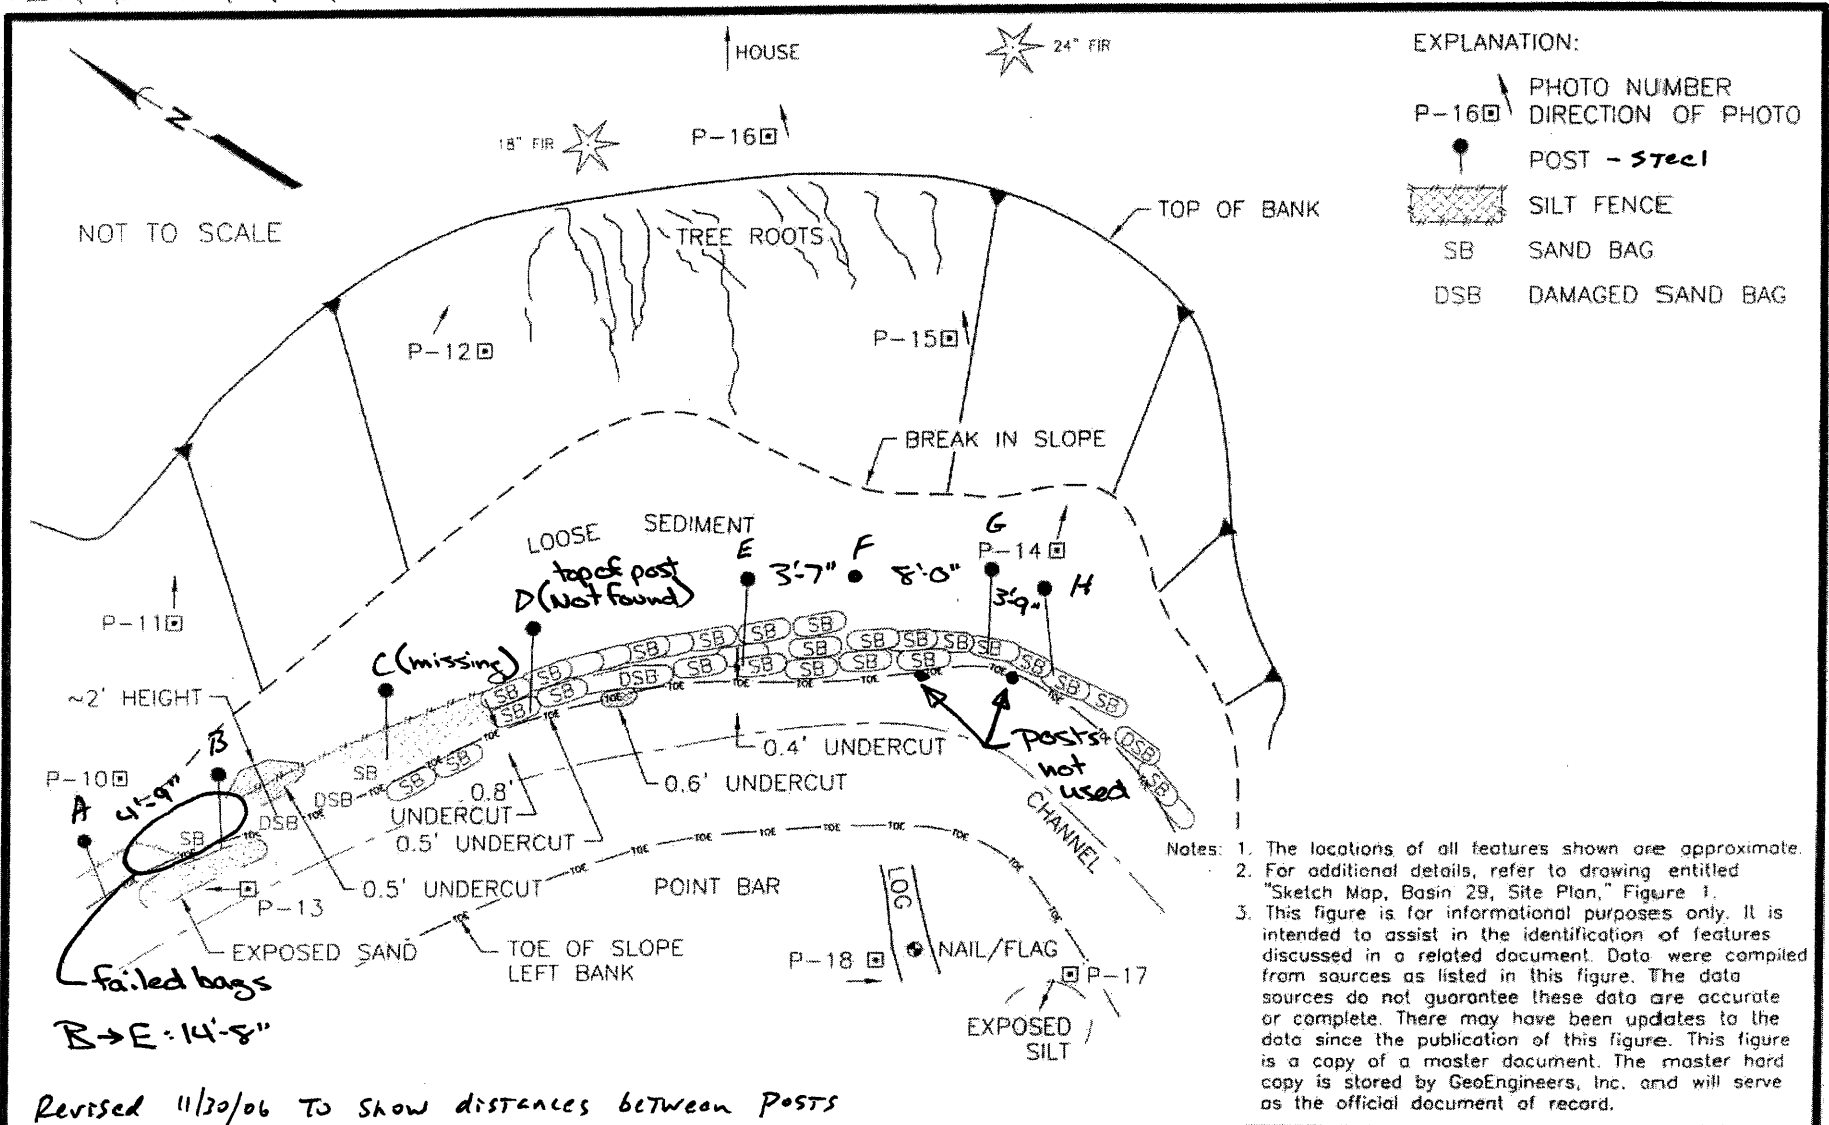
FIGURE 1

X1 PAINTED MONITOR POINT AT LOOSE SEDIMENT/MAIN SCARP CONTACT

SKETCH MAP
 BASIN 29, PLAN VIEW

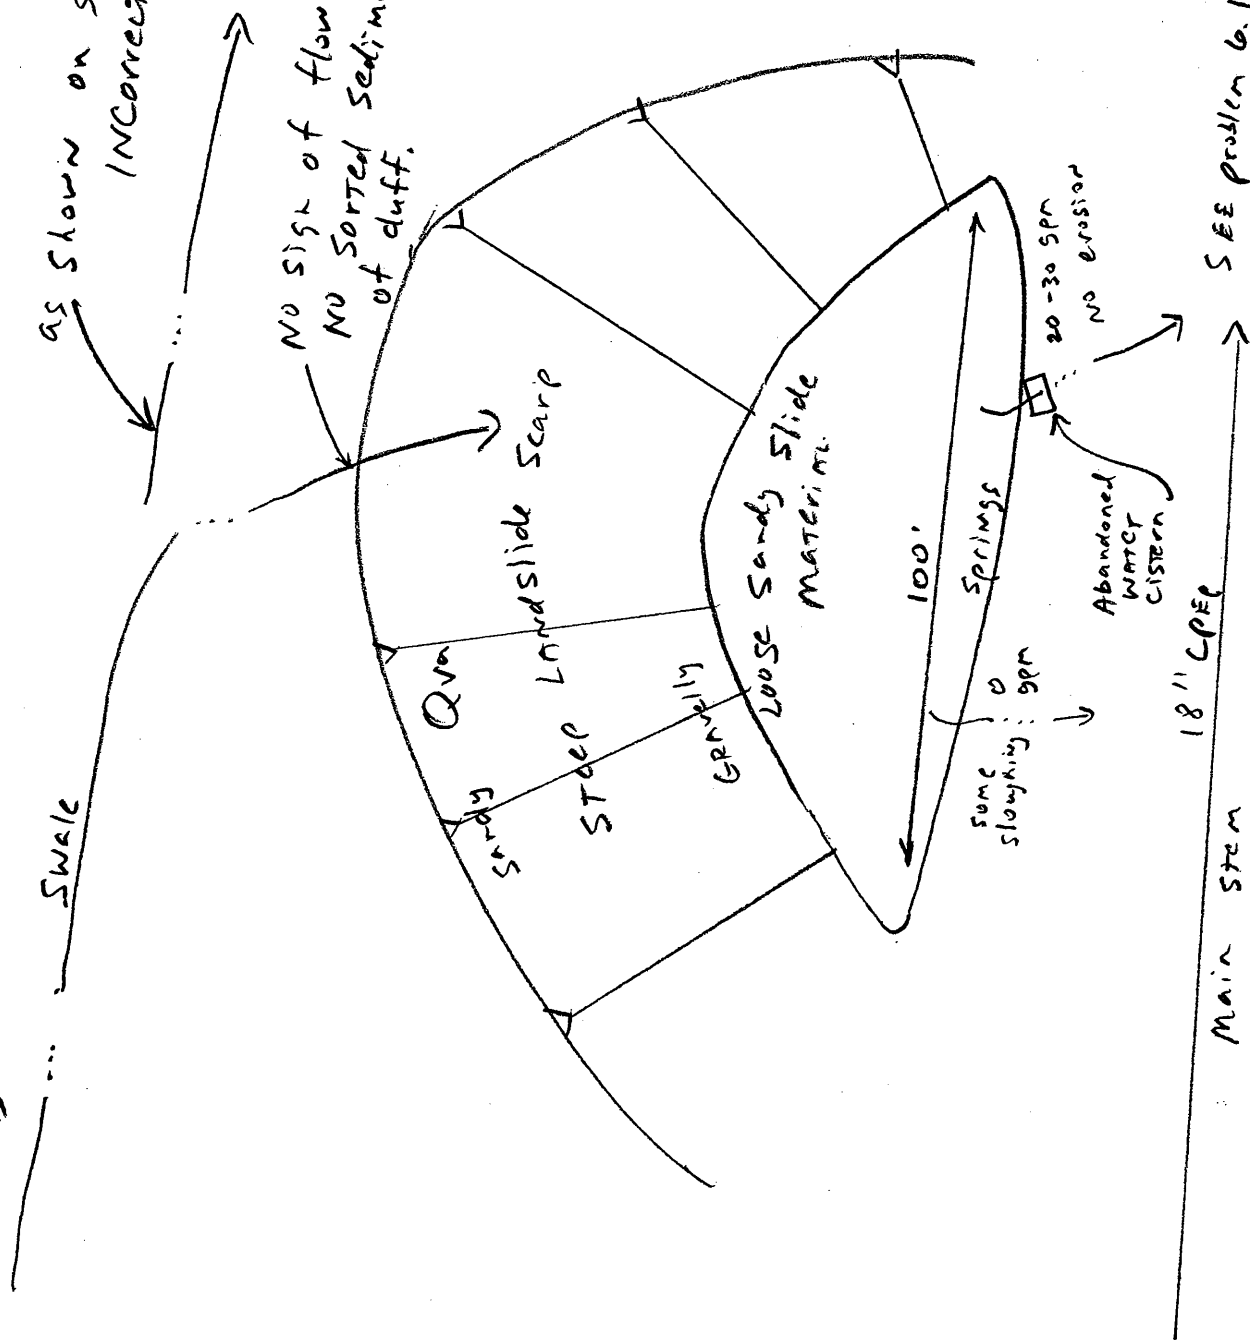
Problem 6.2

NOT A Surface Water erosion Problem
Disturbance caused by bikes, No runoff or sign of flowing water.
Problem Location is at scarp of old slide, Springs in Lower area. Subbasin boundaries need to be adjusted.

LOOSE SANDY SLIDE MATERIAL
