COMPREHENSIVE BASIN REVIEW AND WATERCOURSE MONITORING

VOLUME I – MAIN REPORT

City of Mercer Island

December 2006

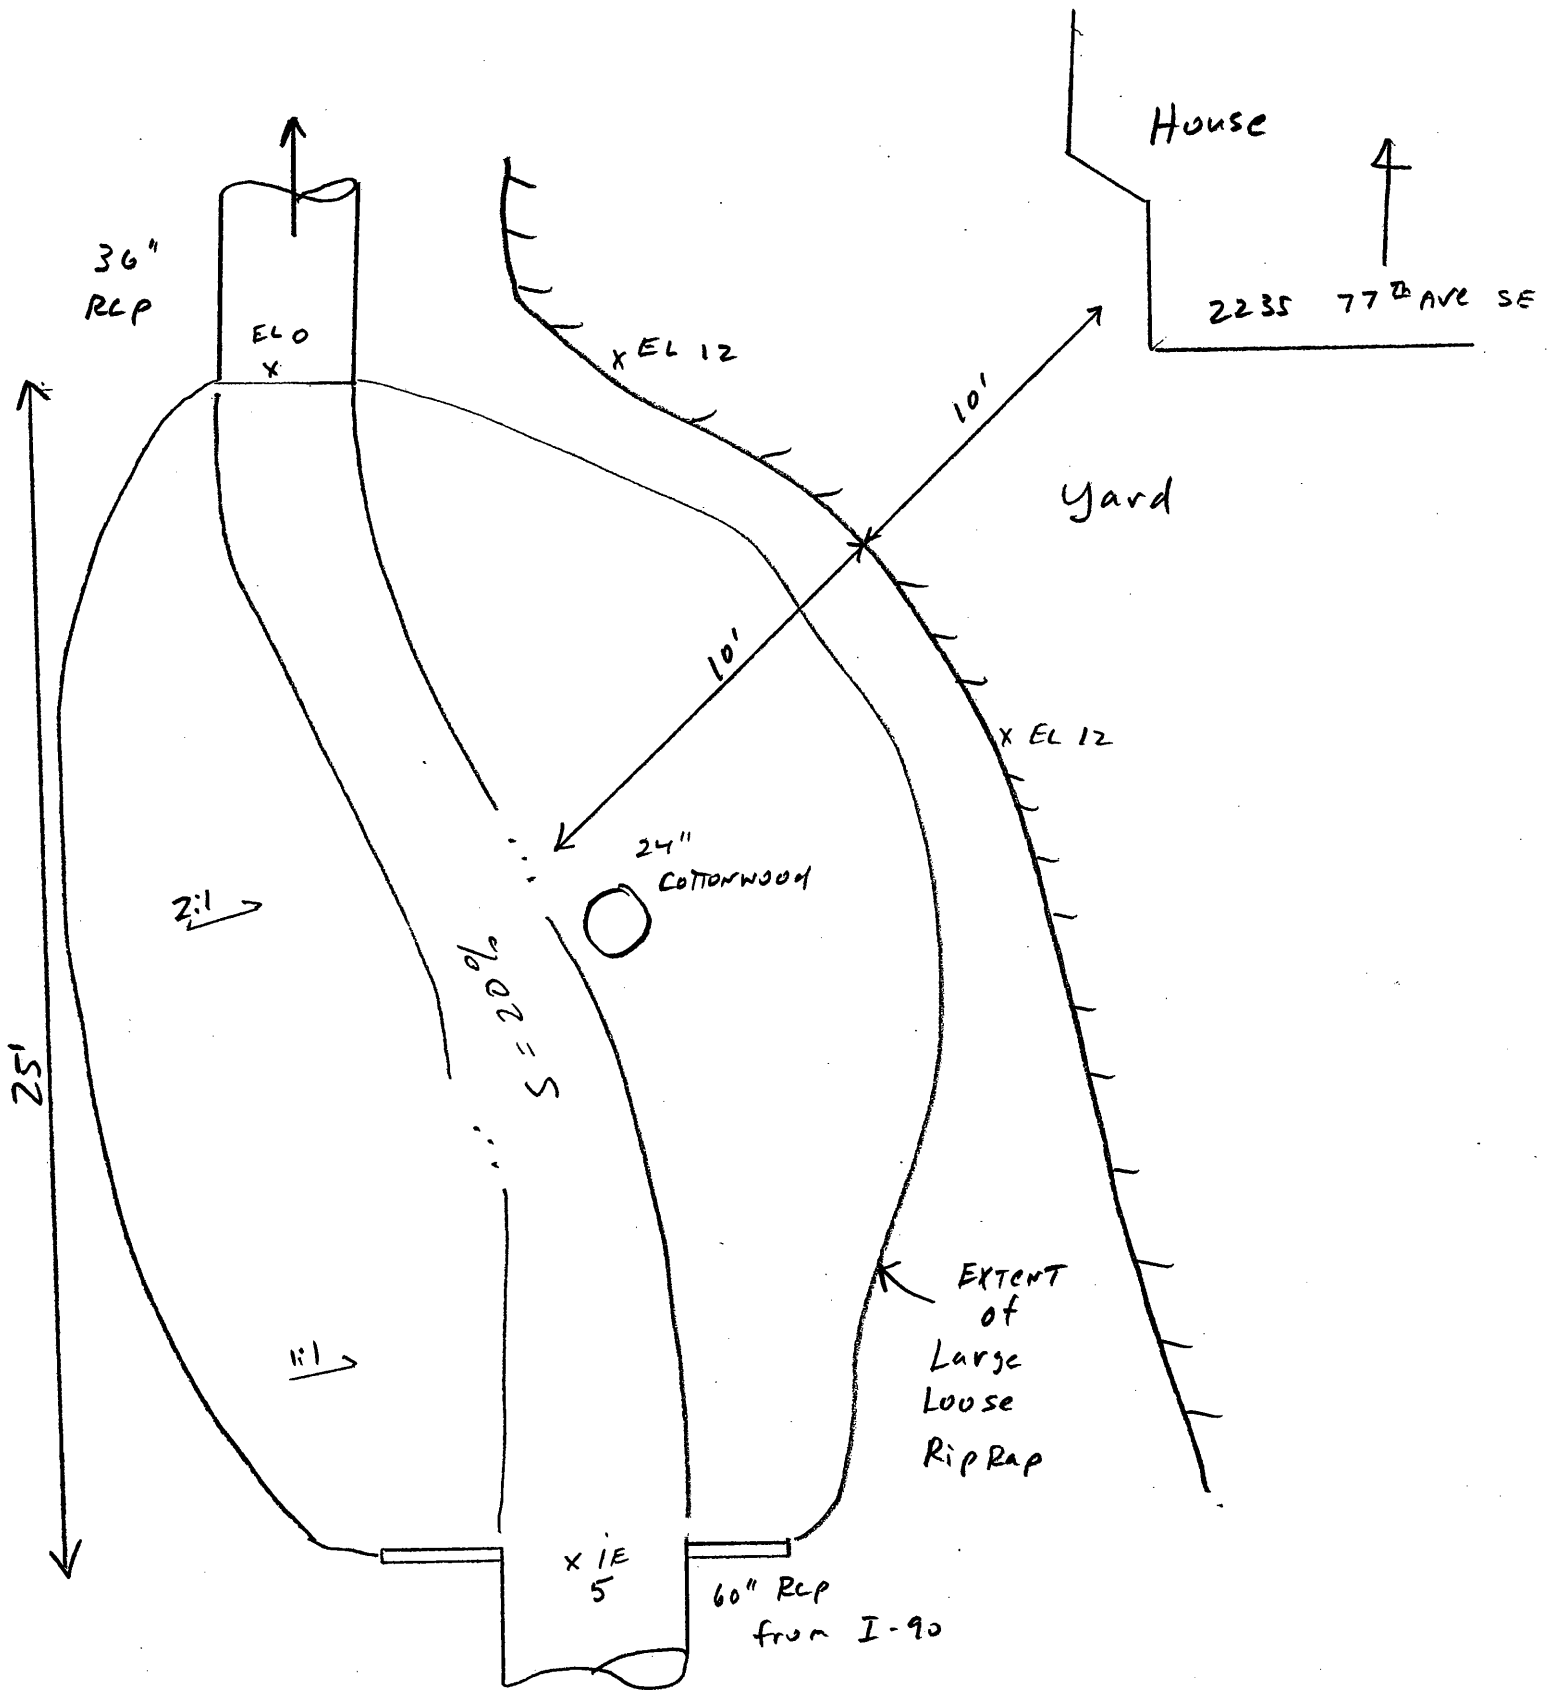
Problem 10.4

NO erosion evident but rock lining NOT very good. Risk depends on expected flow. Additional analysis warranted.

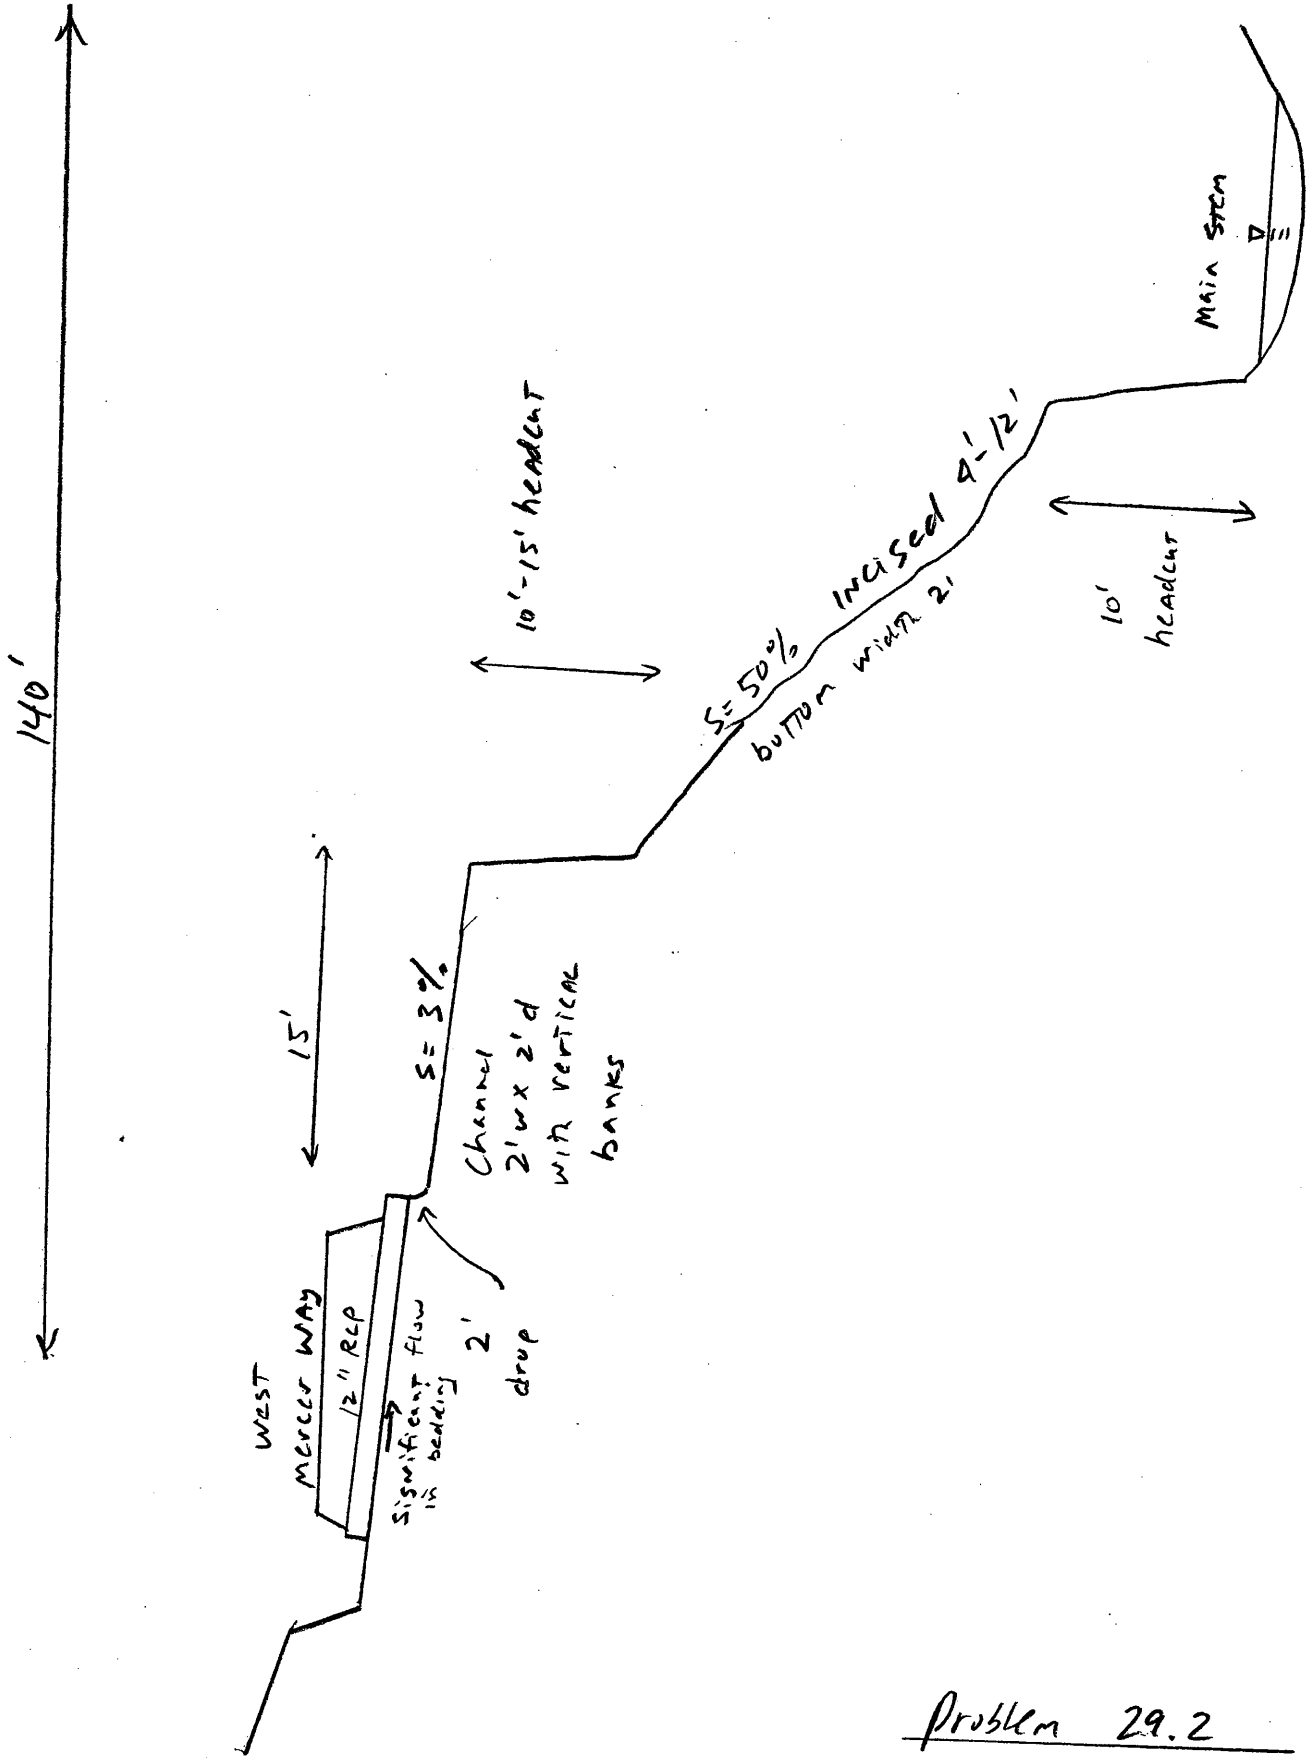
Problem 29.2

Potential Reduction in O&M costs None Small Moderate Significant
 Restoration of construction access: Native Landscaped 25 LF
 Concept: Outfall protection _____ LF
 Bypass Pipe HDPE 140 LF
 Check dams _____ LF
 Channel restoration _____ LF
 Stream restoration _____ LF
 Other _____

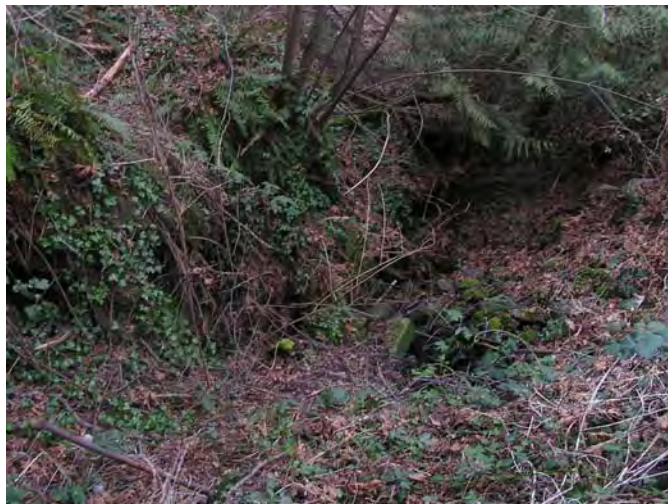
Basin No.:	4
Project No:	4.2
Project Title:	Bypass Pipes along west side of Gallager Hill Road
Problem Description:	Downstream of storm drain outlet, flow is scouring and undercutting toe of large, mapped slide. This is long term risk to Gallager Hill Road as well. Two other storm drain outlets contribute flow. See Appendix E for a field sketch of the problem area.
Project Description:	The preferred approach based upon the field reconnaissance includes installing manholes, anchor blocks, and 12-inch butt-fused HDPE pipes along 100 feet of water course and 40 feet at two side drainage systems to stop erosion of slide toe. Additional investigations are recommended for this problem with considerations of other alternatives and seeking input from WDFW. Two other options could be considered. The first is to re-route the drainage system in the road so that the majority of flow is directed to the downstream side drainage and then extend this pipe system to the channel at the toe of the slope. The system could be designed to allow low flows from the upper side drainage to continue to discharge down its side drainage. The second option is channel stabilization of the channel and only piping the side drainages down the steep slope. The cost estimate is based on the bypass pipes with 12-inch pipe.

Looking Downstream at Outlet 9/24/2005

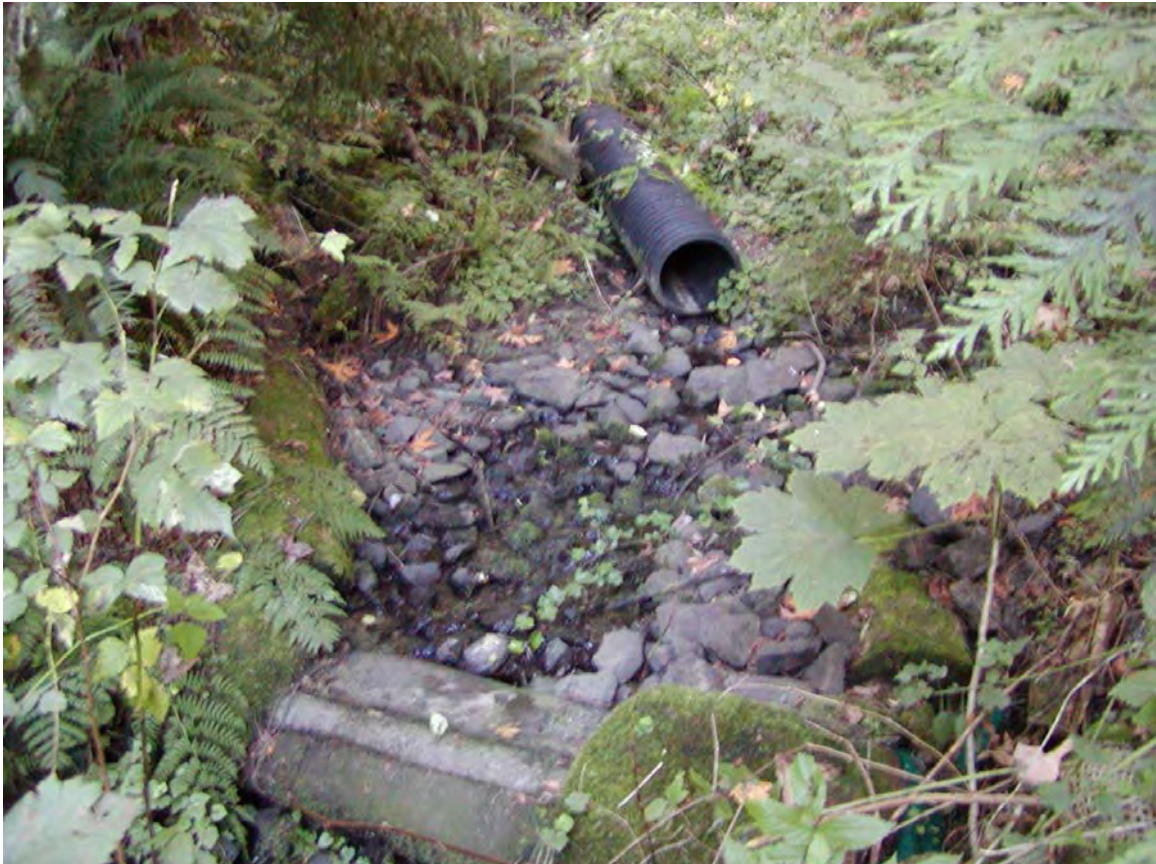
Looking Upstream at 18" Corrugated PE Pipe Outlet 9/28/2005

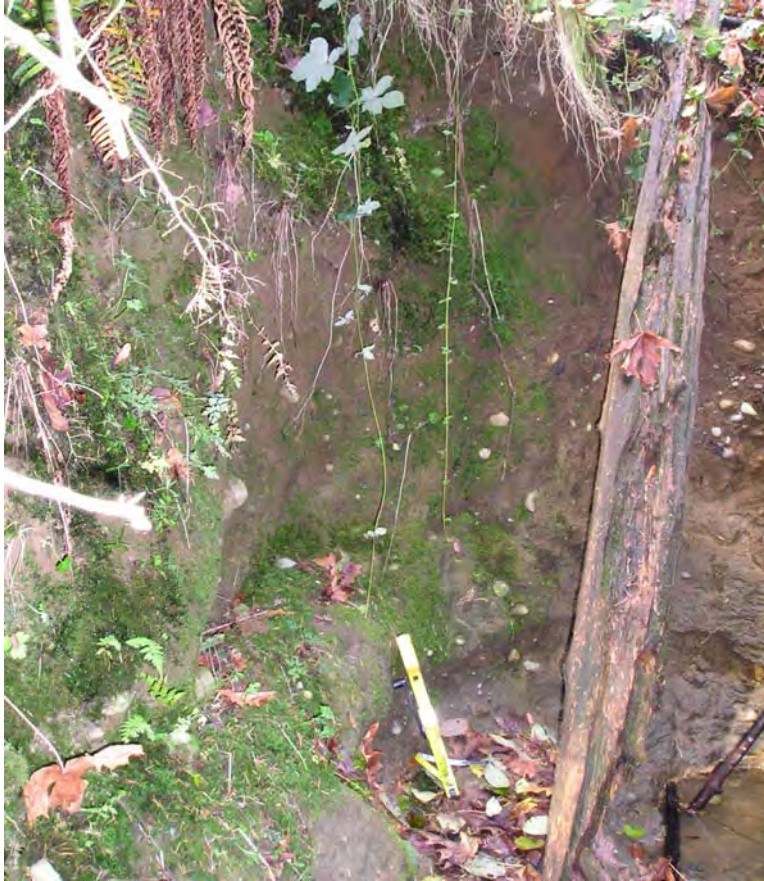
Looking Upstream at Headcut 1/5/2006

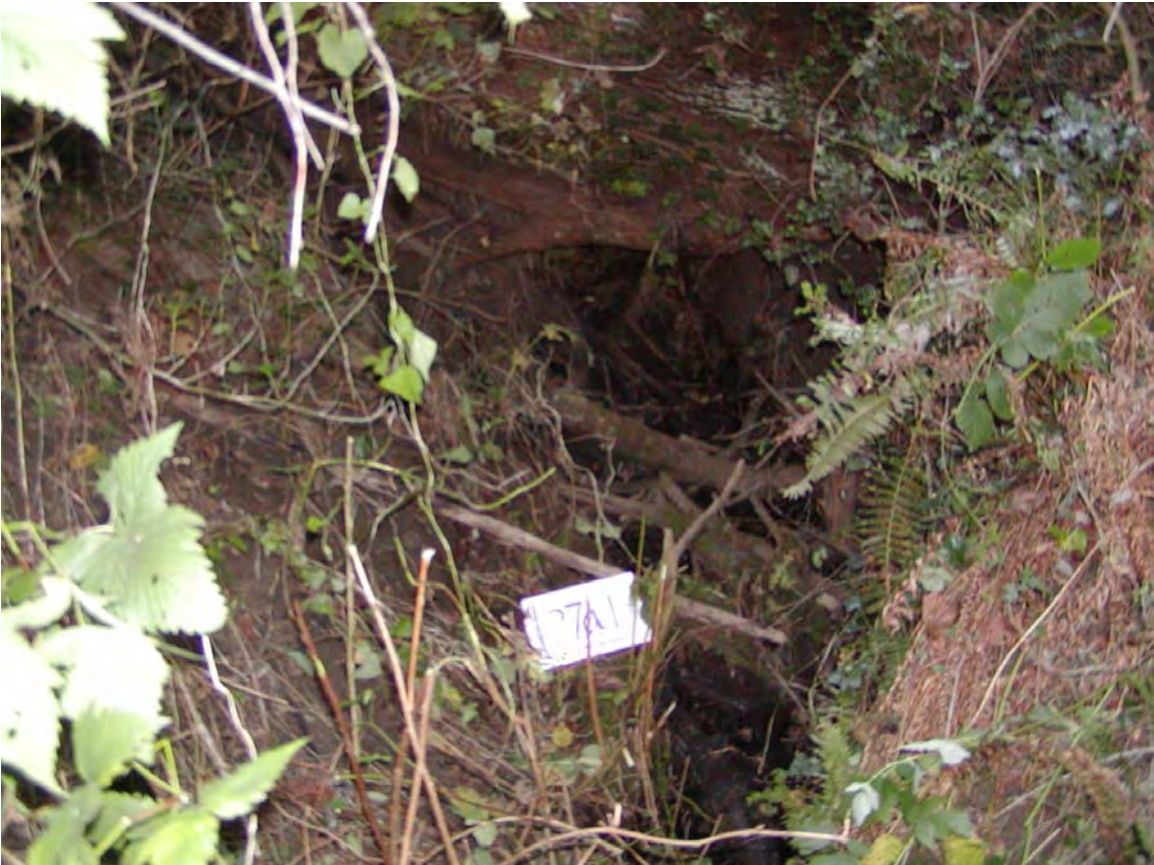
Looking Upstream 9/28/2006

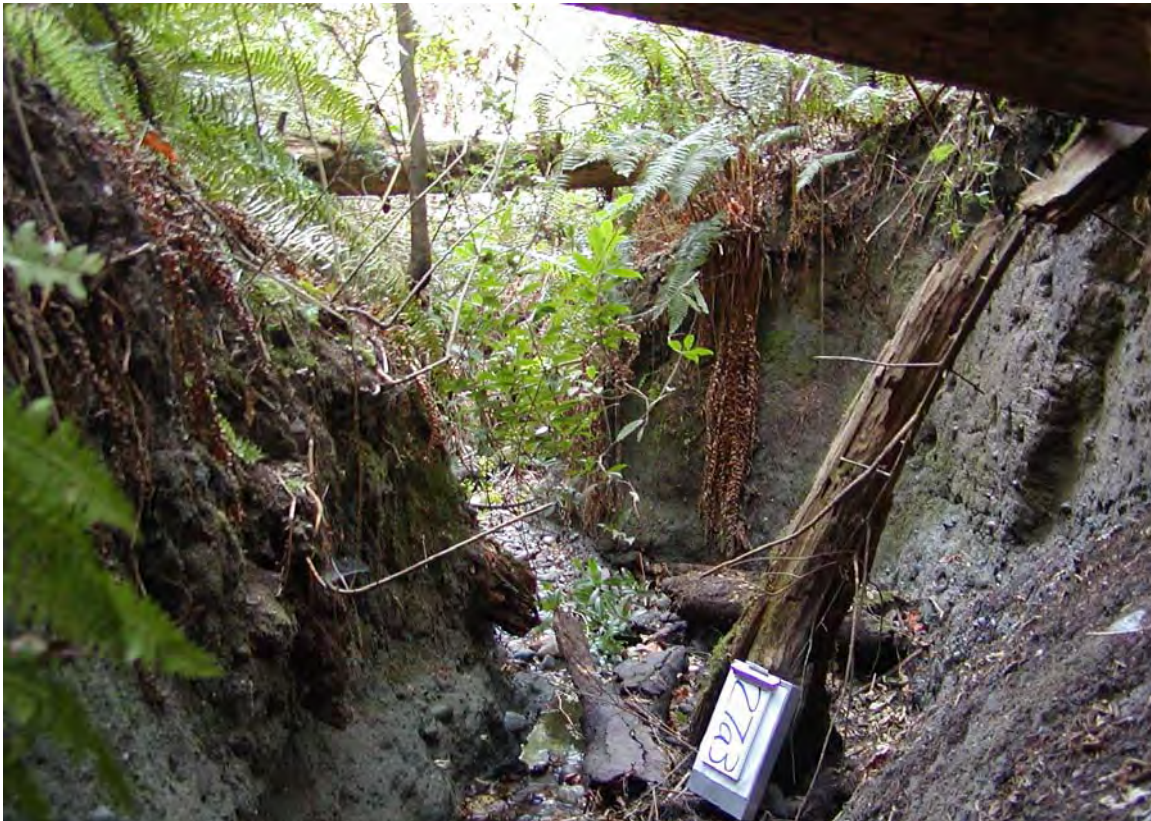
Problem Description: Streambed and bank erosion with headcut formed by 6-foot drop over 30 feet of channel in soft material. Area is subject to long-term erosion and slope failures. Located behind homes in shallow, undeveloped ravine.

Looking Downstream - 9/28/2006

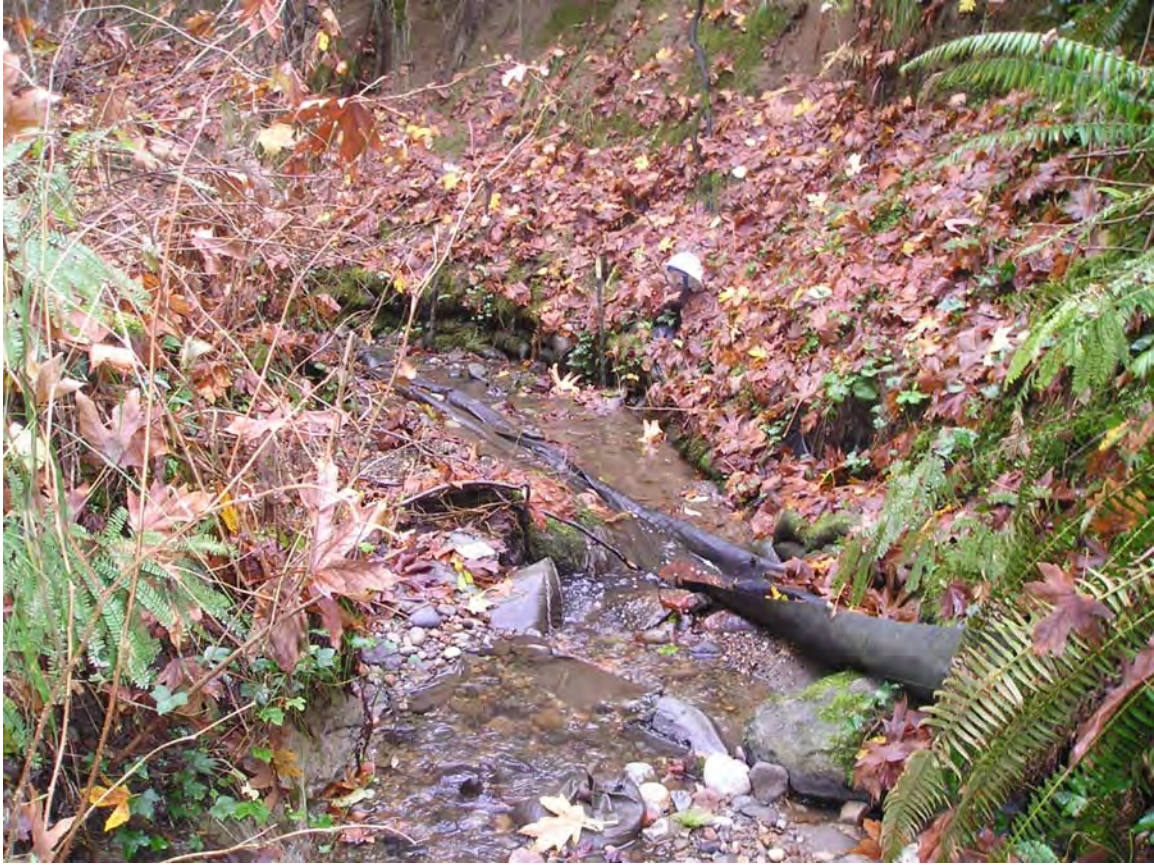
Looking Downstream at Sandbagged Bank 1/5/2006

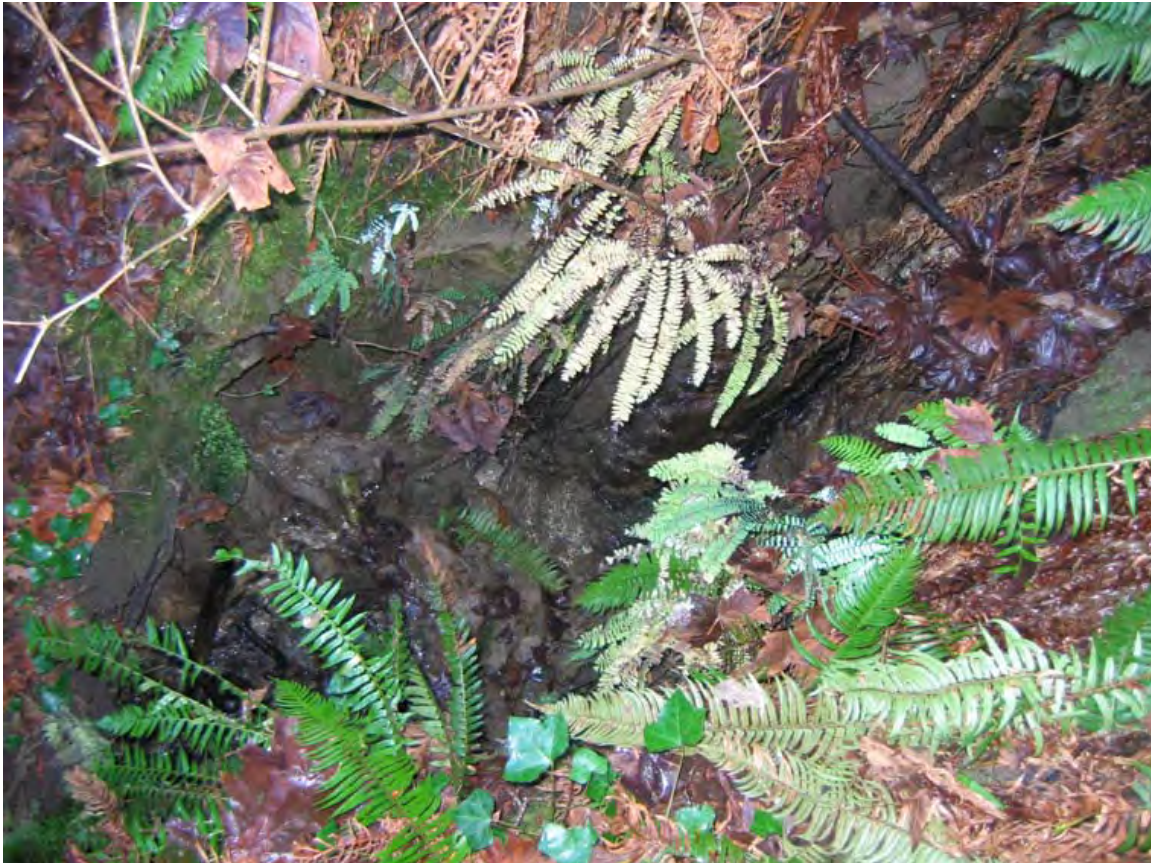
Basin No.:	29
Project No:	29.2
Project Title:	140 LF butt-fused HDPE pipe on west side of West Mercer Way in 6100 block
Problem Description:	Very steep channel has created a headcut and incised into the east bank of the main stem of the creek. The small, narrow channel is up to 12 feet deep and rapidly eroding. See Appendix E for a field sketch of the problem area.
Project Description:	Butt-fused HDPE bypass pipe from West Mercer Way down the steep bank to the ravine bottom, a distance of 140 feet. New manhole and anchor near the street. All flow will be conveyed in the pipe.
Related Projects	None
Estimated Project Cost:	\$115,000

Looking at 10' Incised channel 12/14/2005

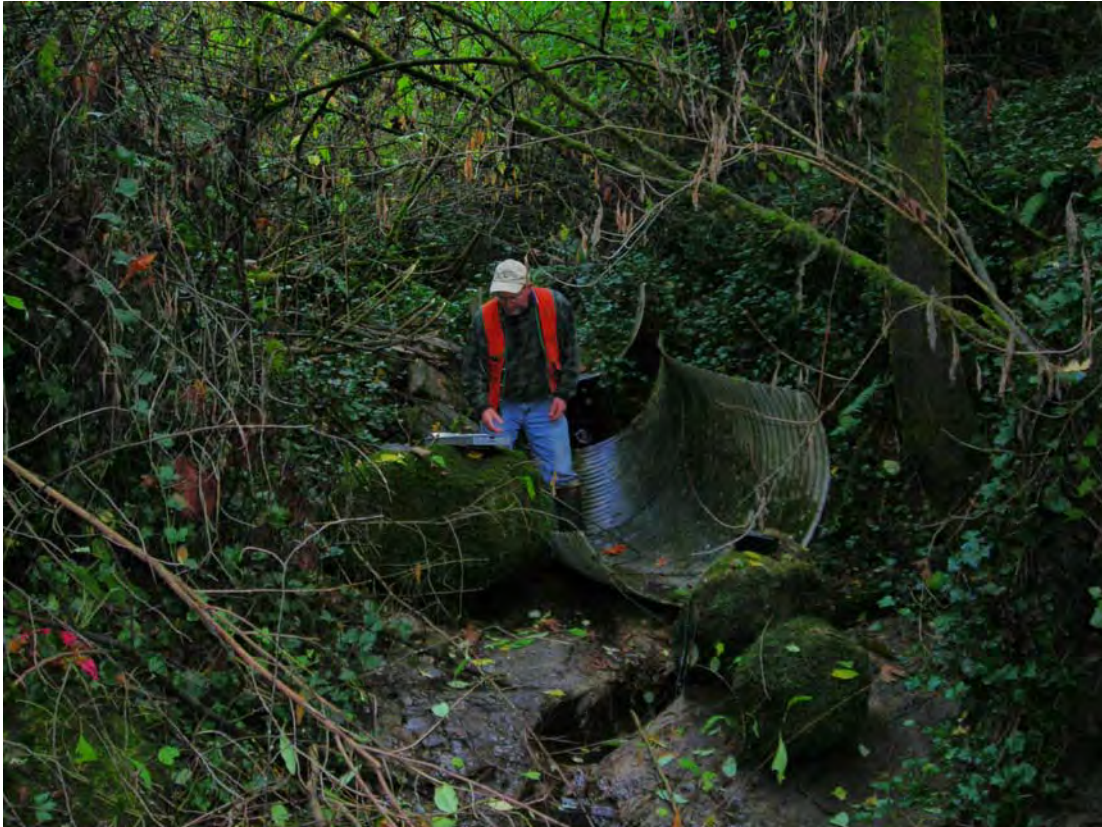
Basin No.:	32
Project No:	32b.1
Project Title:	30 LF of Boulder Cascade as outfall protection for half round pipe south of Meadow Lane, and west of West Mercer Way
Problem Description:	Below the outlet of a 48 inch diameter, half round CMP conveyance pipe, the channel is scoured and drops 3 to 5 vertical feet over 15 to 20 linear feet. Channel is also scouring horizontally below culvert outlet. Water is also flowing along the underside of the half round pipe. Banks are steep, unvegetated, composed of very dense silt and retreating. Channel bottom lacks any substrate and consists of smooth, very dense silt.
Project Description:	Construct approximately 30 linear feet of boulder cascade for outfall protection below half round pipe outlet.
Related Projects	32b.2 (located downstream)
Estimated Project Cost:	\$38,000

Looking Upstream 10/20/2006

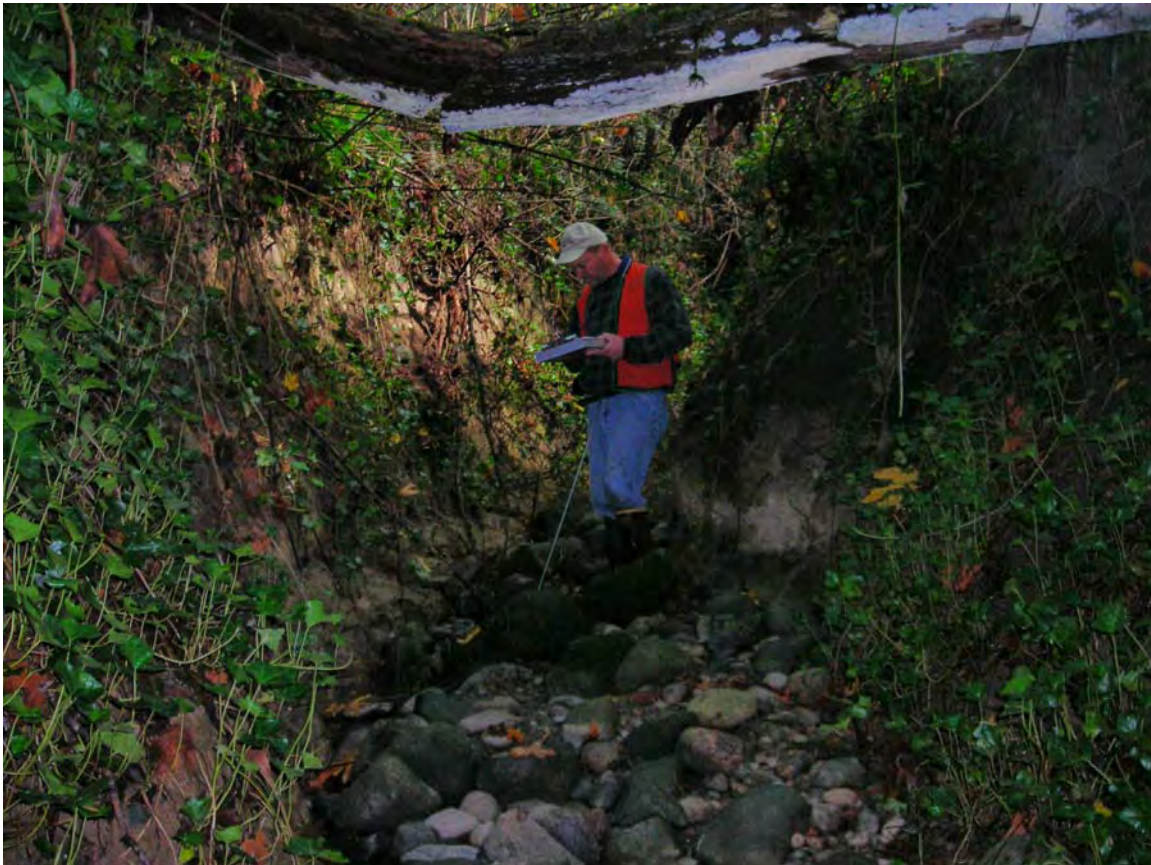
Problem Description: Approximately 5 to 7 foot deep headcut through very dense silt. Below headcut channel is highly incised with vertical, unvegetated banks. Channel bottom has little loose substrate, and consists of very dense silt.

Looking Upstream 10/20/2006

Project Description: Construct approximately 50 linear feet of boulder cascade, regrade upper banks and replace invasive plants with native vegetation.

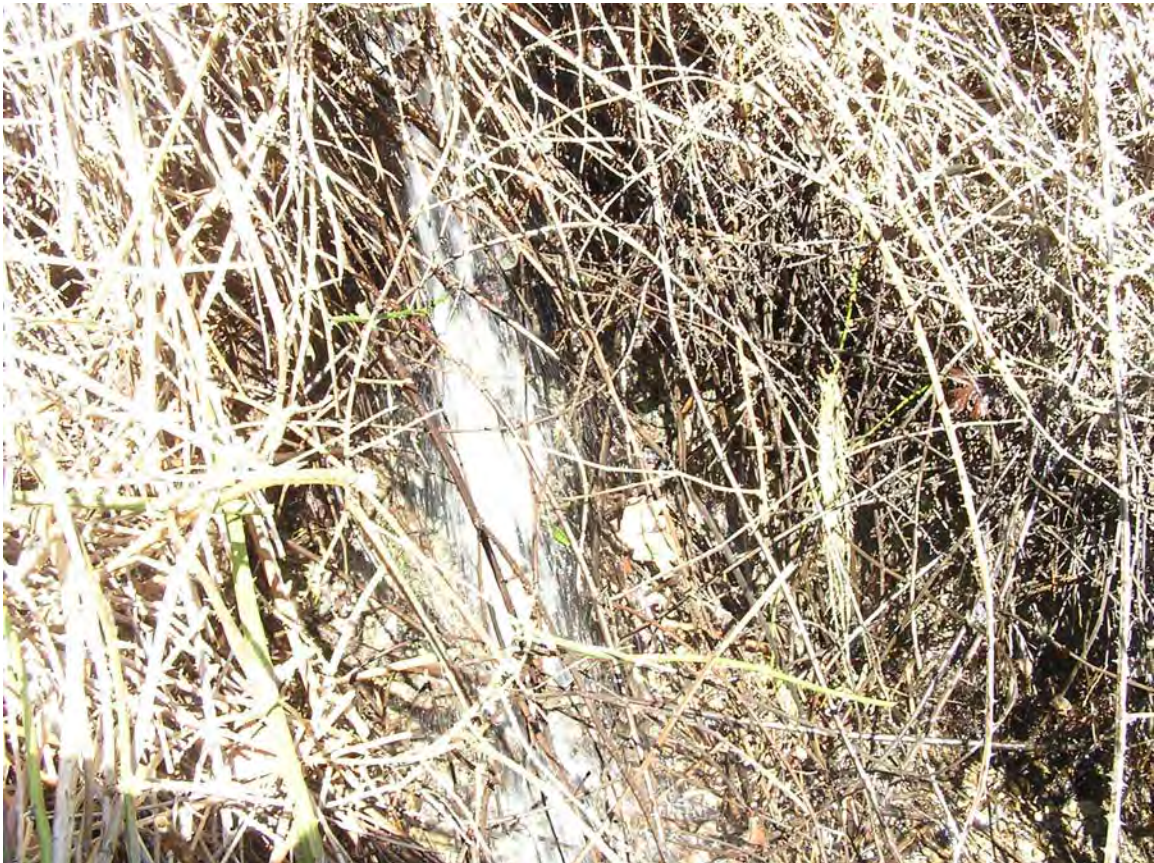
Flow from Pipe Outlet 3/3/2006

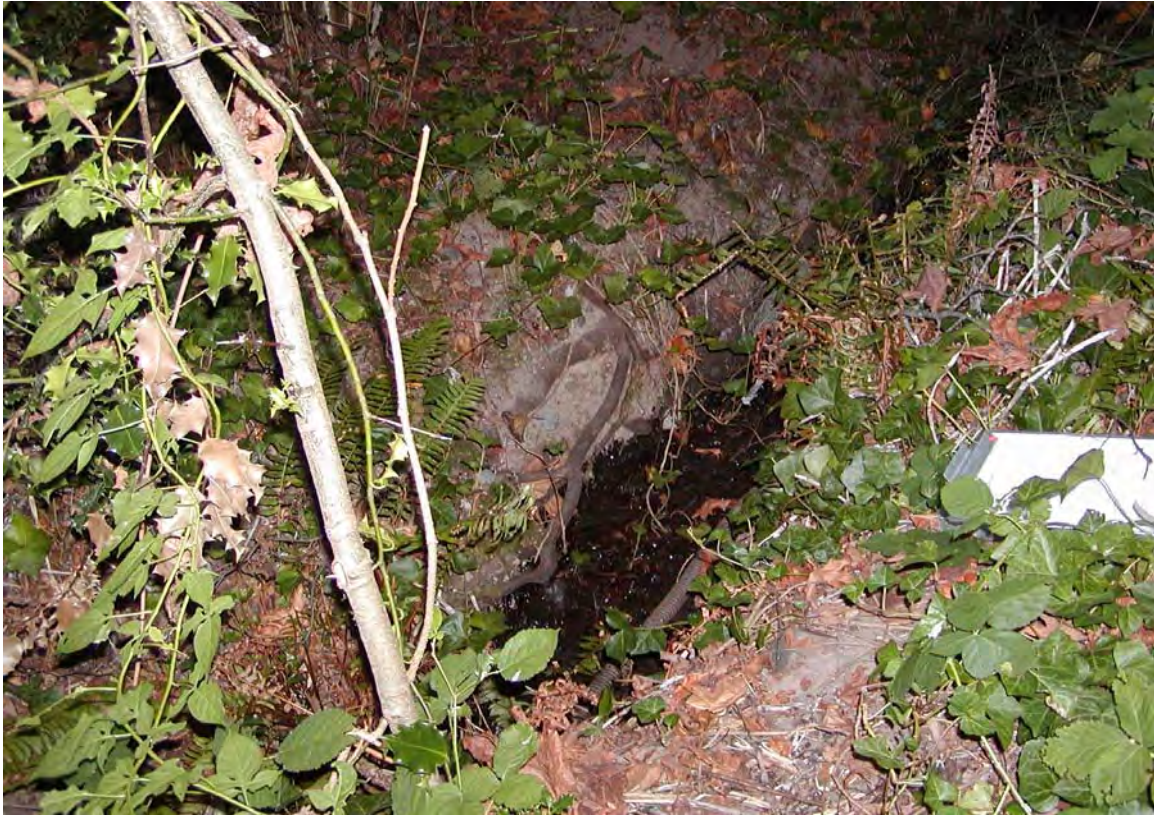
Looking Upstream 9/28/2005

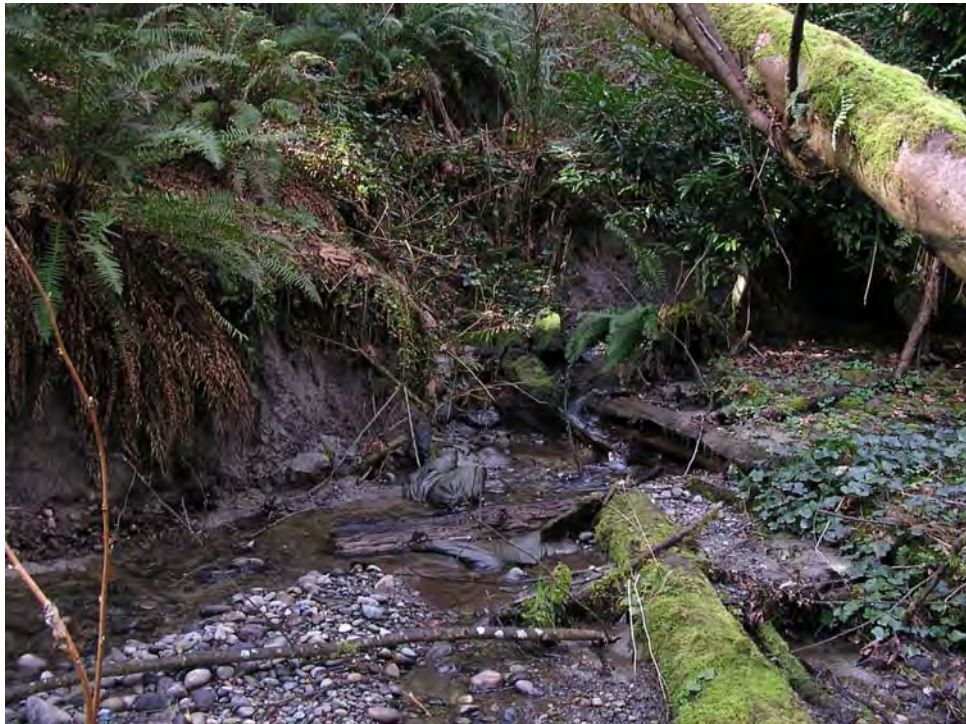
Problem Description: Two sandbag and geotextile check dams and sandbag and geotextile bank protection were temporarily installed for protection of this reach. These are beginning to fail. Some bank erosion is also occurring on the south bank. Not mapped by the Watershed Company as having potential fish use.

Looking Upstream 3/3/2006

Project Description: Replace sandbag check dams with rock check dams or rock vortex weirs. Check dams are less expensive but rock vortex weirs may be needed to provide fish passage. Also provide bank protection and stream restoration along about 60 feet of bank. Stream restoration would include logs/large woody debris, boulders, bank regrading and planting.

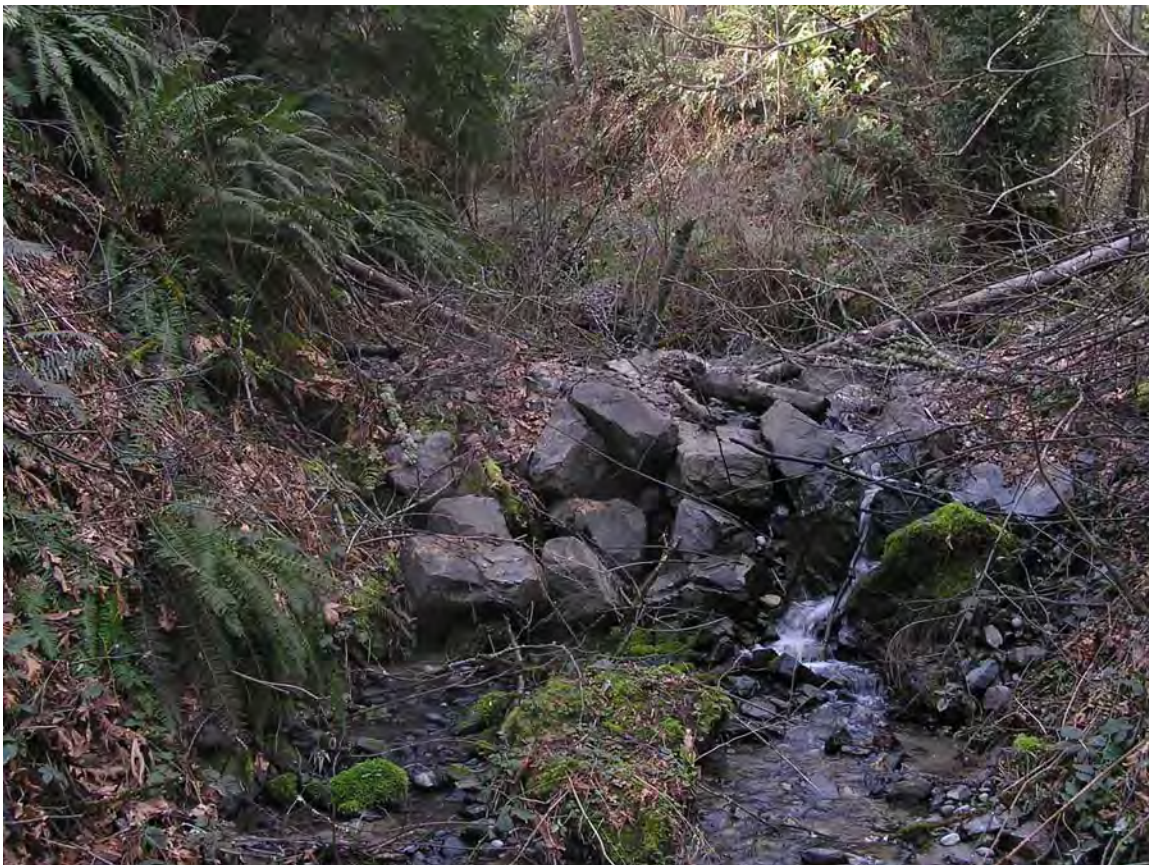
Problem Description: About 100 feet of the south bank of this 300-foot reach is experiencing erosion and needs bank protection and restoration. Two large rock check dams need repairs.

Looking Upstream 3/3/2006

Project Description: 100 feet of stream restoration/bank protection and repairs to two rock check dams.

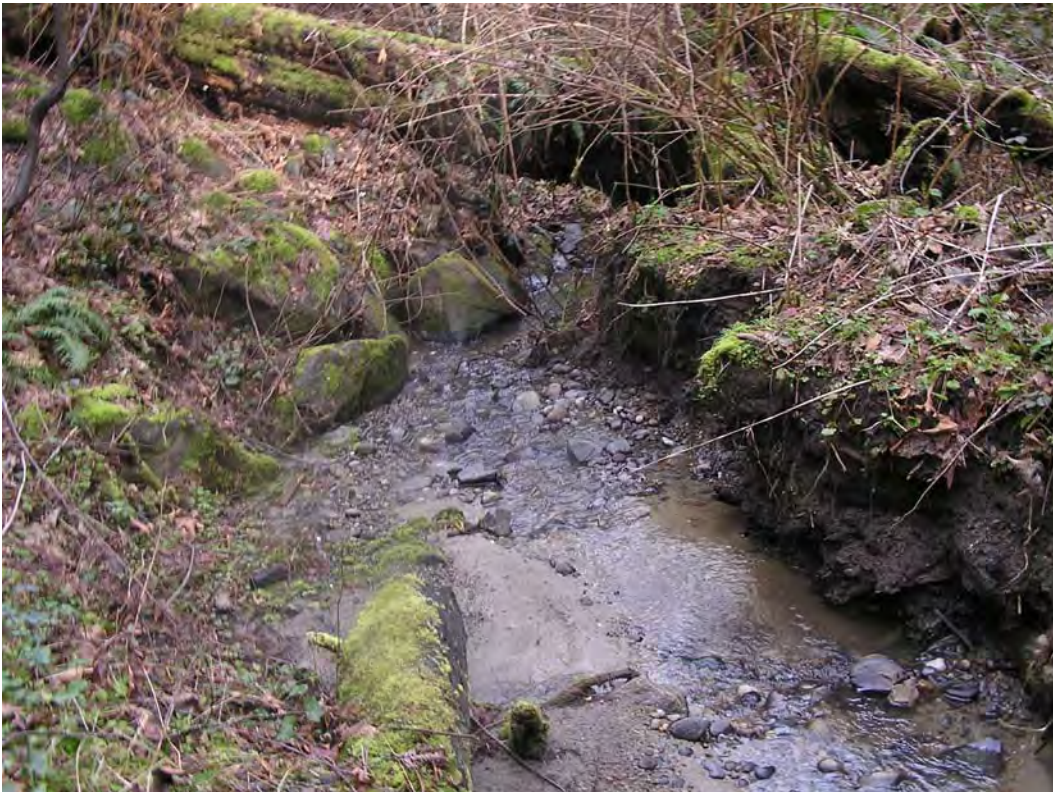
Looking Upstream 3/3/2006

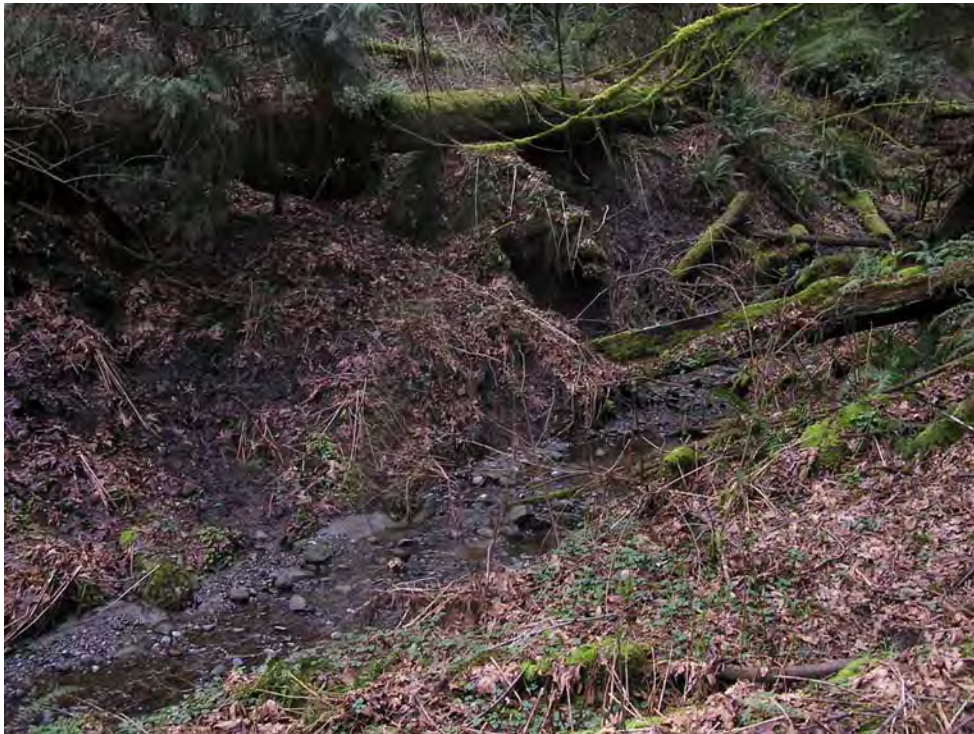
Problem Description: Bank sloughing and spring sapping exists along about one-third of the south bank of this 400-foot reach. Previous restoration work done but additional work is needed. On the north bank the creek runs adjacent to sanitary sewer manhole and is armored with quarry spalls which may be too small in size for adequate protection.

Looking Upstream 3/3/2006

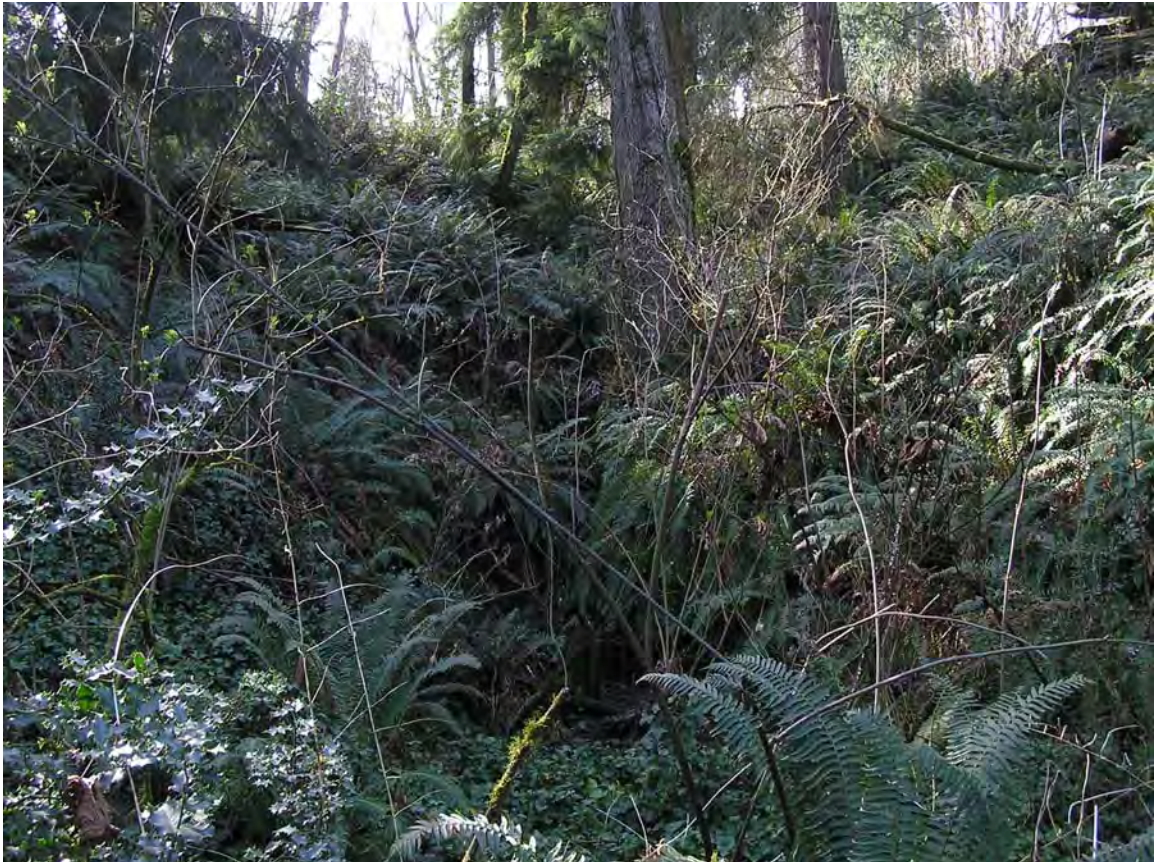
Looking Upstream from East Mercer Way 3/3/2006

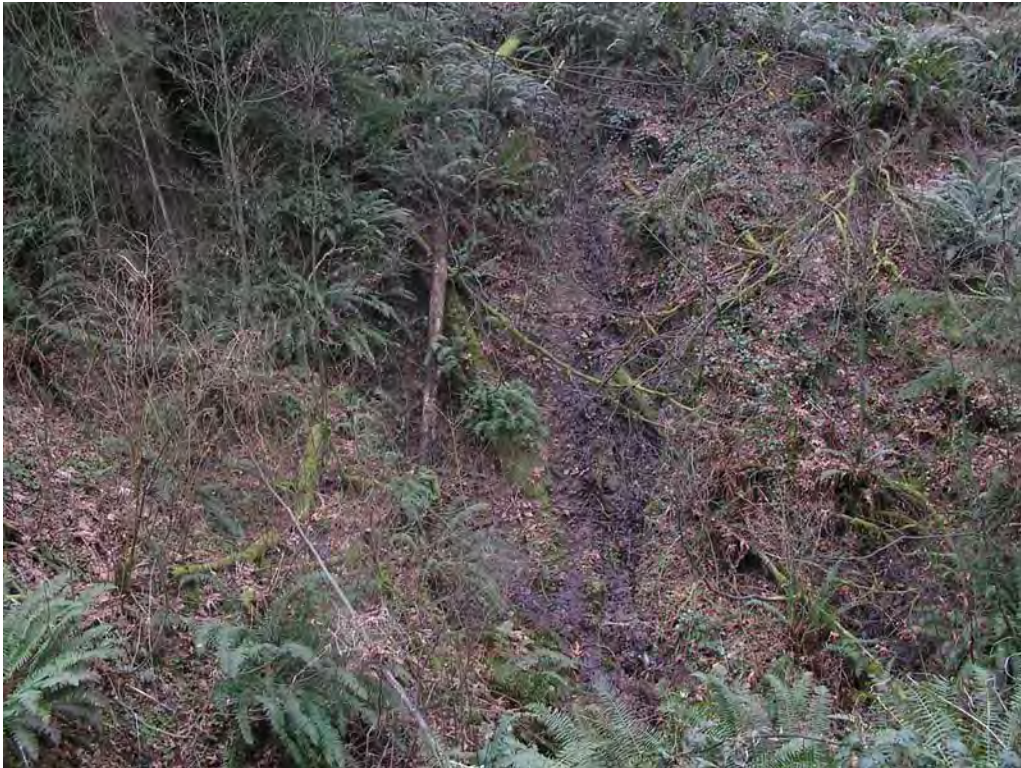
Looking across ravine at water course poorly defined watercourse 3/3/06

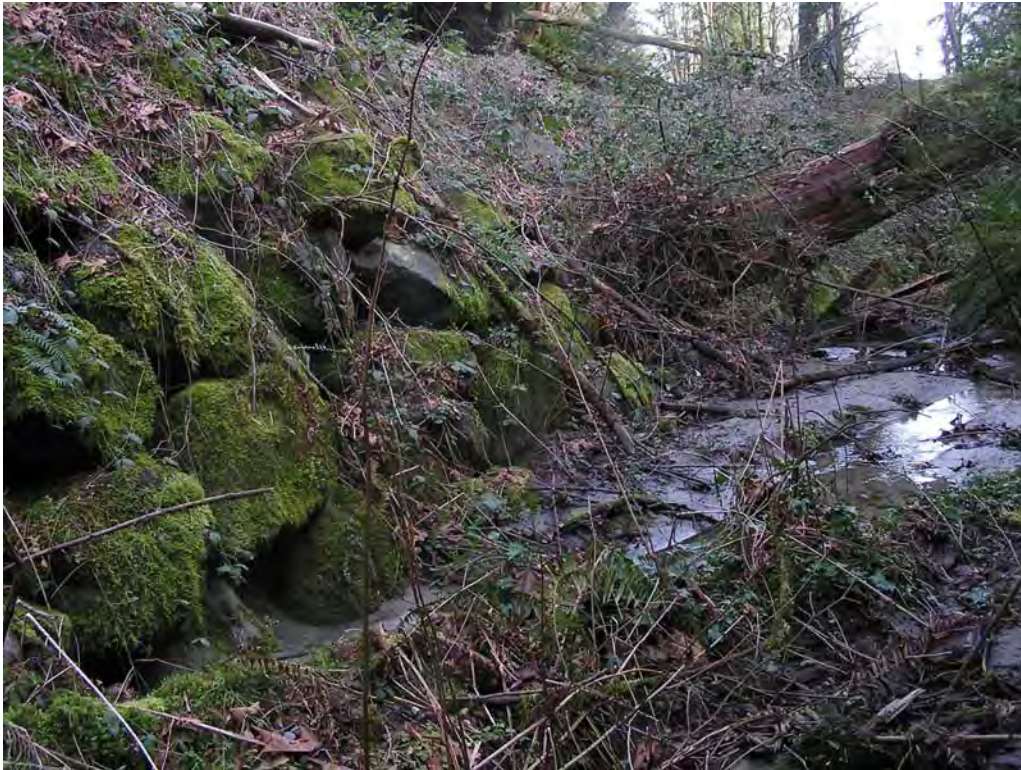
Looking Upstream. Rock Protection on left. 3/3/2006
