COMPREHENSIVE BASIN REVIEW AND WATERCOURSE MONITORING

VOLUME I – MAIN REPORT

City of Mercer Island

December 2006

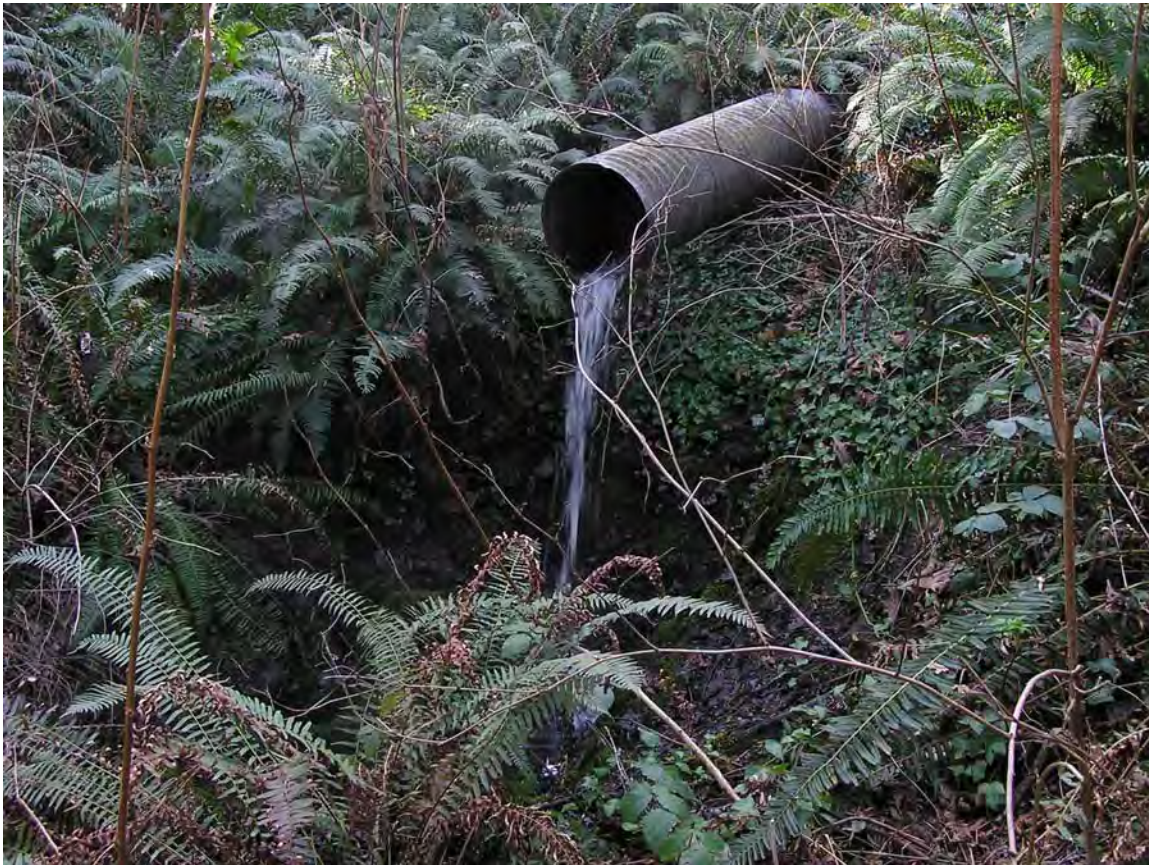
Problem Description: There are two erosion problems at this site; 1) a 5-foot drop from the 18-inch CMP culvert under a private driveway which is undergoing moderate erosion and 2) 30 feet of channel downcutting located 100 feet downstream of the culvert. The soft, wet east bank has wetland characteristics. Site is located in undeveloped ravine. Work may need to be done primarily by hand due to site conditions.

Looking Upstream at Culvert Outlet 3/3/2006

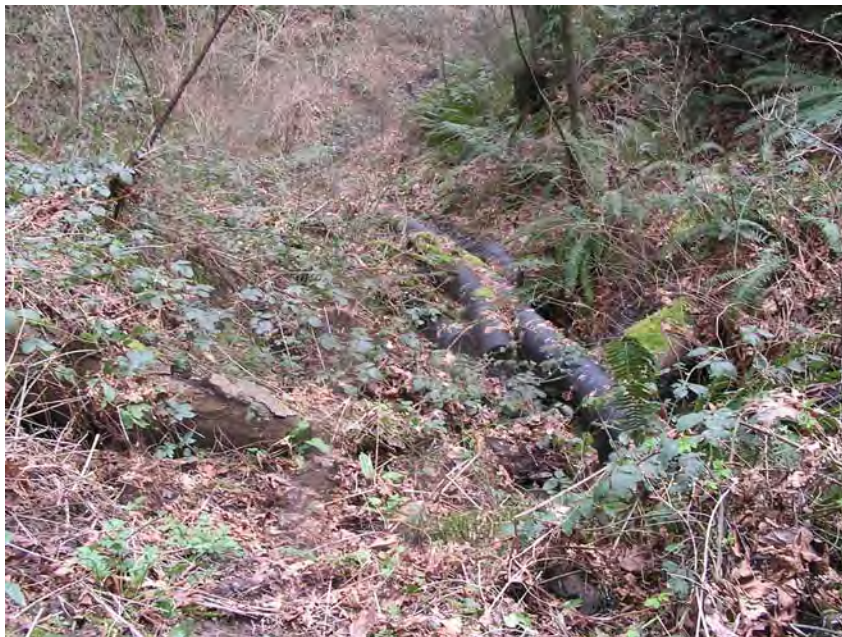
Basin No.:	42
Project No:	42.10
Project Title:	Remove half round pipe, install manhole and 30 feet of 24-inch pipe and fill.
Problem Description:	Existing public drainage system consists of a manhole with a sound CMP outlet pipe on top of the ravine about 50 feet long, about 30 feet of half round CMP, an above ground transition from the half-round pipe to a 24-inch corrugated polyethylene pipe and 80 feet of corrugated polyethylene pipe which lies on the ground in the bottom of the small ravine. The system conveys flow to the main water course. Only one of the corrugated polyethylene pipe joints is capable of handling thrust. There is considerable leakage from the pipe and seepage from the hillslope. The seepage has contributed to slope instability particularly on the south bank.
Project Description:	Install manhole at the downstream end of the sound, buried CMP. Remove half round pipe and replace with 24-inch corrugated polyethylene pipe (CPEP) extending from the new manhole to the existing 24-inch CPEP. Cover CPEP with 150 cy of well draining material to stabilize this pipe as well as the slopes. It may be possible to deliver fill with chute or blower truck.

Looking Downstream at Surface CPEP 3/3/2006

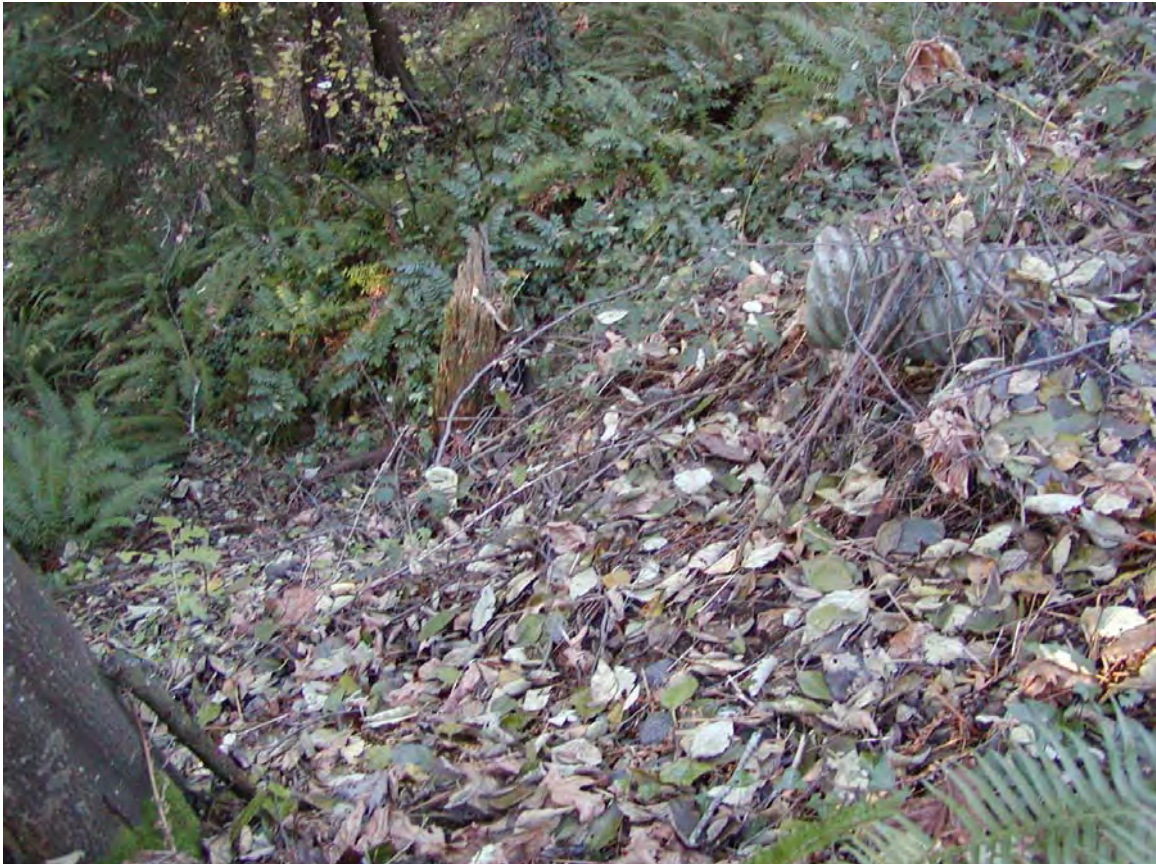
Culvert Outfall on Steep Slope 12/8/2005

Project Description: Replace culvert with manhole, concrete anchor and 120 feet of butt-fused HDPE pipe to ravine bottom.

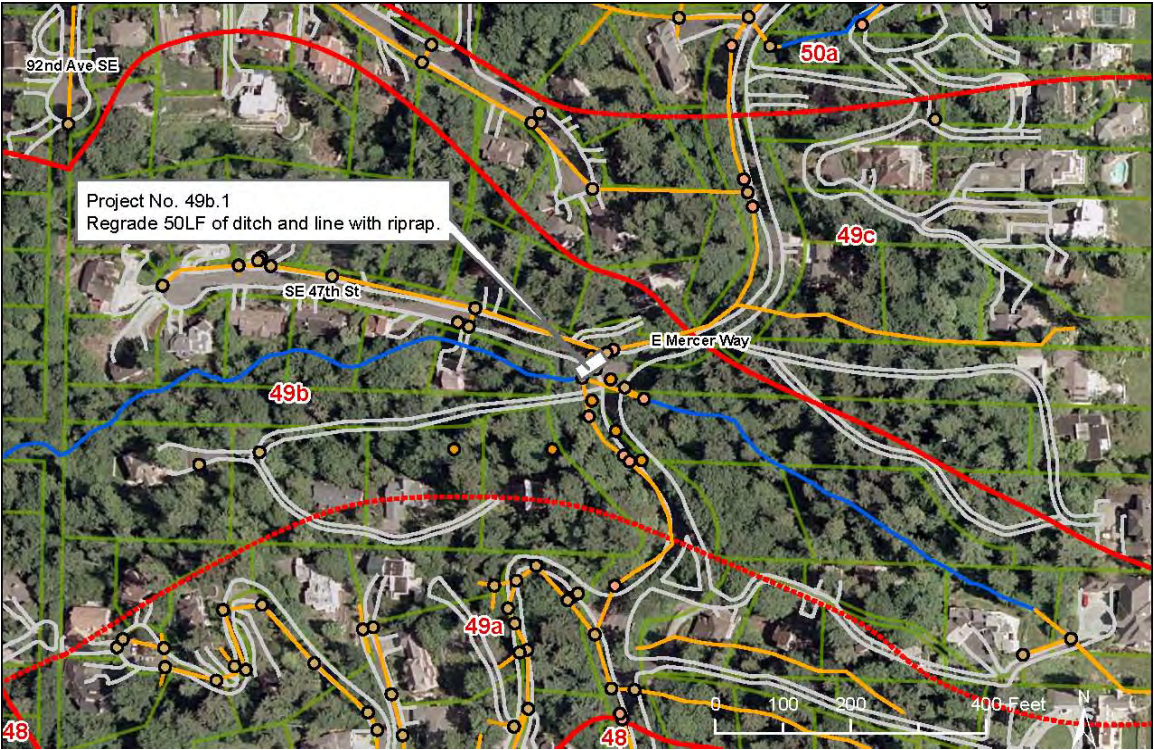
Erosion at Pipe Outlet (pipe crushed) 12/8/2005

Project Description: Regrade 50 LF of outlet ditch and line with riprap. (Quarry spalls would be too small.)

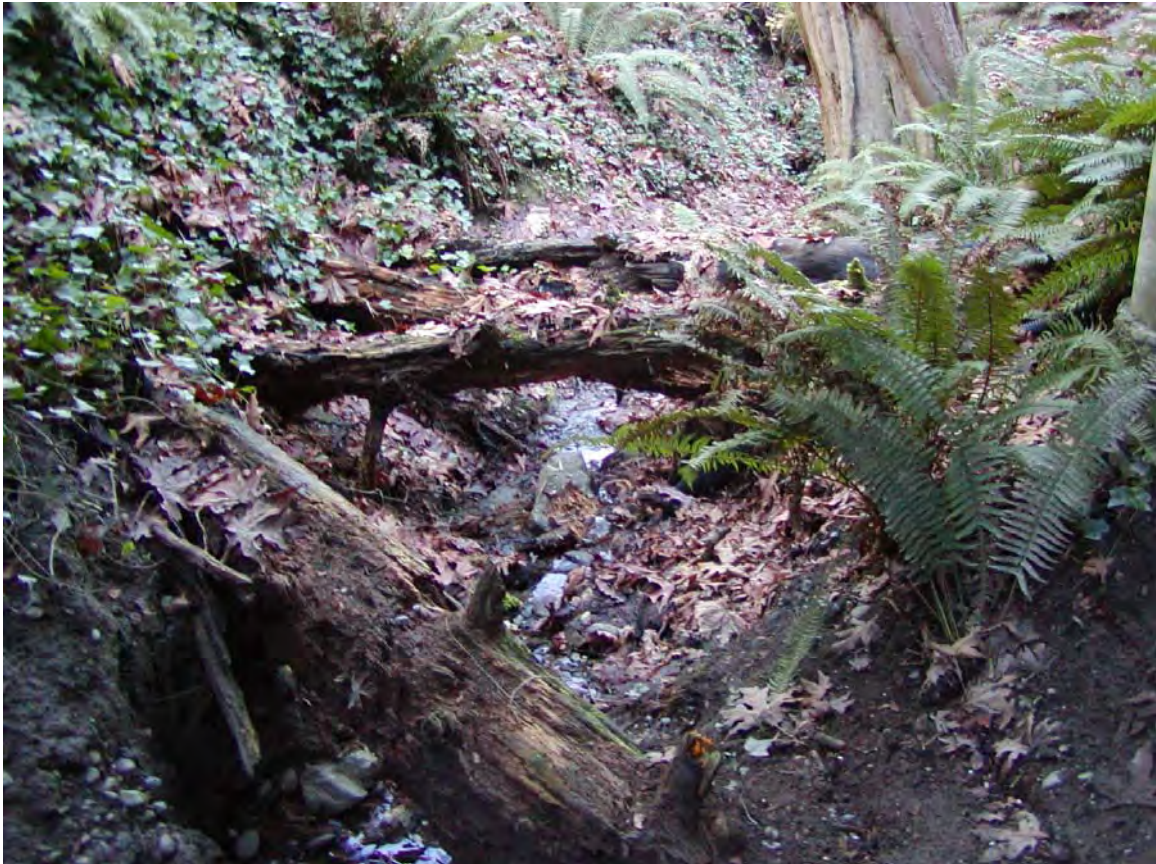
Looking Upstream 12/8/2005

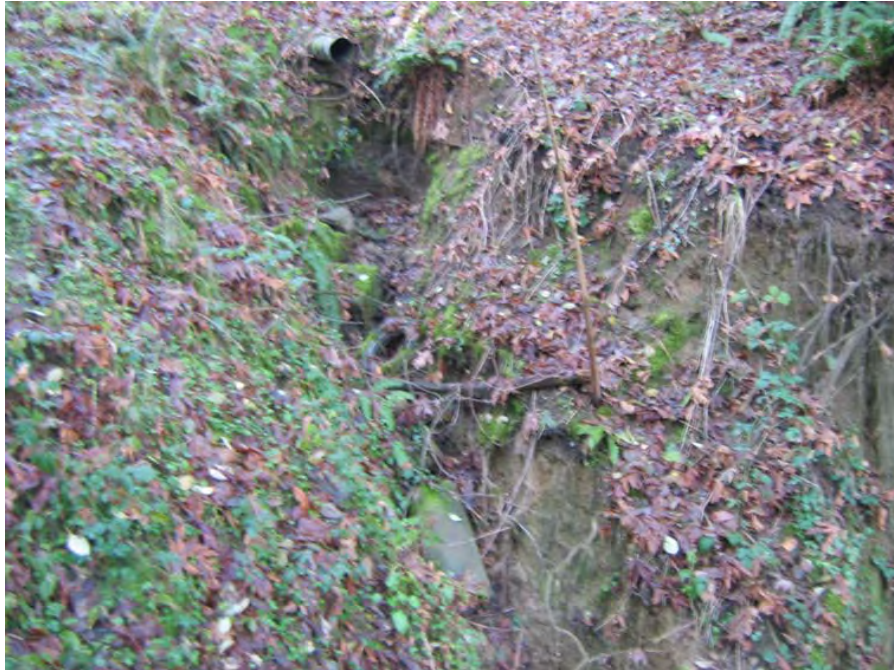
Basin No.:	49b
Project No:	49b.4
Project Title:	Butt-fused HDPE pipeline on stream stabilization east of 91st Avenue SE in 4700 Block
Problem Description:	Large scale, severe erosion of 1,000 CY at an existing 12-inch storm drainage outlet which drops six feet into a steep channel in sandy soil. Channel incision is about 100 feet long and the depth varies from 5 to 20 feet. See Appendix E for a field sketch of the problem area.
Project Description:	Two alternatives are considered for this problem. The first is to install 12-inch-diameter HDPE pipeline with manhole energy dissipator at the downstream end. Under this alternative it may be desirable to fill the erosion scar. The second alternative is stream stabilization along the 100 feet of channel. It is recommended the City get input from WDFW prior to selecting the preferred alternative. The cost estimate is based on the HDPE pipeline alternative.

Looking Upstream at Upper Half of Erosion Problem 12/14/2005

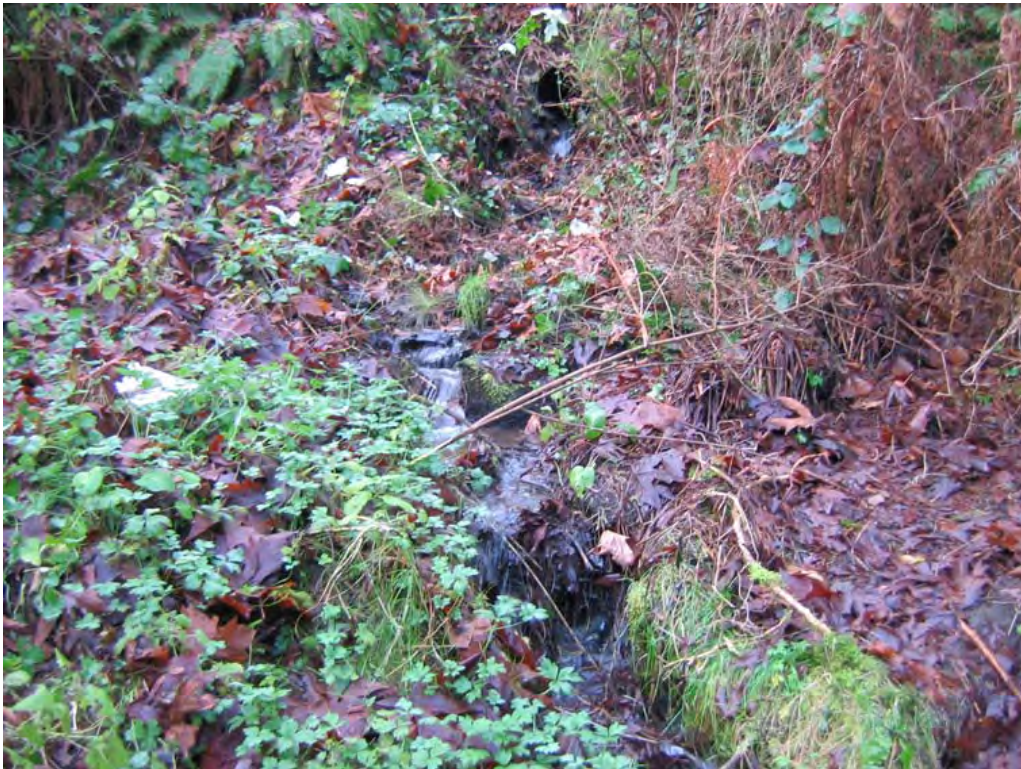
Looking Upstream at Steep Channel and Outlet. Erosion of Bank on Left.
12/14/2005

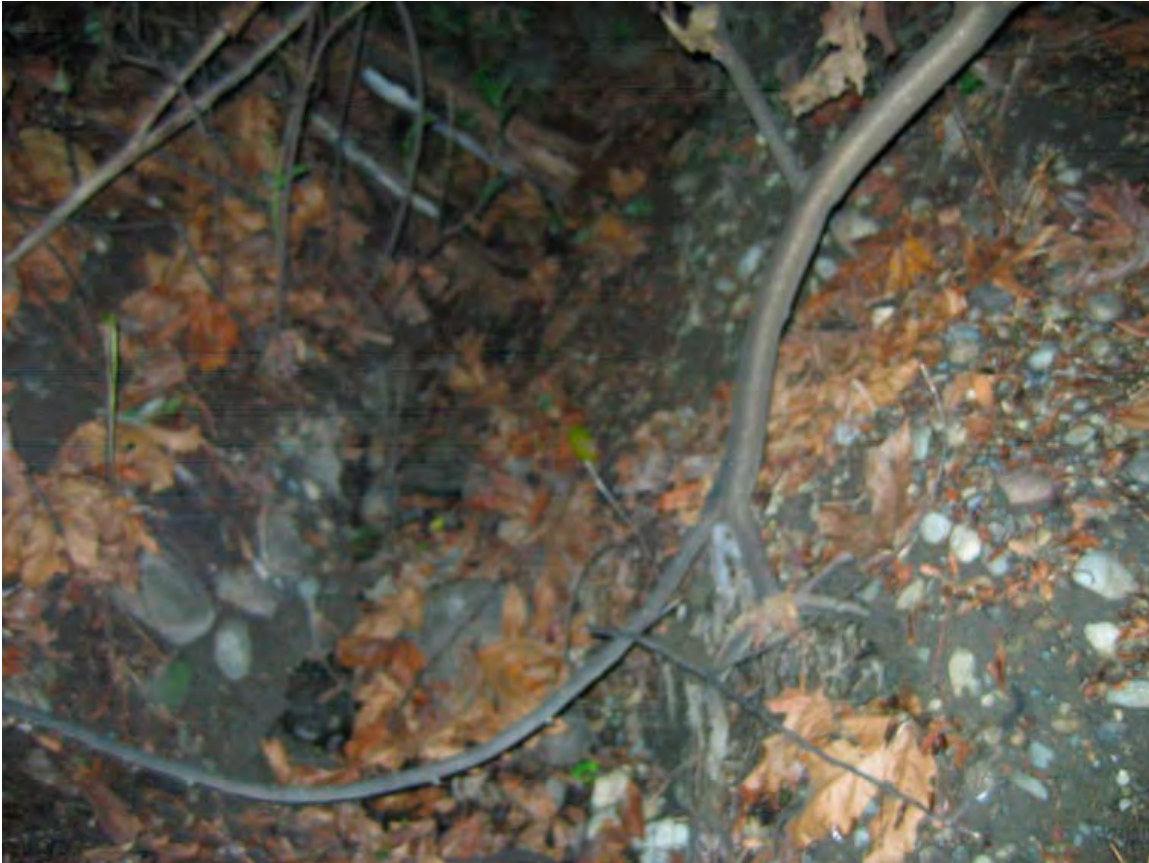
Looking Upstream 12/14/2005

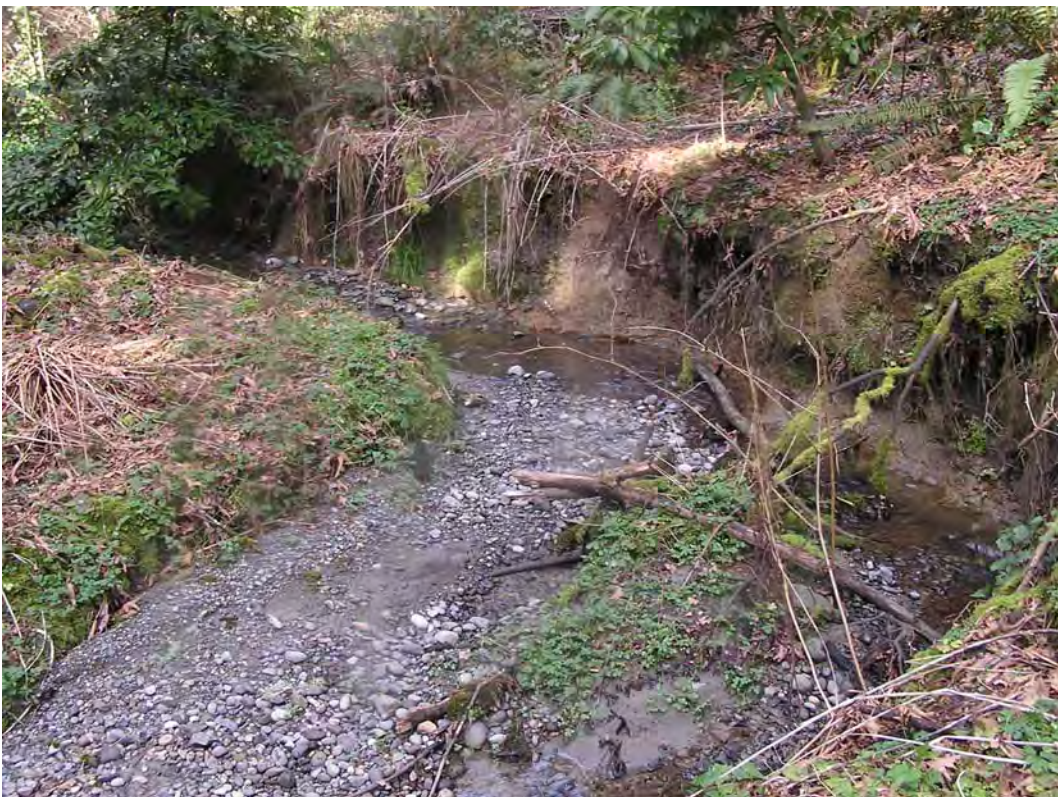
Problem No. 42.1a

Basin No.:	42
Project No:	42.1
Project Title:	Replace about 12 sandbag check dams with rock check dams or rock vortex weirs. Also install large woody debris for bank protection.
Problem Description:	Sandbag and geotextile check dams were installed at 20 to 100 feet spacing for temporary protection of this 600-foot reach. The dams are up to 4 feet high and are beginning to fail. Some bank erosion is also occurring. There is a large amount of fine grained sand behind the dams and in the channel. South bank appears to be slide material. Much of the riparian area would be considered wetlands. Not mapped by the Watershed Company as having potential fish use.
Project Description:	Replace about 12 sandbag check dams with rock check dams or rock vortex weirs. Check dams are less expensive but rock vortex weirs may be needed to provide fish passage. Also install logs/large woody debris for bank protection.
