COMPREHENSIVE BASIN REVIEW AND WATERCOURSE MONITORING

VOLUME I – MAIN REPORT

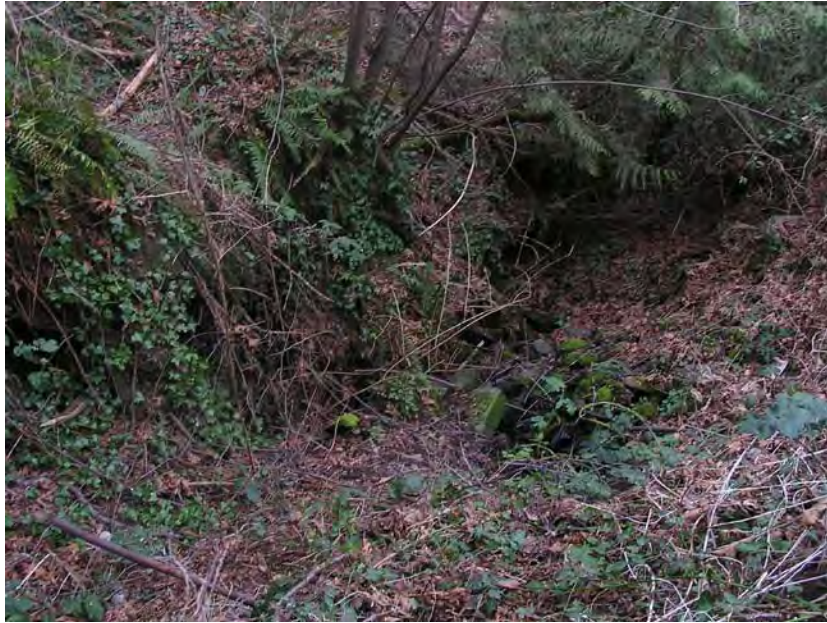
Project 4.2: Looking Downstream at Outlet 9/24/2005

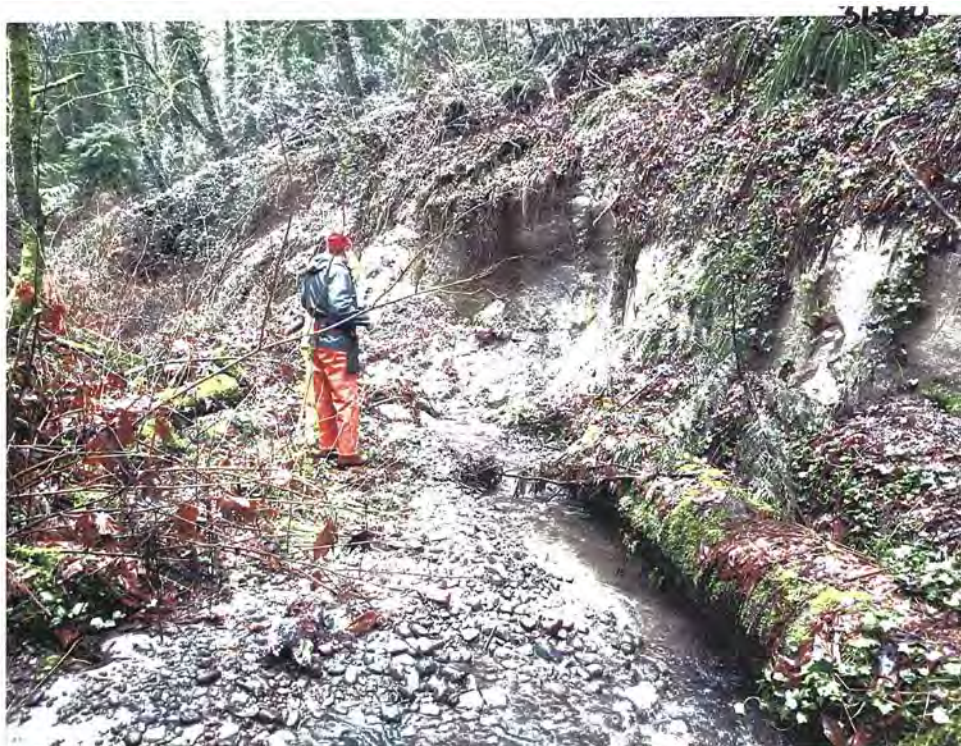
Project 6.5: Eroding bank 31+70 2/15/2011

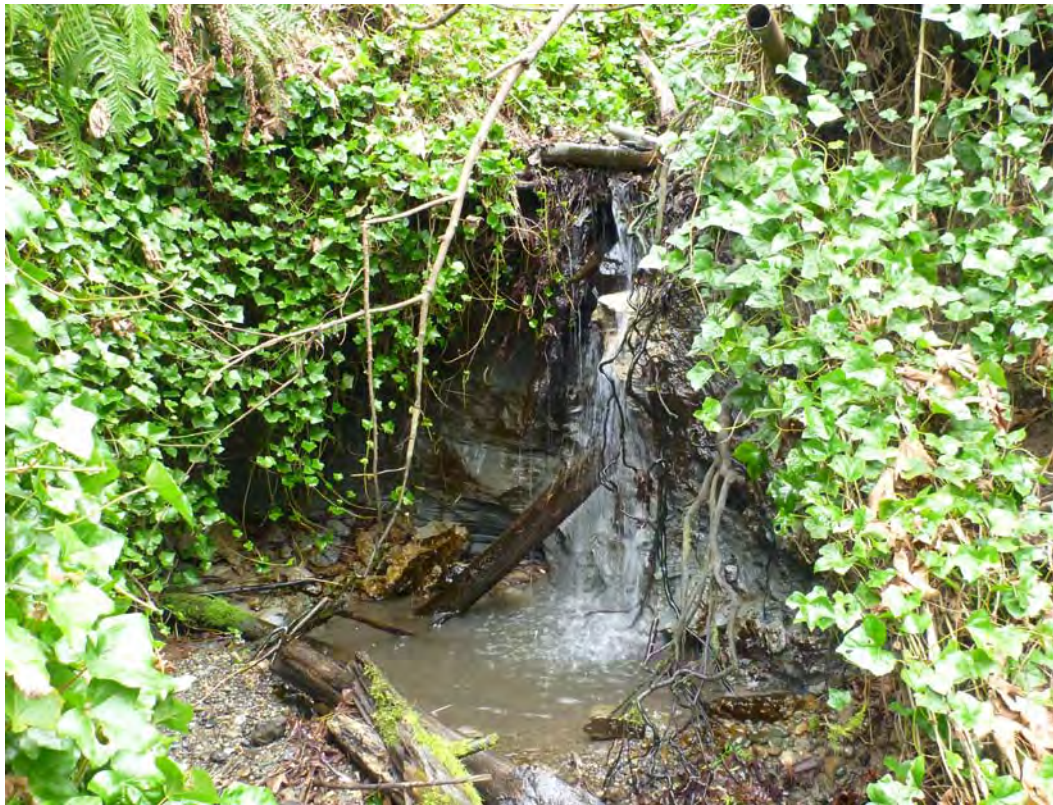
Headcut at Station 2+00 with 10 Foot Drop 3/9/2012

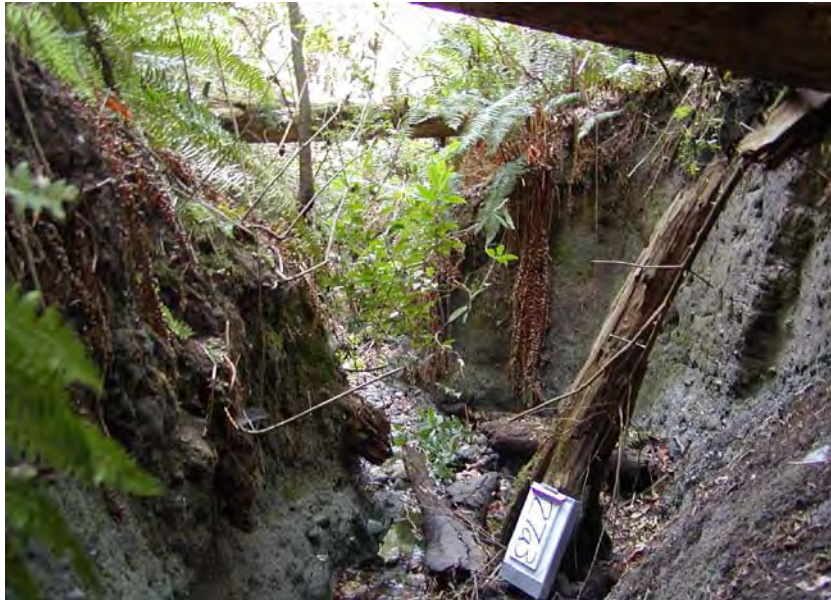
Basin No.:	27a
Project No:	27a.3 (downstream) and 27a.11 (upstream)
Project Title:	100 LF of Channel Restoration and Stream Restoration of Incised Channel East of 82nd Avenue SE and North of West Mercer Way
Problem Description:	<p>In Project 27a.3, a small channel is deeply incised for about 110 feet. The channel has a bottom width of 3 to 4 feet, a depth of 4 to 7 feet and near vertical banks comprised of glacial till. Headcuts of 4 and 5 feet high also occur. The rate of erosion is moderate.</p> <p>In Project 27a.11, 80-100 LF of incised channel with steep 8-10 foot banks is cutting through erodible material: loose silty sand in the top 3 feet overlying moderately dense silty sand. The 6-7 foot headcut has retreated approximately 10 feet since 2010. The right bank has retreated approximately 4 feet and the left bank has eroded back where a tree failed. Minor erosion is also occurring from the culvert below West Mercer Way. See Appendix E for a field sketch of the problem areas.</p>

Project 27a.3: Looking Downstream - 9/28/2006

Project Description:	Project 27a.3: Stream restoration and lay back the top of the banks in undeveloped ravine area. Project 27a.11: Fill channel with rock and recreate water course.
Related Projects	None
Estimated Project Cost:	\$179,000 (2012 revision)

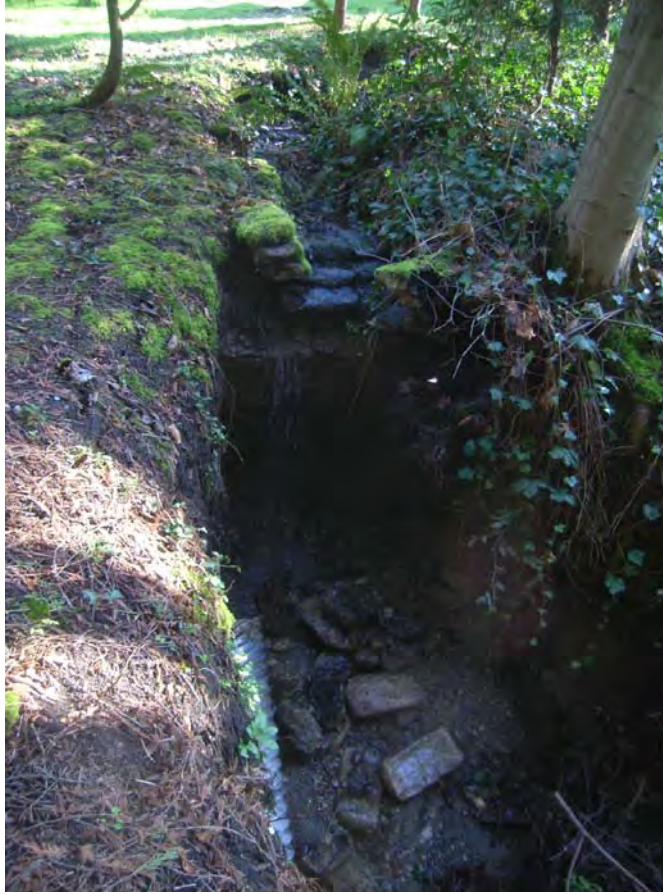
Project 27a.11: Looking Upstream 03/17/2010

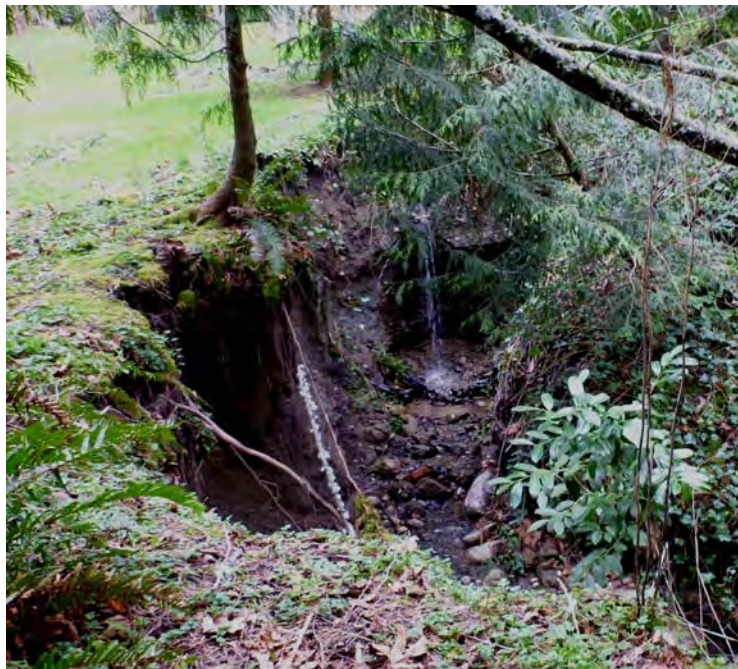
Project 27a.11: Looking Upstream 03/09/2012

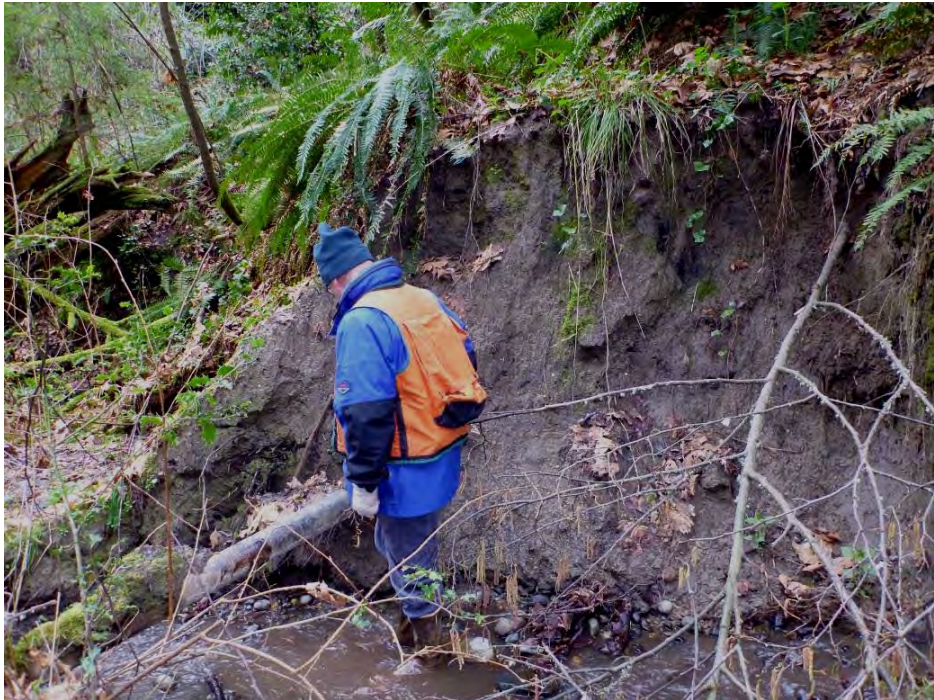
Downstream end of eroding right bank, 7 feet high and 50 feet long, with undercut and separated pipe directly in front of engineer 03/09/2012.

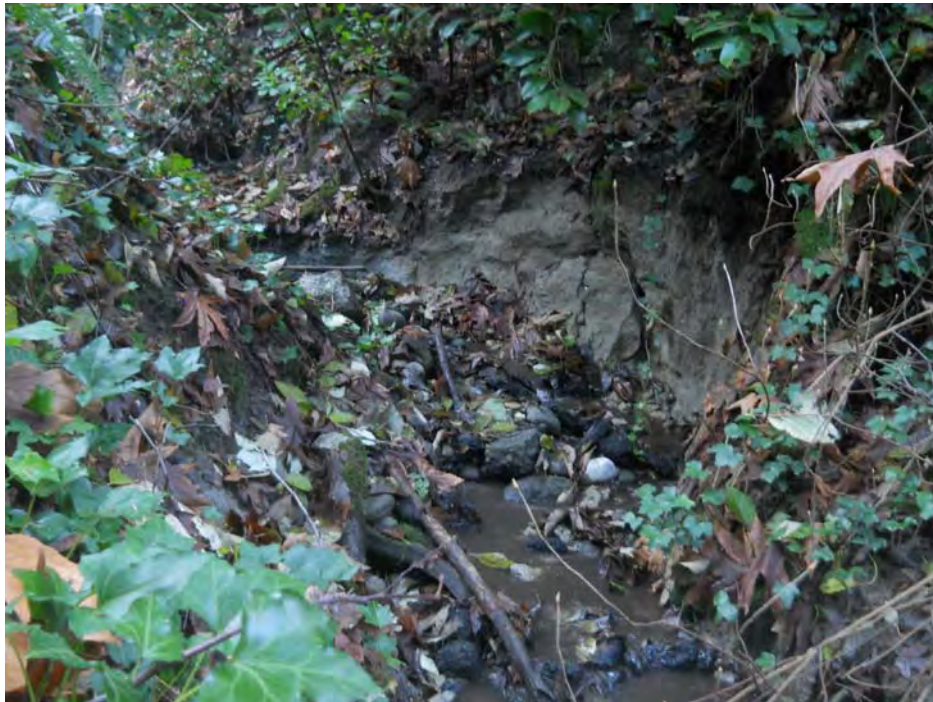
Looking Upstream at Recent Bank Erosion 12/22/2011

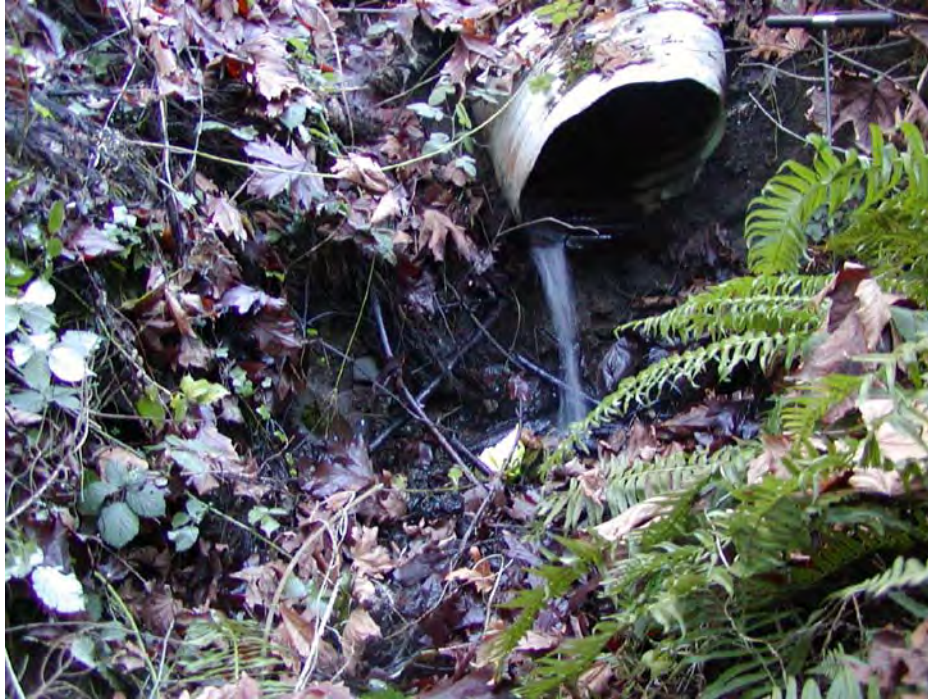
Erosion at Pipe Outlet (pipe crushed) 12/8/2005

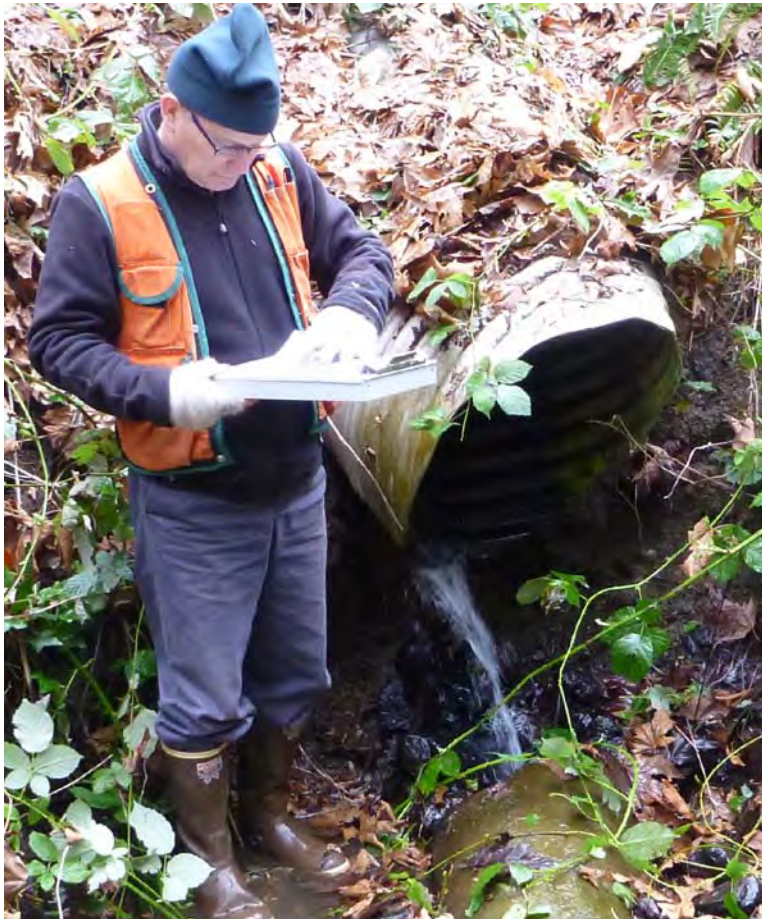
Erosion at Pipe Outlet, same location as above 03/09/2012

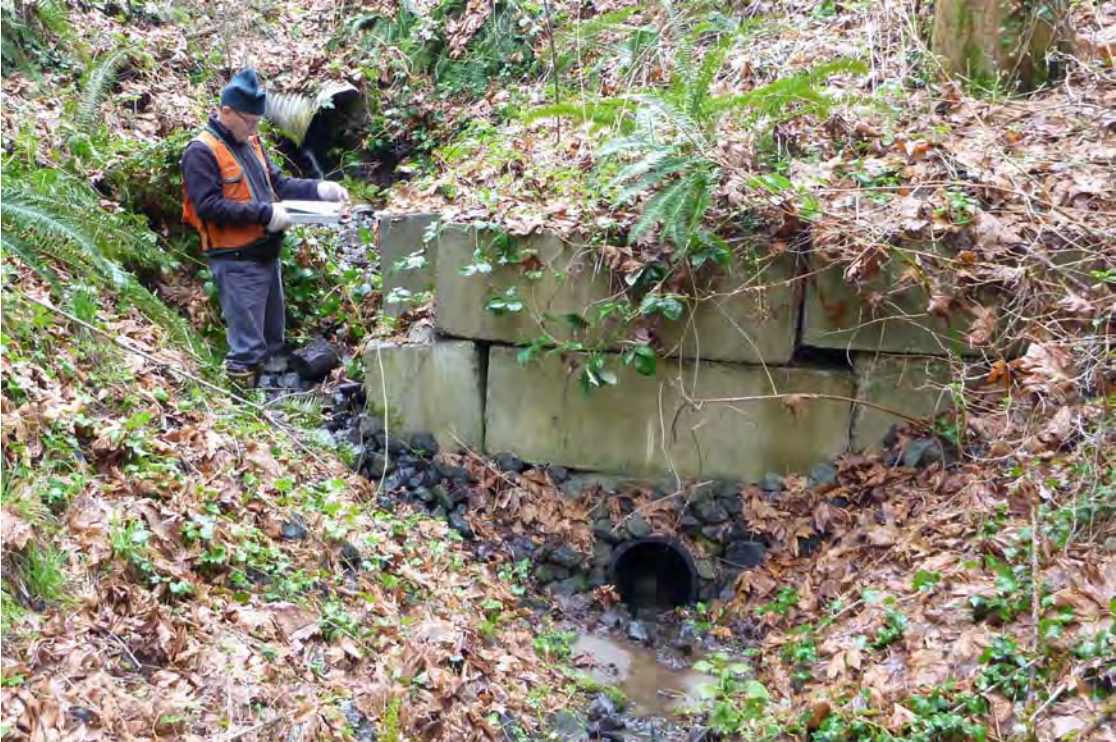
Looking toward East Mercer Way with outfall from road at upper left and culvert draining slope behind camera 03/09/2012

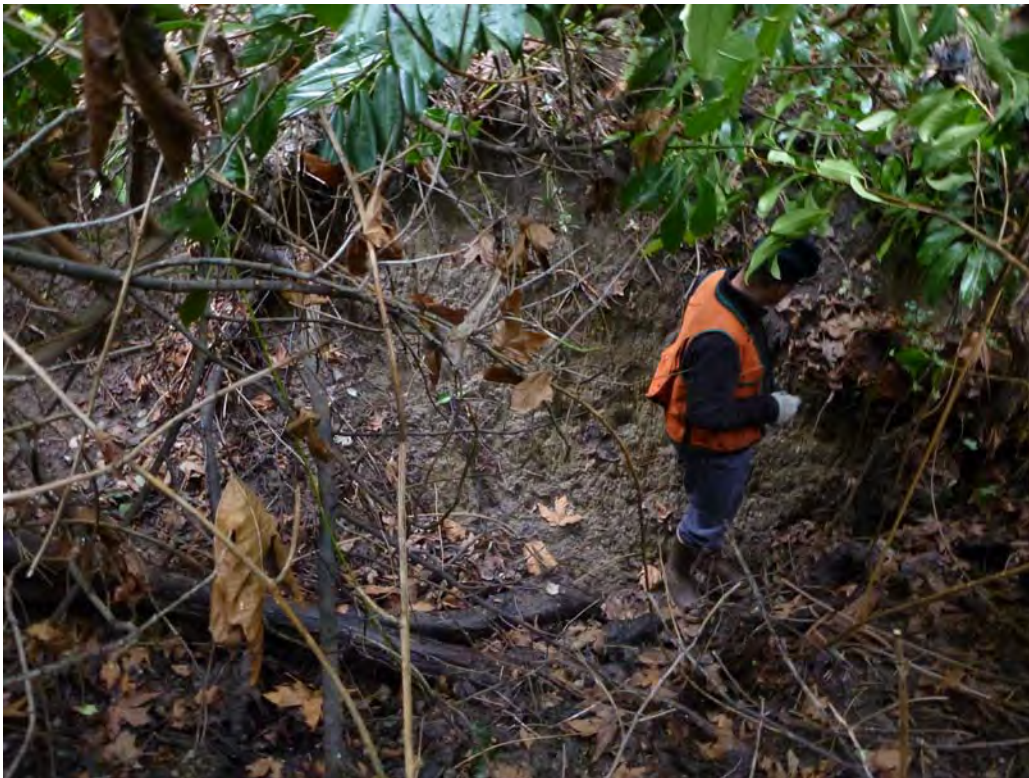
Steep Silty Sand 8' High Banks from Right Bank 3/9/2012

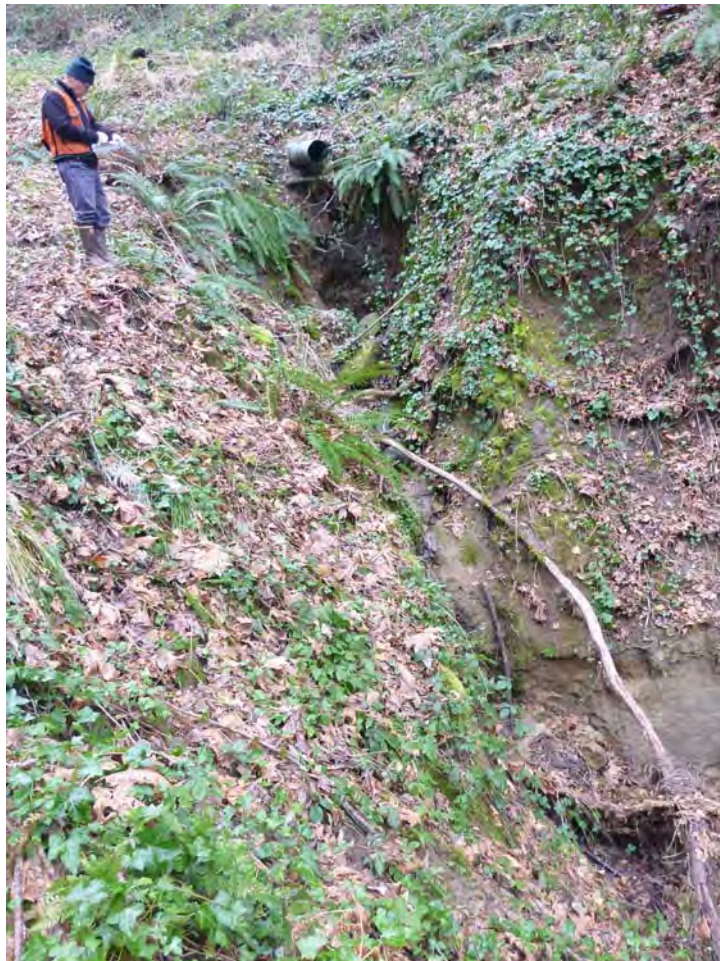
Basin No.:	49b
Project No:	49b.4
Project Title:	Butt-fused HDPE Pipeline on Stream Stabilization East of 91st Avenue SE in 4700 Block
Problem Description:	Large scale, severe erosion of 1,000 CY at an existing 12-inch storm drainage outlet in 47 th Open Space near a primitive trail. The outlet drops 8 feet at invert into a steep channel in semi-consolidated sandy silt. Channel incision is about 100 feet long and the depth varies from 5 to 25 feet. Slope material above 5 feet is loose colluvium. This site is likely not a natural watercourse, but developed from erosion of storm water drainage. Change since 2005 has been slow to moderate. The steep channel gradient creates high risk of long-term erosion and downcutting. See Appendix E for a field sketch of the problem area.
Project Description:	Two alternatives are considered for this problem. The first is to install 12-inch-diameter HDPE pipeline with manhole energy dissipator at the downstream end. Under this alternative it may be desirable to fill the erosion scar. The second alternative is stream stabilization through reconstruction of 100 feet of channel. It is recommended the City get input from WDFW prior to selecting the preferred alternative. The cost estimate is based on the HDPE pipeline alternative.

Looking Upstream at Total 25' Vertical Drop 03/09/2012
