COMPREHENSIVE BASIN REVIEW AND WATERCOURSE MONITORING

VOLUME I – MAIN REPORT

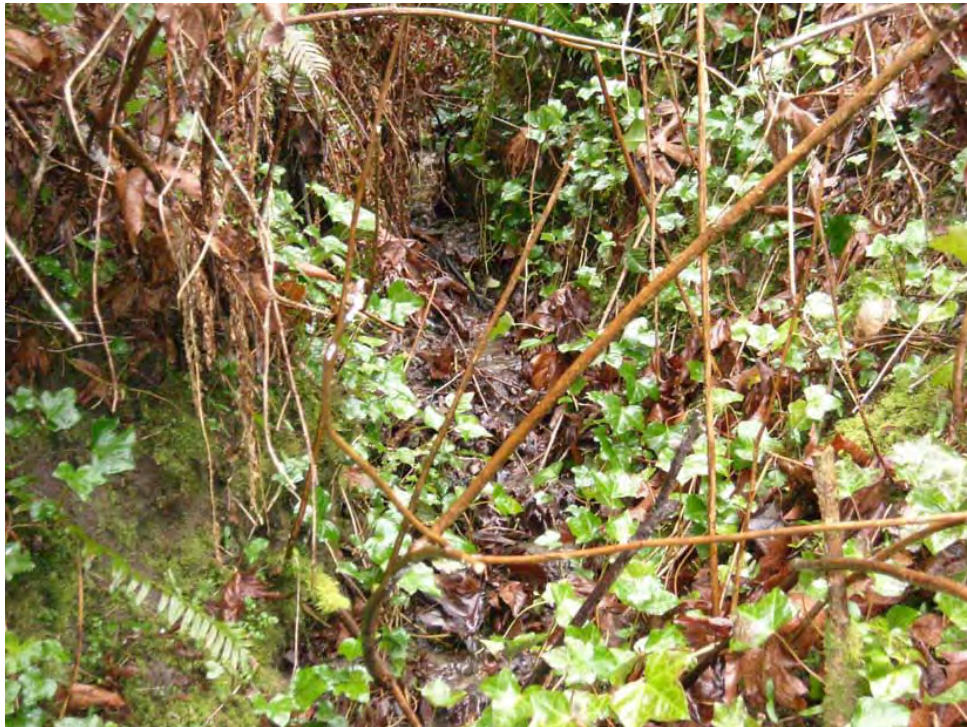
Project 4.4: Looking Upstream 3/13/2008

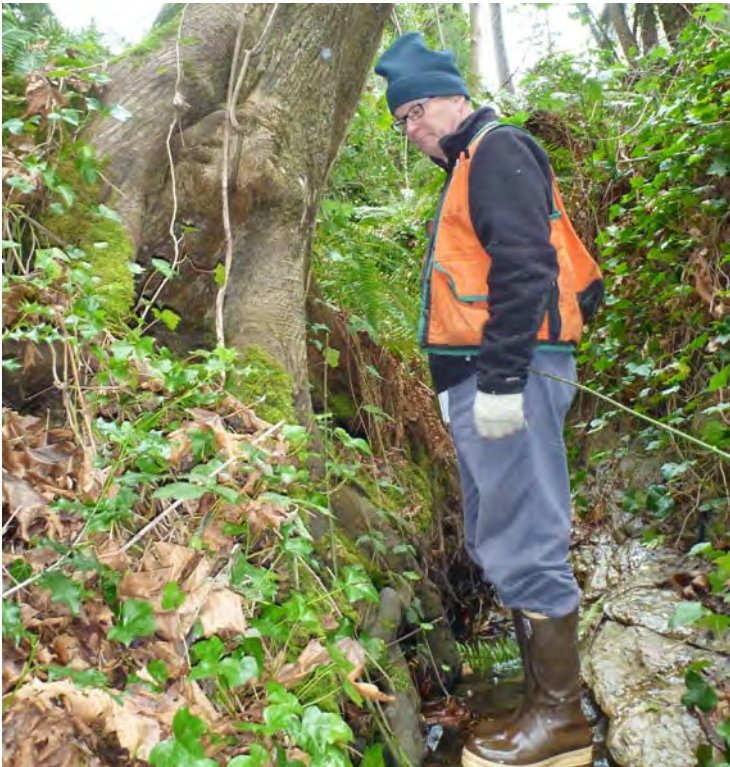
2 Foot DBH Maple on Right Bank 03/9/2012

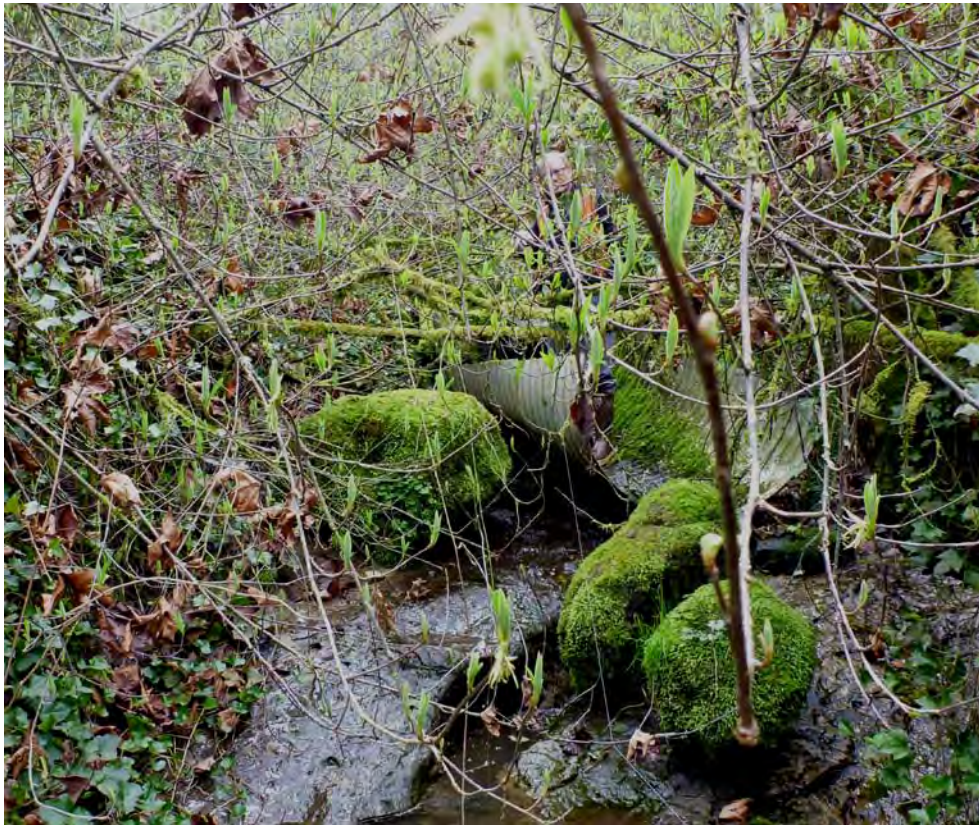
Looking upstream at previous photo (32b.1) 03/09/2012

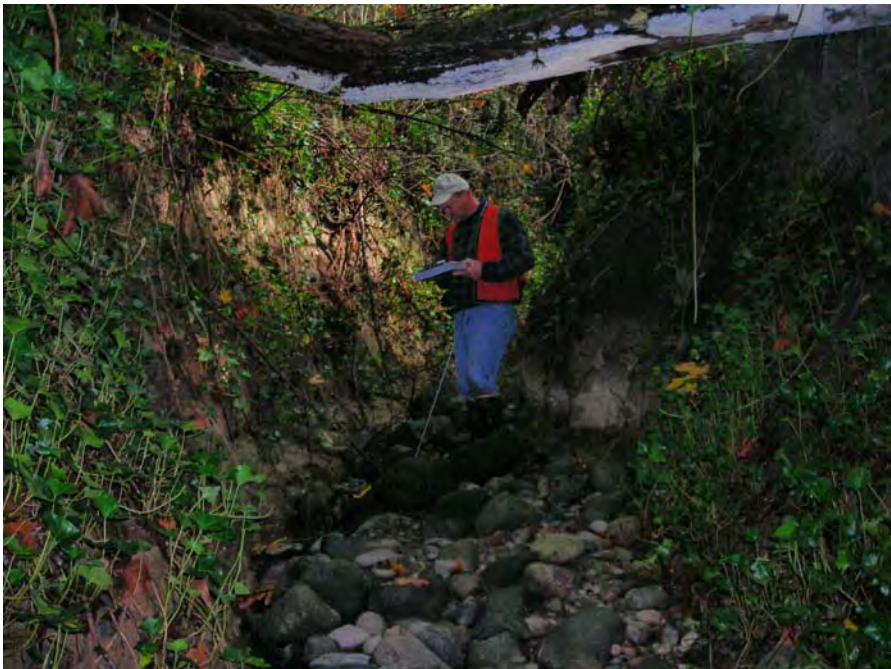
Looking Upstream (32b.2) 10/20/2006

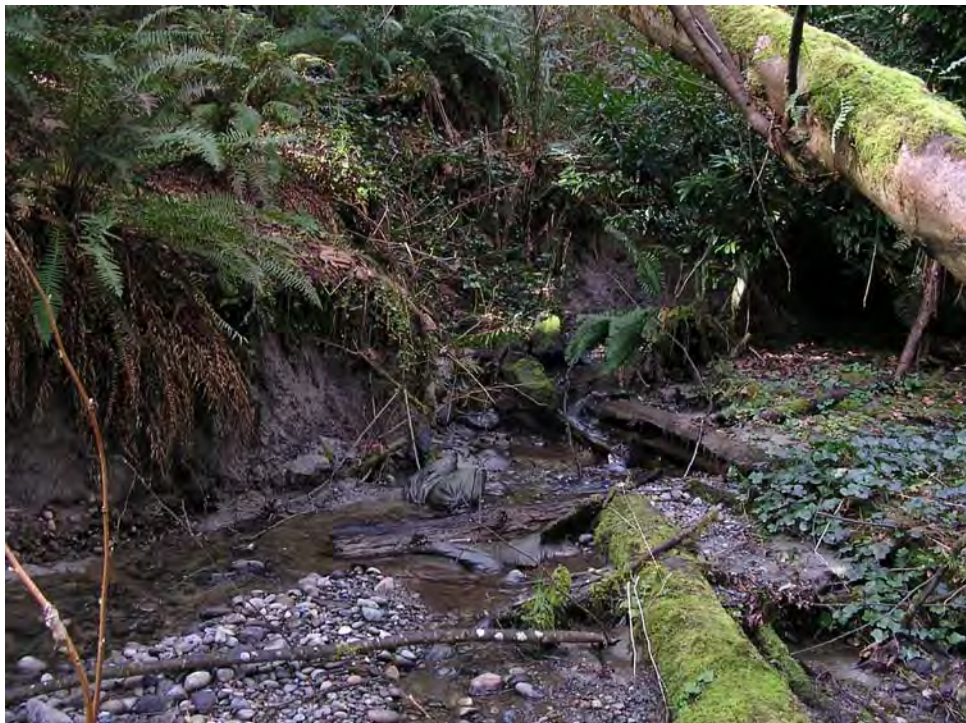
Looking Upstream 3/3/2006

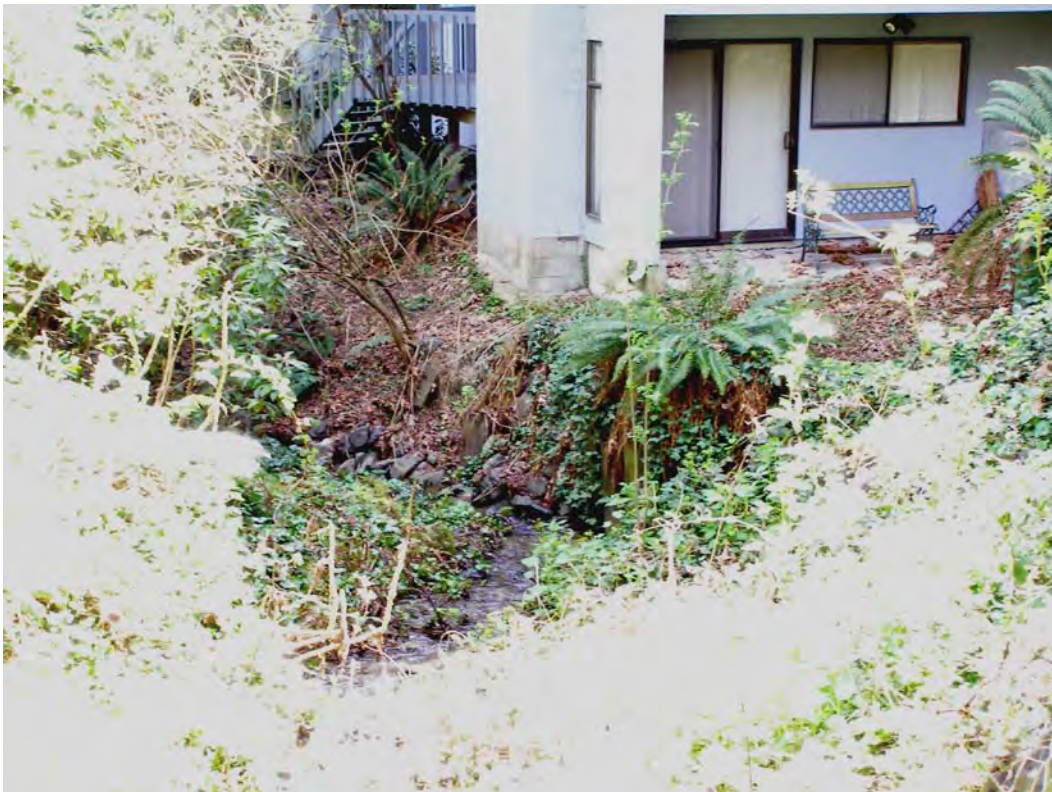
Looking Downstream at Residence 3/31/2008

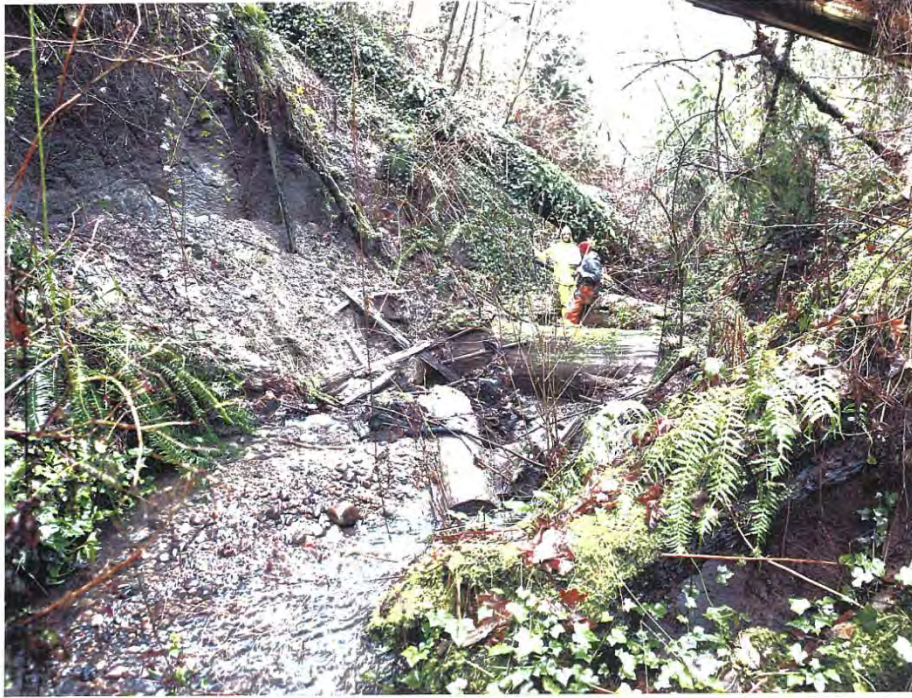
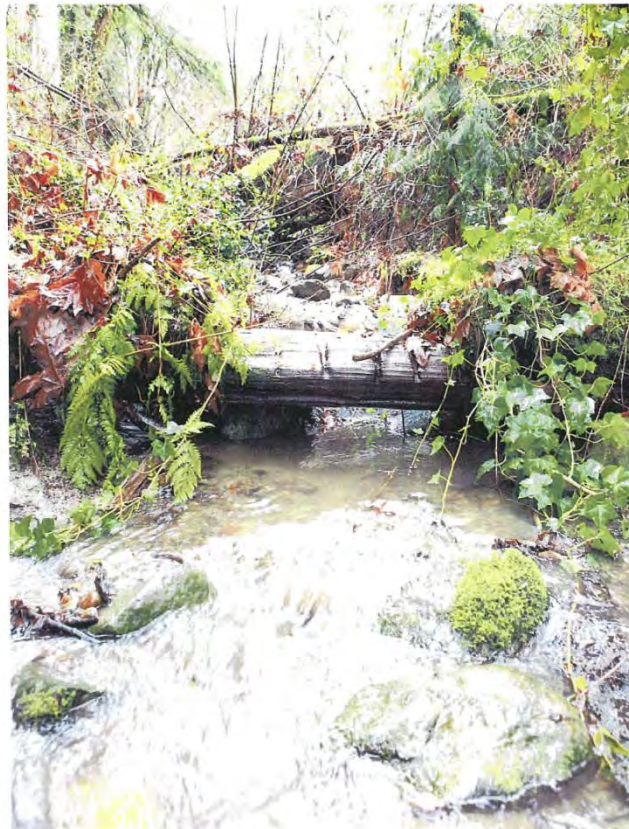
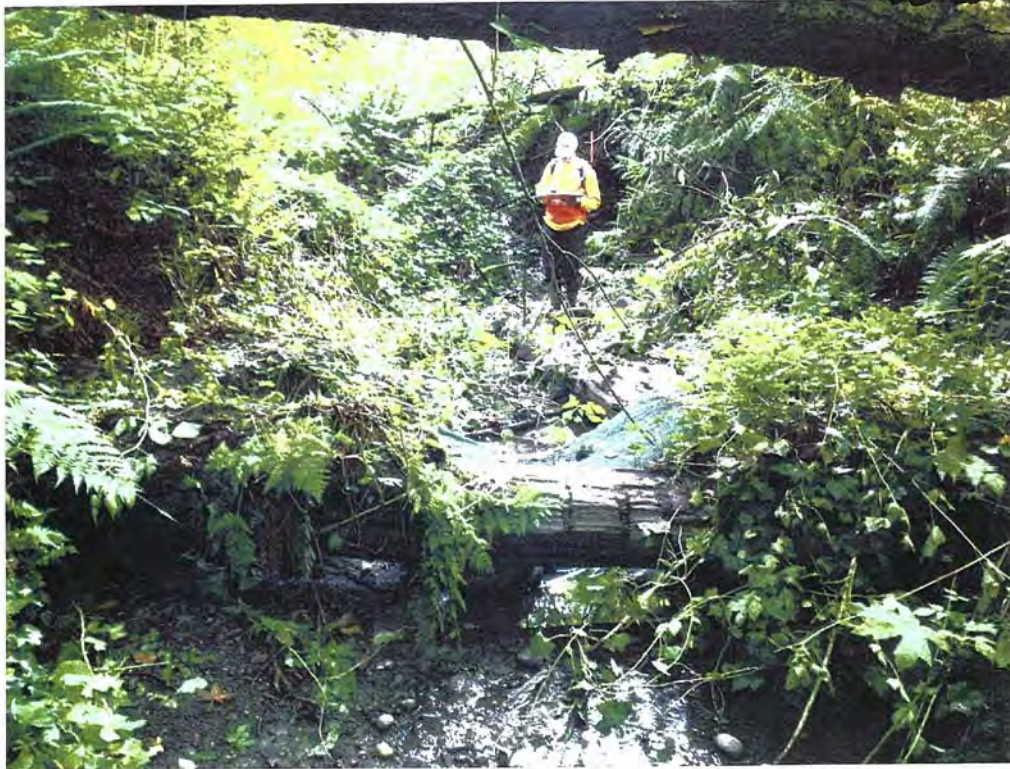
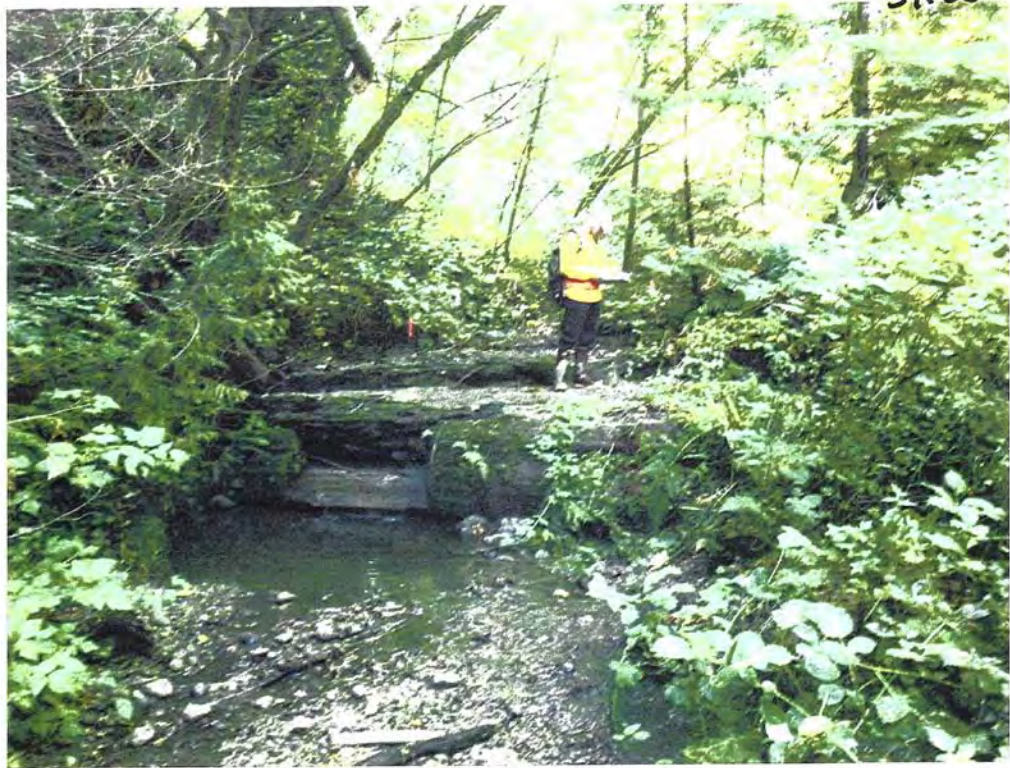
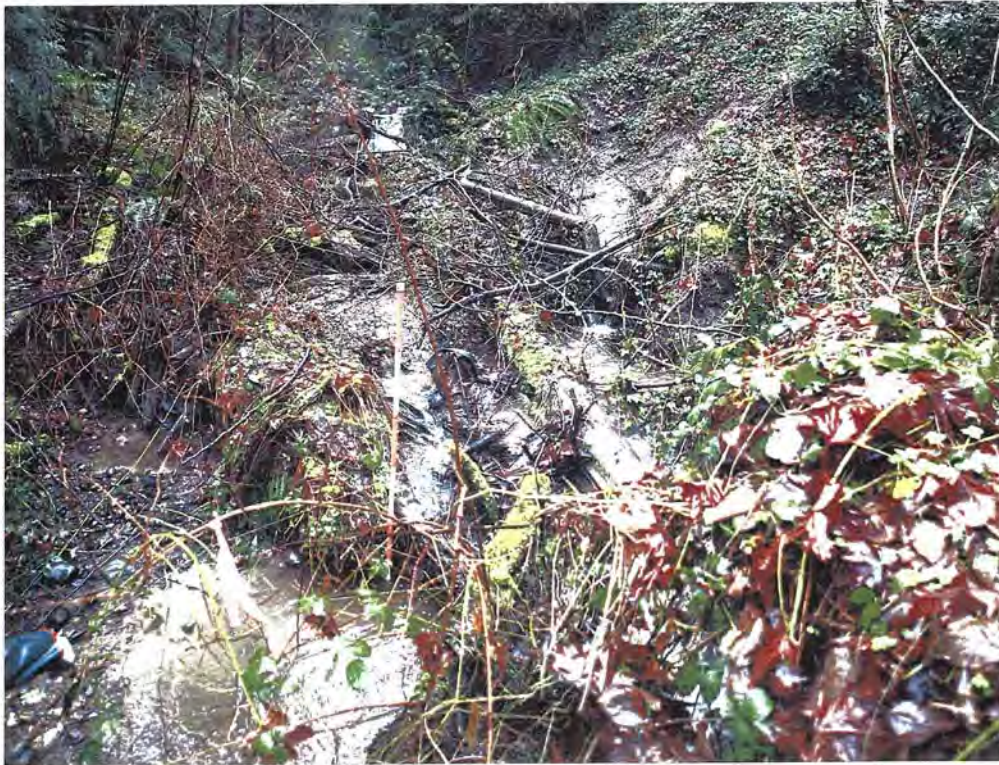
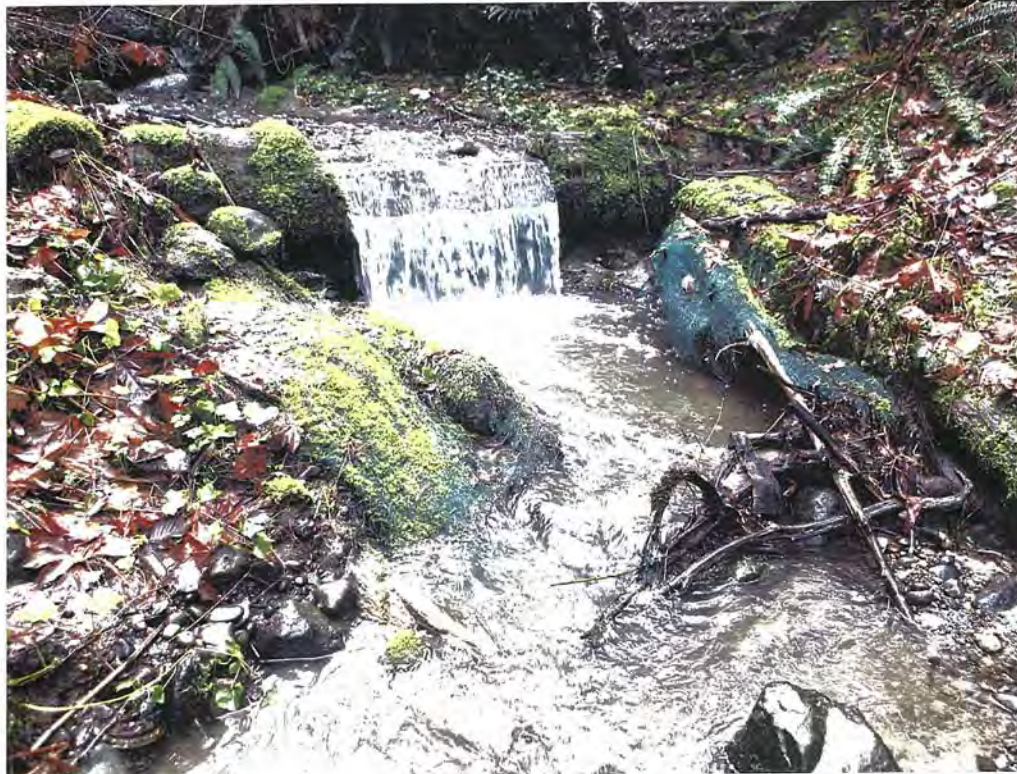
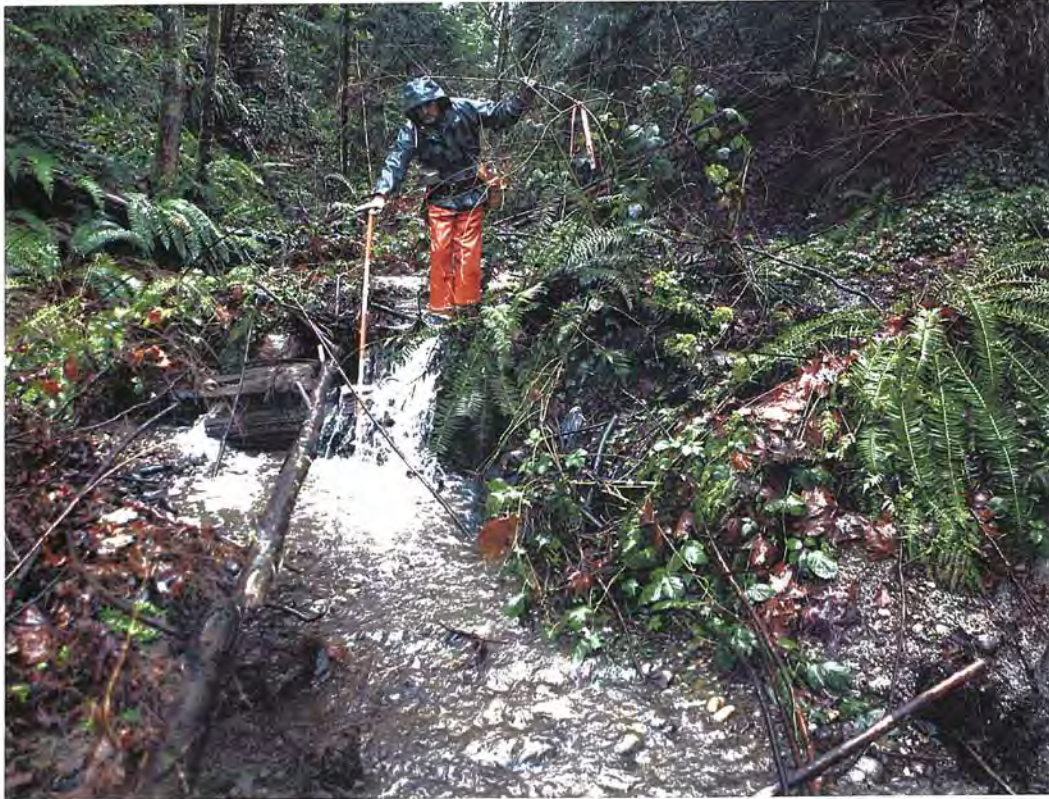
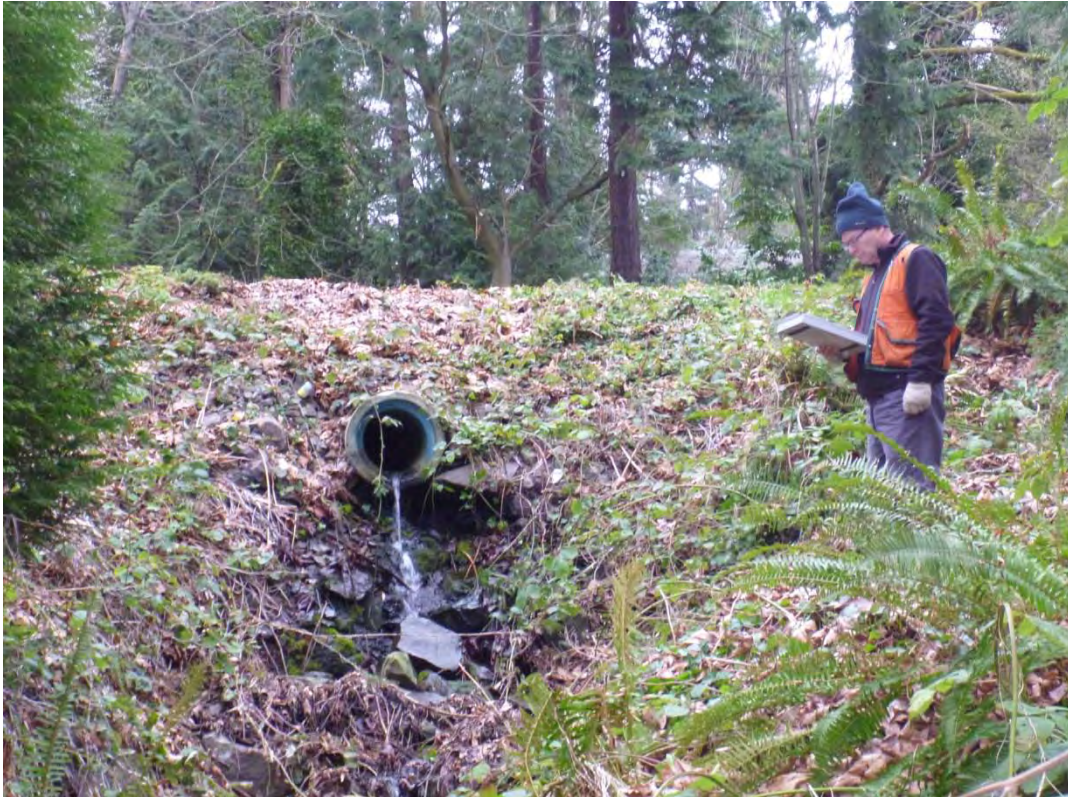
Problem 6.4/6.5

Project 6.5: Failed Log Weir Station 33+20 2/15/2011

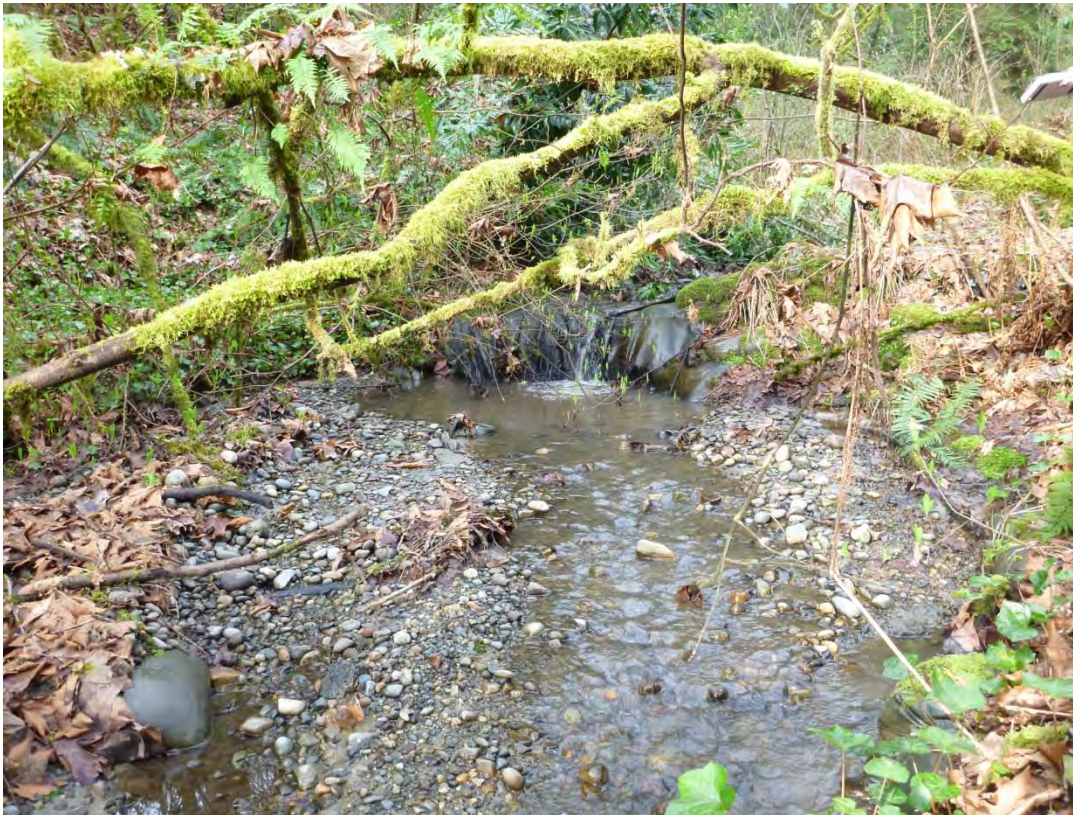
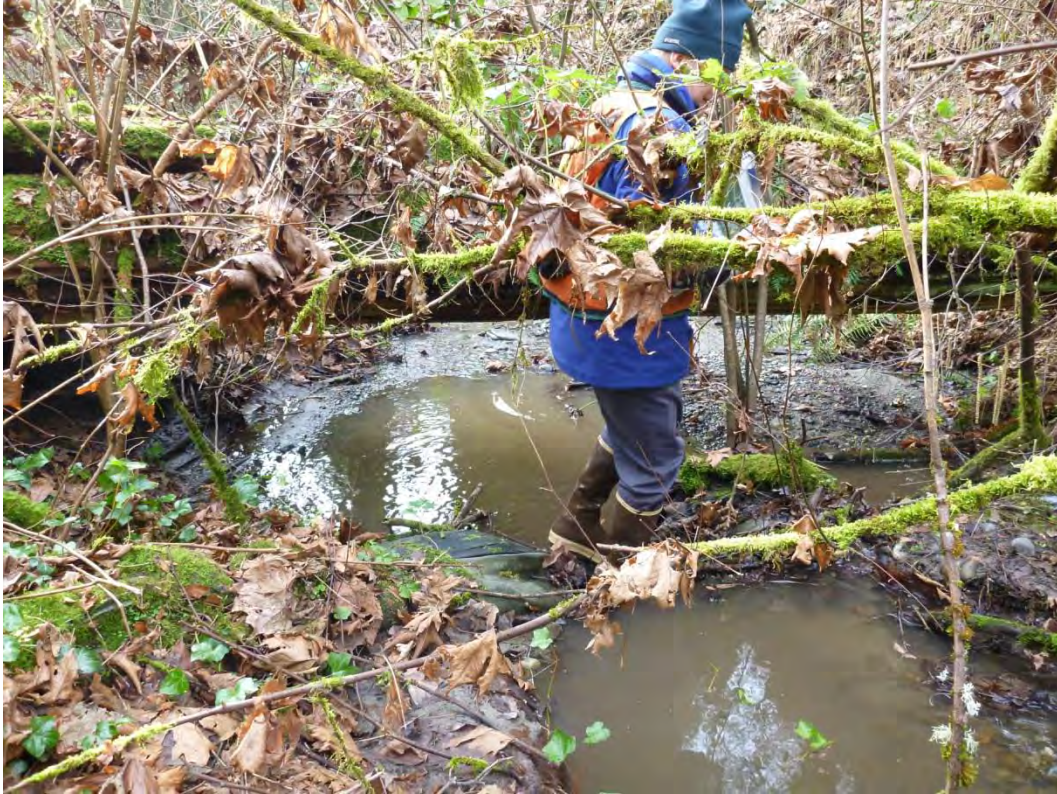
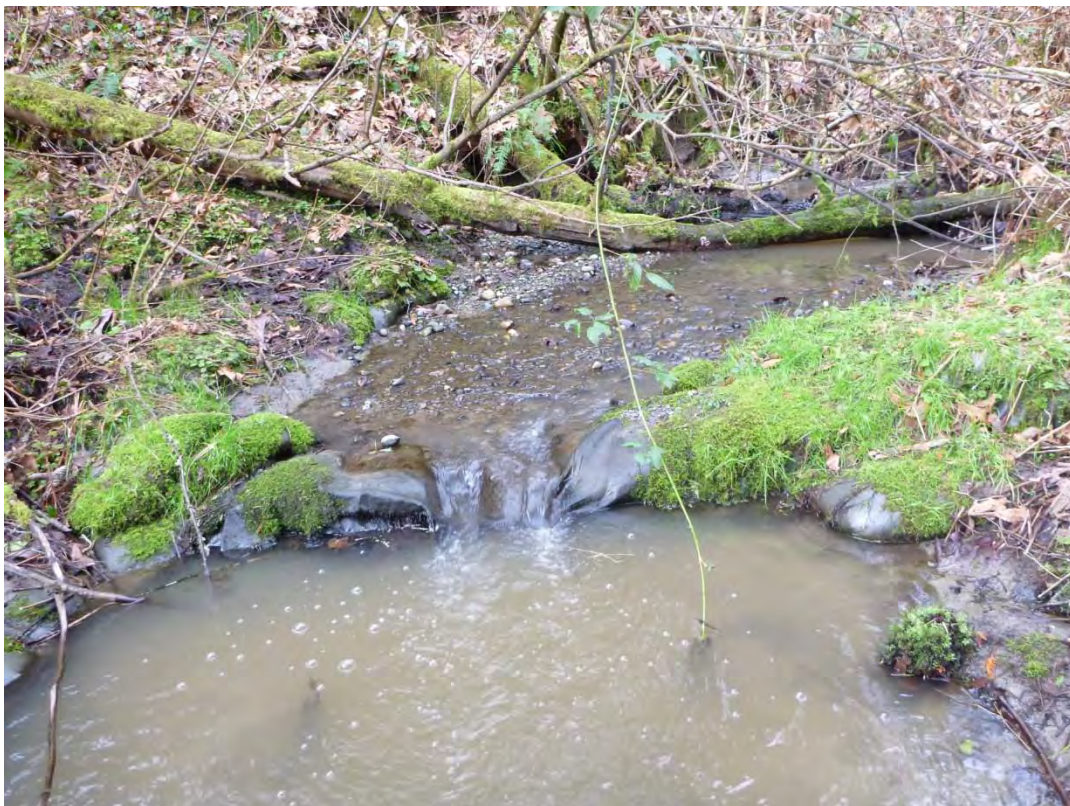
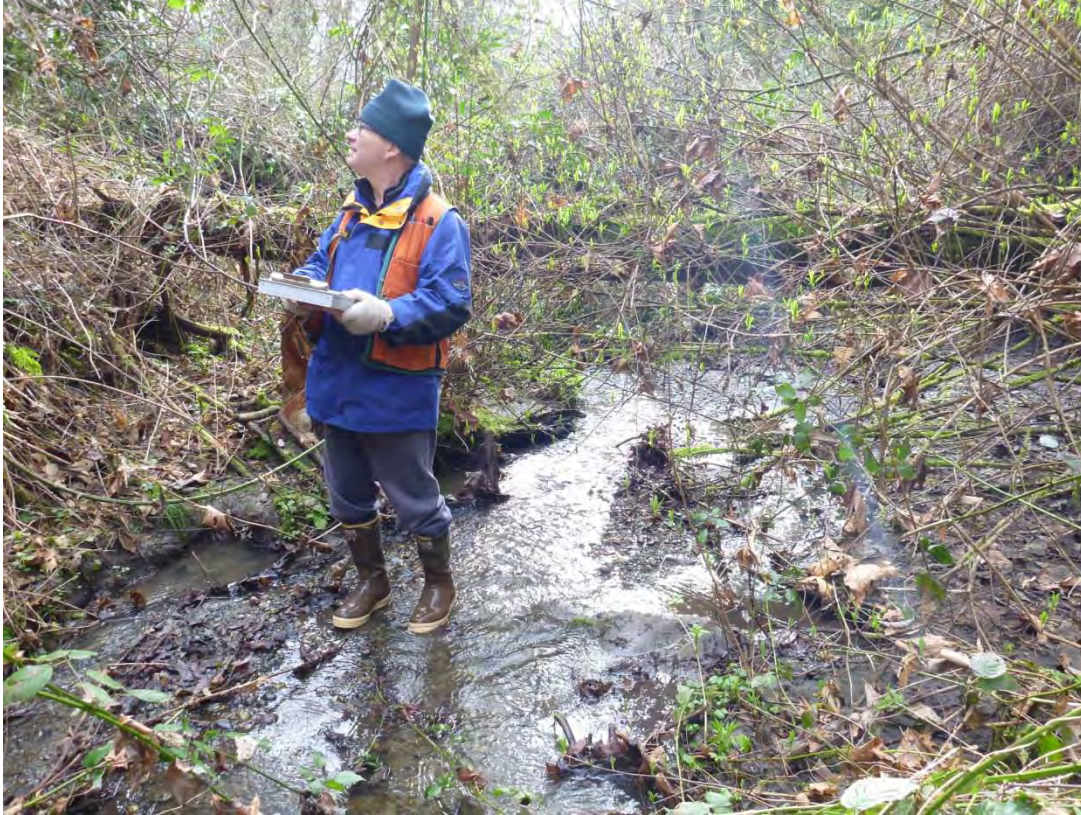
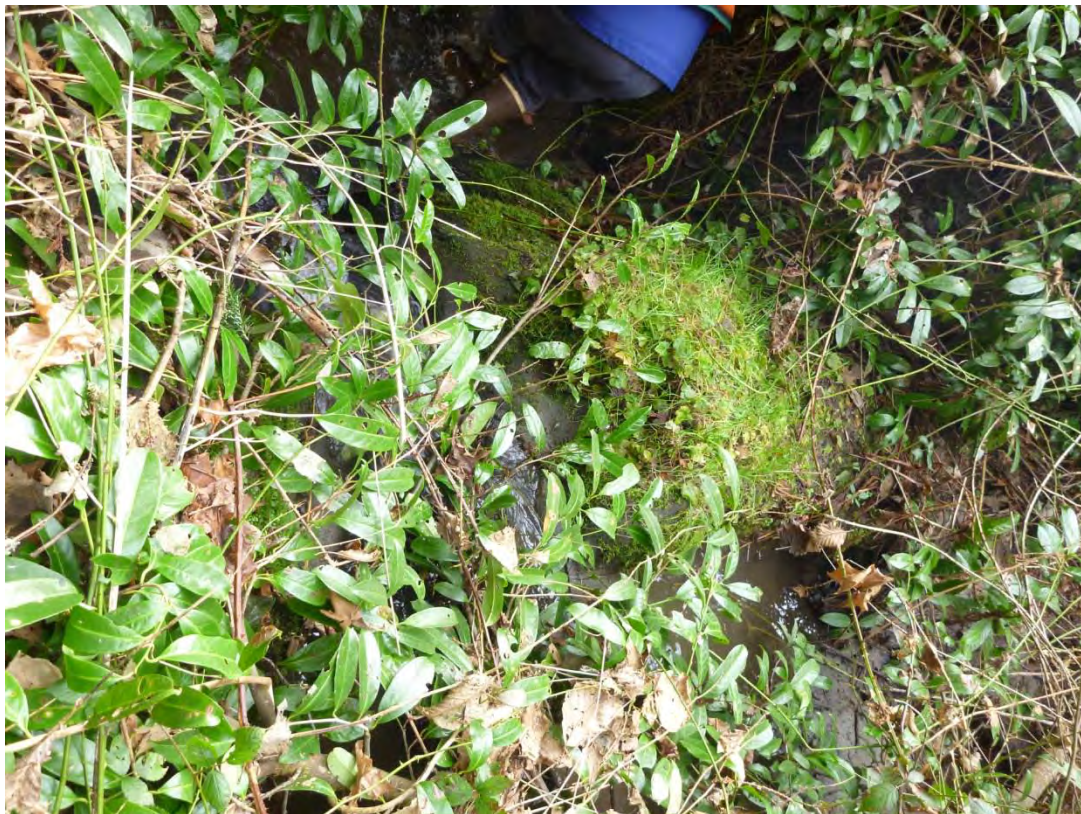
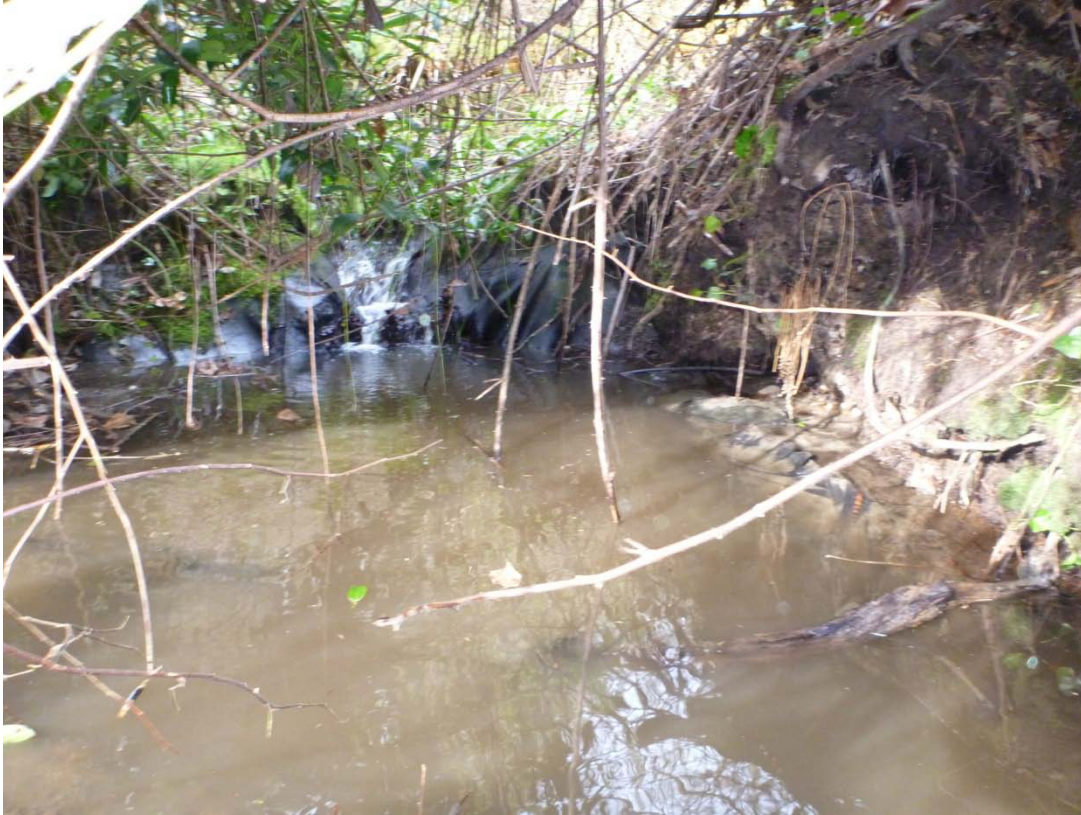
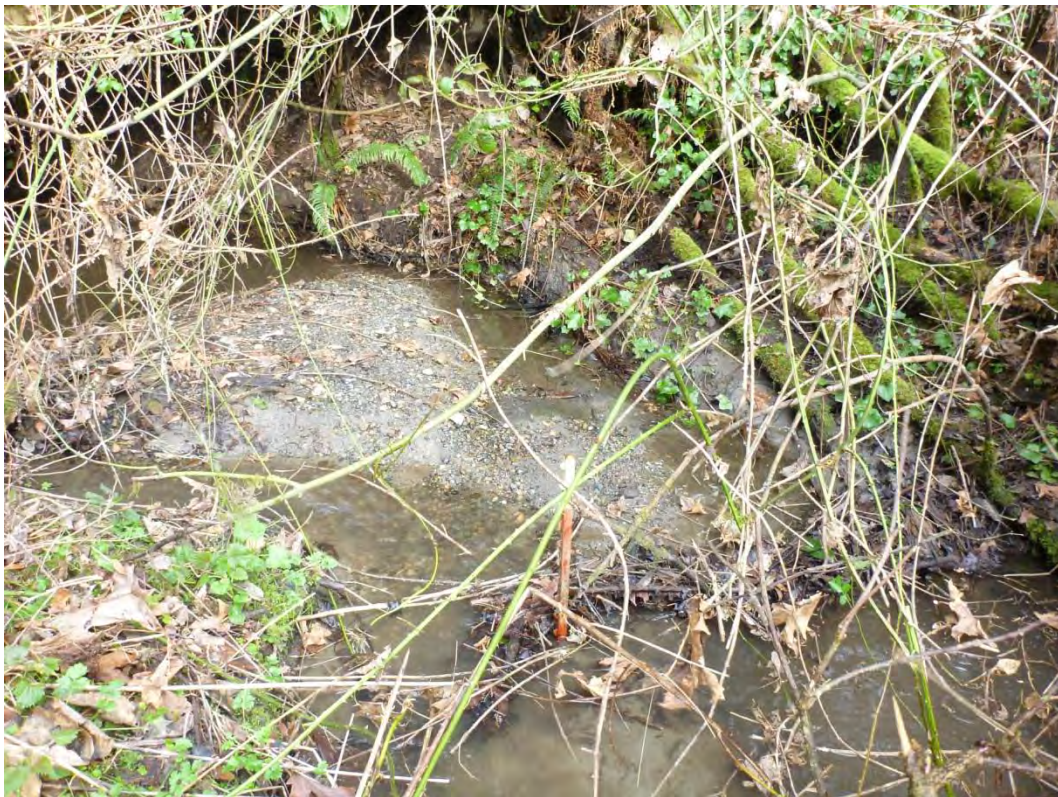
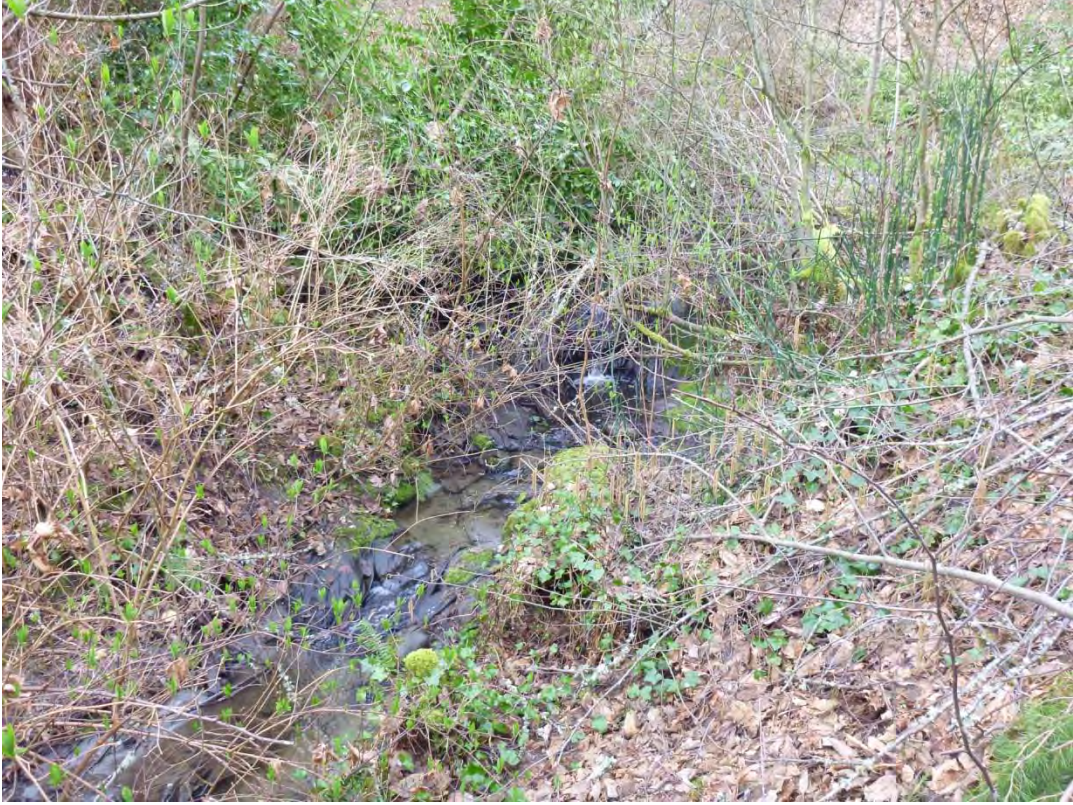
Problem 42.1/42.1A

Basin No.:	42
Project No:	42.1a (upstream) and 42.1 (downstream)
Project Title:	Install Large Woody Debris for Bank Protection and Stream Restoration Along 95 LF of Bank and Replace 3 Failing Sandbag Check Dams with Rock Check Dams or Rock Vortex Weirs Where Failure Poses a Risk.
Problem Description:	<p>About 14 sandbag and geotextile check dams were installed at 20 to 100 feet intervals as temporary protection of these reaches. The dams are up to 4 feet high and most are beginning to fail. While there is a large amount of fine grained sand behind the dams and in the channel, in some cases the failure will not increase the risk of erosion. On the downstream end of the reach (Project 42.1), a 30 foot long sandbag check dam with a 4 foot drop and 1.5 foot plunge pool is showing failure with erosion on both banks into blue-grey silt overlain with 2 feet of soils. Failure of this structure would release a large amount of fine sediment. Another check dam in the downstream end with a 2 foot drop and 3 foot plunge pool may fail by undercutting.</p> <p>Bank erosion is also occurring in several locations. One eroding bank of loose soils on the right bank measures 8 feet high and 30 feet long; another measures 4 to 5 feet high and 15 feet long, and another 50 feet of 7 foot high bank is eroding. In addition, a 2 to 3 foot high debris jam at the upstream end of the reach (Project 42.1a) could fail. The south bank appears to be slide material and much of the riparian area would be considered wetlands. Not mapped by the Watershed Company as having potential fish use. See Appendix E for a field sketch of the problem area.</p>

Project Description:	Replace failing sandbag check dams that pose a risk to increase erosion with rock check dams or rock vortex weirs. Check dams are less expensive but rock vortex weirs may be needed to provide fish passage. Also provide bank protection and stream restoration along about 95 feet of bank. Stream restoration would include logs/large woody debris, boulders, bank regrading and planting.
Related Projects	None
Estimated Project Cost:	\$284,000 (2012 revision)

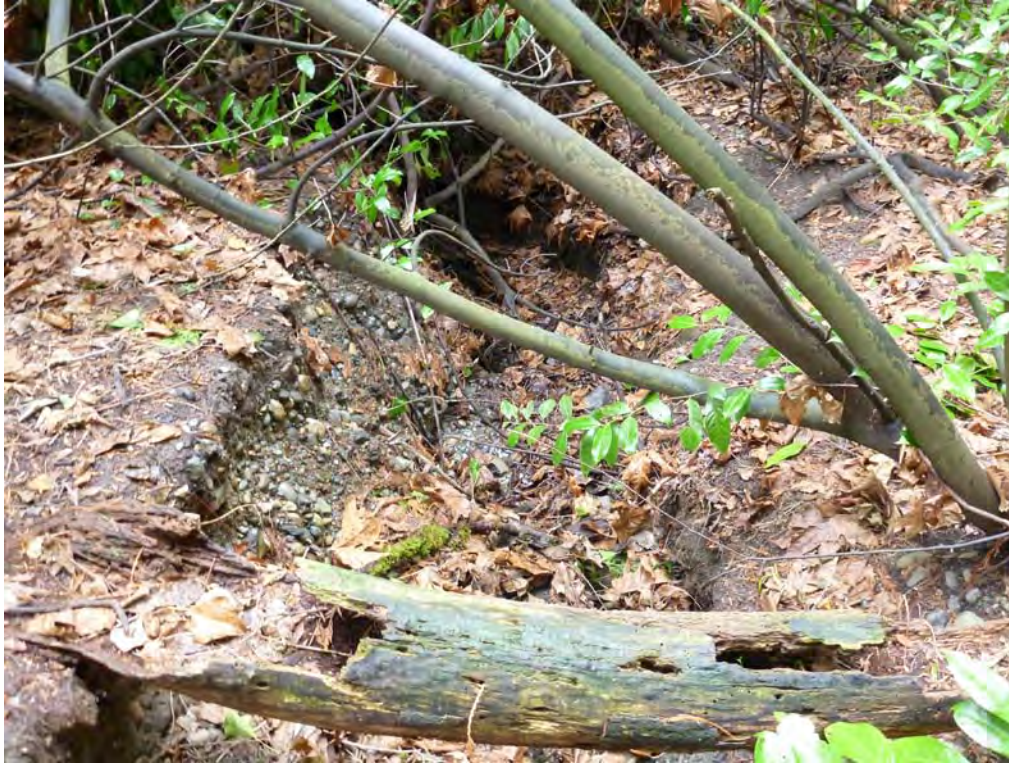
Looking Downstream at Poorly Sorted, Unconsolidated Sand to Very Coarse Gravel 3/9/2012
