COMPREHENSIVE BASIN REVIEW AND WATERCOURSE MONITORING

VOLUME I – MAIN REPORT

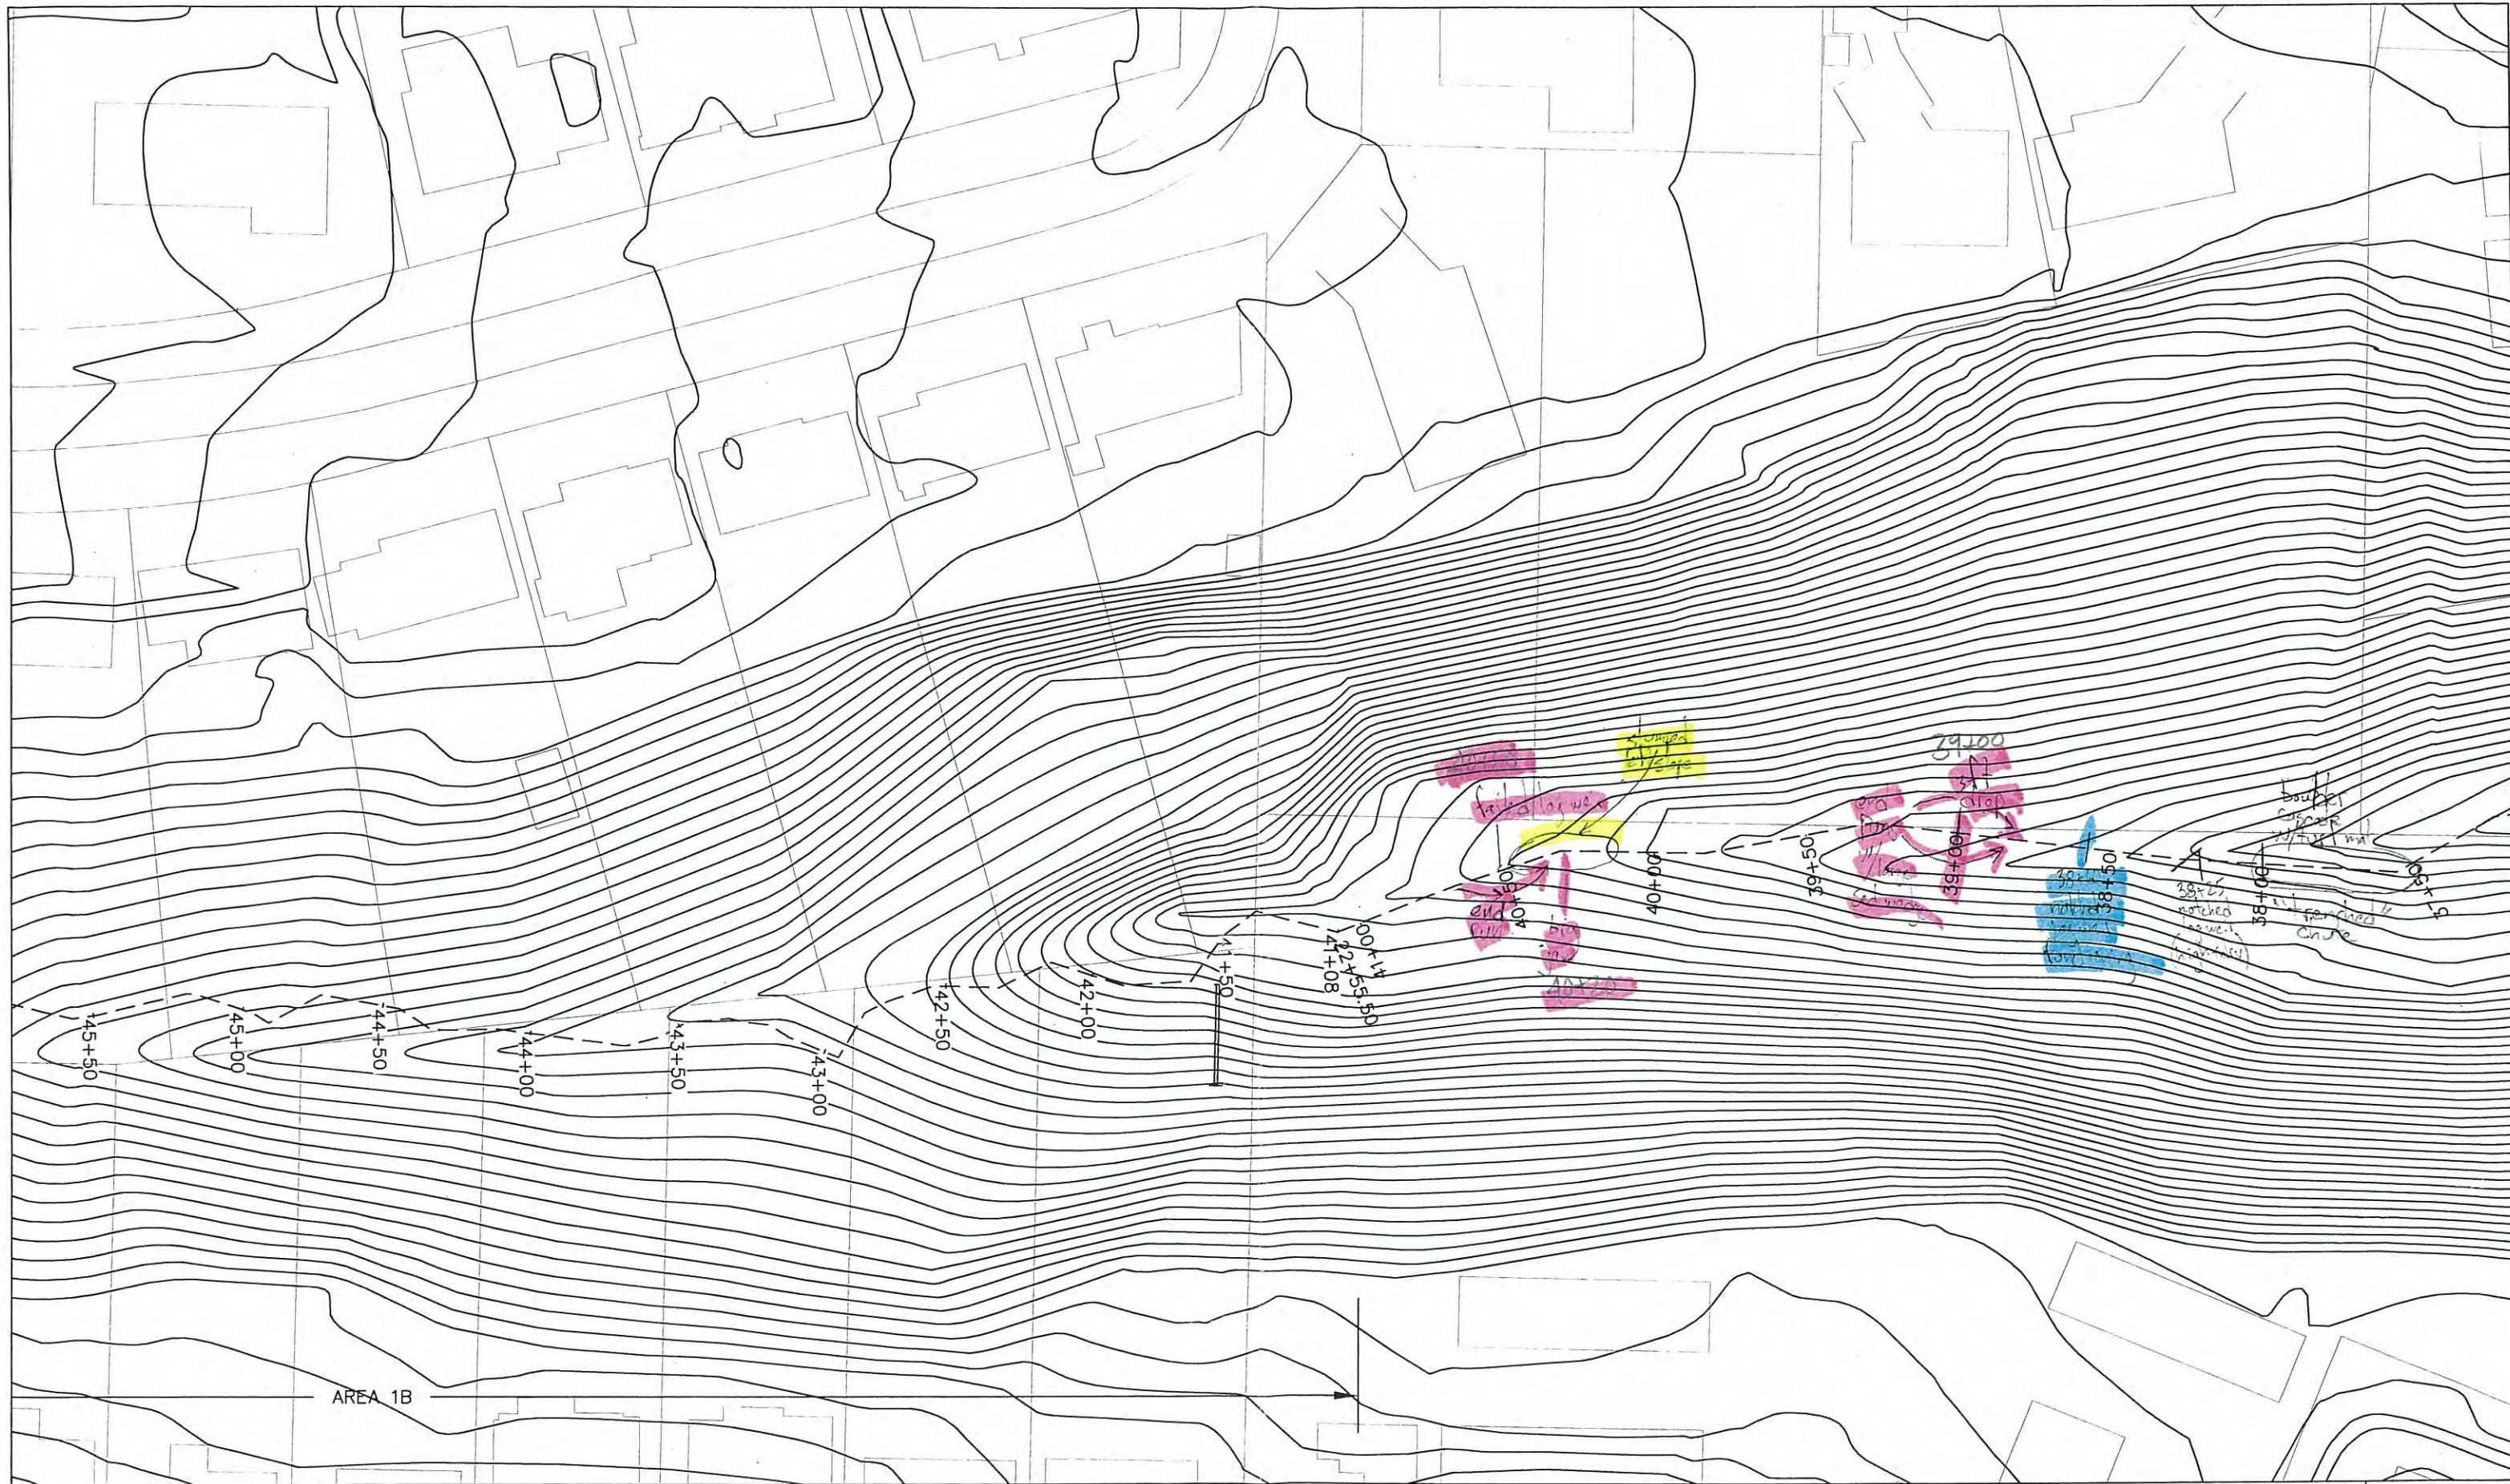
No.	STA	Field Notes	Recommended Fix
1	2450	Failing vertical slope LB. Sand/gravel. 40ft long, 10ft tall. Incised channel 2ft, cobble/gravel. Aspect STA 25+00	
2	2700	Failed log weir, 3ft drop. Massive failed slope LB, 40ft long, 20ft tall. Large (3ft-6ft DBH) trees. Above slope (5-maple, fir, cedar (3)). Incised channel 5ft deep downstream of weir. End-run LB - likely triggered toe failure of LB.	
3	2775	Functioning log weir, but continued drop scour could undermine.	Place boulders/cobble in plunge pool to reduce/eliminate scour
4	2830	Eroding LB, 6-10ft vertical sand/clay.	Place toe boulders and/or catch/fill structure
5	2875	Log weir, 3ft drop. End-run LB. Functioning, but potentially soon to fail. End-run RB.	
6	2920	Functioning log weir, but continued drop scour could undermine.	Place boulders/cobble in plunge pool to reduce/eliminate scour
7	2980	Recently/barely failed log weir - continued "jet" scour will further undermine.	Plug undermined area w/additional logs/rock. Place boulders/cobble in plunge pool to reduce/eliminate scour.

8	3060	Massive failed slope LB, 40ft long, 20ft tall. Multiple downed trees.	
9	3120	Template jam. In-channel, 3ft drop, stable.	
10	3170	Failing RB 40ft long - center. Failed weir, 3ft drop, scour behind RB toe logs for 10ft.	
11	3200	Template jam. In-channel, small drop, holding back 4ft of sediment.	
12	3275	Destabilized bank logs. Incised channel 3ft. Vertical clay bank. Aspect flag 18+00.	
13	3320	Failed log weir. Incised 4ft. In-channel jam at 33+30. Stabilized 2ft of upstream fill. Failed DS bank log along RB. SD incised channel 3ft. Bank log LB, RB US. Vertical US LB w/bank log at toe - appears stable.	Stabilize in-channel jam at 33+30 to make into catch/fill structure.
14	3400	1ft drop in bed over historic bed log. Aspect flag 17+00.	Place boulders/cobble in plunge pool to reduce/eliminate scour
15	3420	Log weir 2ft drop. Large sand bar upstream. Stable (generally). May underscour at weir north. In-channel downstream logs providing down-channel stability for 80% of weir.	Place boulders/cobble in plunge pool to reduce/eliminate scour

16	3500	Failed log wier. Double-notched. Channel incising 3ft-4ft upstream to 35+20 and downstream to 34+00 and beyond. Storm drain (10-inch) at upstream side of weir. 4-man rock US. Minor end-run along RB. Active slumping LB.	
17	3520	In-channel jam. 3ft drop. Some destabilizing on LB.	Stabilize jam - reinforce left bank to prevent continued destabilization.
18	3560	Log weir. Less than 1ft drop. End-run along LB.	Place boulders/cobble in plunge pool to reduce/eliminate scour. Stabilize end-run along LB.
19	3580	LB steep shoulder (?) and vertical clay face.	Place layers of large boulders at toe of left bank to minimize toe scour.
20	3650	Failing log weir. 4ft drop. Upstream double bank logs. Proceeding for 50ft.	Place boulders/cobble in plunge pool to reduce/eliminate scour. Place similar to rock bed control structure, but at surface to gradually step (4H:1V) from log weir to streambed.
21	3675	Destabilized rock stop, 1.5ft drop. Bank logs both sides.	Build up rock stop at end of bank/toe logs and use area between bank/toe logs as catch/fill structure.

22	3700	LB slide area (Aspect flag). Bank logs both sides. Channel downcut as much as 2ft.	
23	3725	Bottom of 75ft long cascade/trench/chute. Clay bottom. Incised but fairly stable. Bank logs perched 3ft above streambed along RB.	Supplement with additional large boulders to dissipate energy and fill-in undercut banks. ?Possibly remove unsightly green geotextile fabric?
24	3860	Log weir. Stable. Top of cascade.	Reinforce log weir/jam. Place boulders/cobble in plunge pool to reduce/eliminate scour. Stabilize end-run along LB and RB.
25	3900	Failing log weir. 4ft drop. End-run on RB and LB. 30ft sediment wedge.	Reinforce log weir/jam. Place boulders/cobble in plunge pool to reduce/eliminate scour. Stabilize end-run along LB and RB.
26	4020	Bottom end of section. Failed log step and bank log. 4ft drop. Slump LB 20ft.	
27	4050	Failing log step. End-run RB. 4ft drop.	Place boulders/cobble in plunge pool to reduce/eliminate scour. Stabilize end-run along RB.

TRANSPORT MATERIALS BY WAY OF ZIPLINE AND/OR BY FOOT.
REPAIR & REPLACE APPROXIMATELY 20 FAILED LOG WEIRS THAT WERE BUILT IN 1978.
PLACE BOWLDERS / COBBLE IN PLUNGE POOLS. PLUG UNDERMINED AREA WITH ADDITIONAL LOGS / ROLLS.
WDFW SUPPORTS PIPING W. BRANCH OF WATERCOURSE

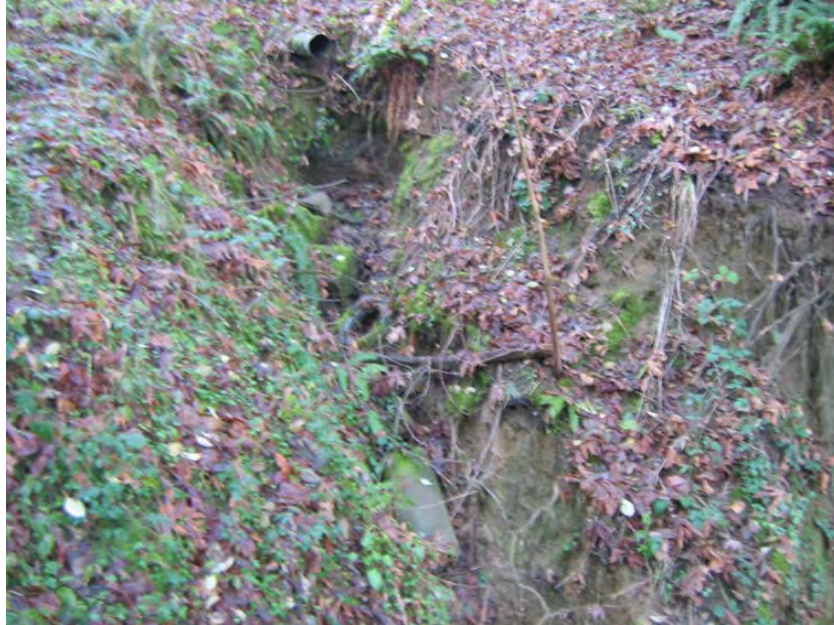
Basin No.:	49b
Project No:	49b.4
Project Title:	Butt-fused HDPE Pipeline on Stream Stabilization East of 91st Avenue SE in 4700 Block
Problem Description:	Large scale, severe erosion of 1,000 CY at an existing 12-inch storm drainage outlet in 47 th Open Space near a primitive trail. The outlet drops 8 feet at invert into a steep channel in semi-consolidated sandy silt. Channel incision is about 100 feet long and the depth varies from 5 to 25 feet. Slope material above 5 feet is loose colluvium. This site is likely not a natural watercourse, but developed from erosion of storm water drainage. Change since 2005 has been slow to moderate. The steep channel gradient creates high risk of long-term erosion and downcutting. See Appendix E for a field sketch of the problem area.
Project Description:	Two alternatives are considered for this problem. The first is to install 12-inch-diameter HDPE pipeline with manhole energy dissipator at the downstream end. Under this alternative it may be desirable to fill the erosion scar. The second alternative is stream stabilization through reconstruction of 100 feet of channel. It is recommended the City get input from WDFW prior to selecting the preferred alternative. The cost estimate is based on the HDPE pipeline alternative.

Looking Upstream at Upper Half of Erosion Problem 12/14/2005
